Station: BEND

T 26 S, R 6W, Sec 19

DESCRIPTION and TO REACH

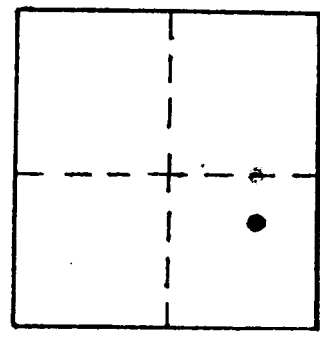
A 2 INCH DIAMETER BRASS DISK STAMPED "BEND 1998"
SET IN QUICK-SET CONCRETE IN TOP OF ROUGH CONCRETE
CULVERT HEADWALL AT NORTH EDGE OF ROAD.

FROM THE INTERSECTION OF GARDEN VALLEY ROAD (Co. Rd. #6) AND
BIG BEND ROAD (Co. Rd. #220) IN T26S, R6W, SEC 19 PROCEED WESTERLY
ALONG BIG BEND ROAD APPROX. 0.3 MI TO MONUMENT ON RIGHT.
