DCSO Designation: C-057

VERTICAL CONTROL

HORIZONTAL CONTROL

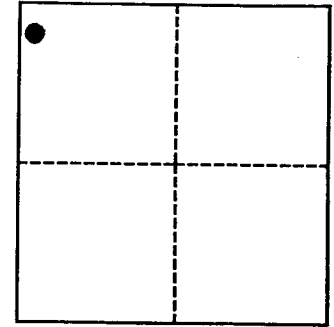
Description: A DCSO disk stamped "CALMEN 1985" set in middle of westerly head wall of bridge over tributary to Lookingglass Creek stamped "CALMEN 1985".

To reach: From the intersection of Brockway-Lookingglass Rd. (Co. Rd. #47) and Happy Valley Rd. (Co. Rd. #26) in T28S R6W Sec7, proceed northwesterly along Co. Rd. #47 approx. 1.2 miles to monument on left.
