**DOUGLAS COUNTY SURVEYOR'S OFFICE**

Designation: G-029 Station: GLEND A T 26S R 6W S 25 1/4 SE

Date Recovered: 2/28/08 Recovered by: SJF, JAP

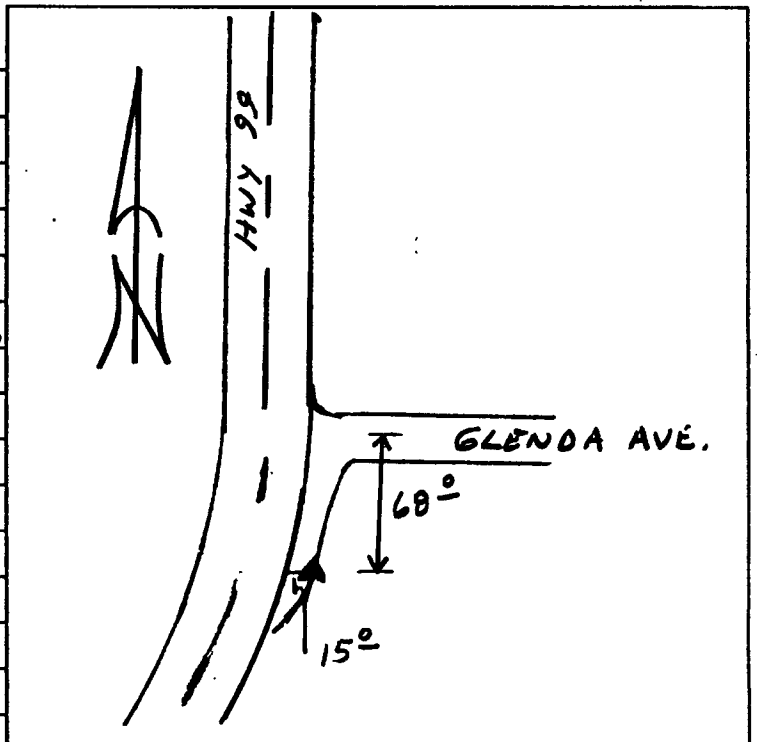
PHOTO  
#100-1324

ADCSO DISK STAMPED  
"GLEND A 1983" SET FLUSH  
IN CONCRETE CURB.

\* NOTE: CURB IS CRACKED  
DCPW 2003 ELEVATION  
REFLECTS ELEVATION  
CHANGE.
