OFFICE OF THE
DOUGLAS COUNTY SURVEYOR

Station: HEN-8

T 22 S, R 86W, Sec 20

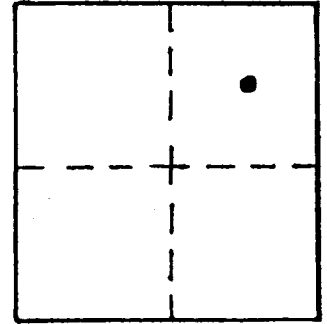
2' W
2' W
7200 475'

A DCSO RISK STAMPED "HEN-8 1998" SET FLUSH IN TOP OF CONCRETE FILLED 8x4S INCH CONCRETE BELLTILE WHICH IS FIRMLY SET AND PROTRUDES APPROXIMATELY 6 INCHES ABOVE GROUND.
