OFFICE OF THE
DOUGLAS COUNTY SURVEYOR

Station: IMAGE T 27 S, R 2 W , Sec 3
 Set By (Agency): DCSO
 Date Set: 1981
 Recovered By _____
 Date Recovered _____
 Recovered By _____
 Date Recovered _____
 Recovered By _____
 Date Recovered _____

1-004
IMAGE

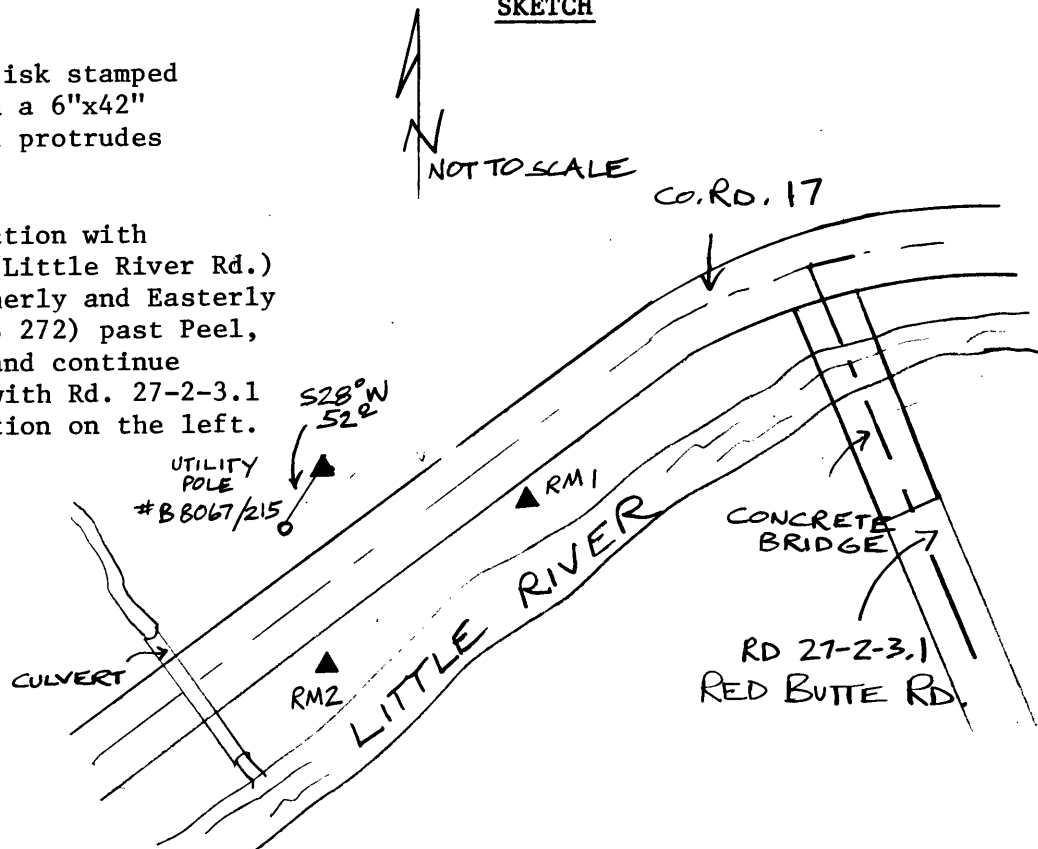
SKETCH

"IMAGE RM 1 1981" is a standard DCSO disk in concrete filled belltile, protruding 6" above the ground bears S83°00'22"E 59.75 ft. (grid) from the station.
 "IMAGE RM 2 1981" is a standard DCSO disk set in concrete filled belltile, protruding 4" above the ground bears S 0°32'57"W 98.77 ft. (grid) from the station.

Station is a standard DCSO disk stamped "IMAGE 1981". Disk is set in a 6"x42" concrete filled belltile and protrudes 2" from the ground.

To Reach: From the intersection with St. Hwy 138 and Co. Rd. 17 (Little River Rd.) west of Glide, proceed Southerly and Easterly on Co. Rd. 17 (it becomes FS 272) past Peel, and the Wolf Cr. Job Corps and continue almost to its intersection with Rd. 27-2-3.1 (Red Butte Rd.) and the station on the left.
