OFFICE OF THE
DOUGLAS COUNTY SURVEYOR

T 26 S, R 6W, Sec 18

J-017
JANE

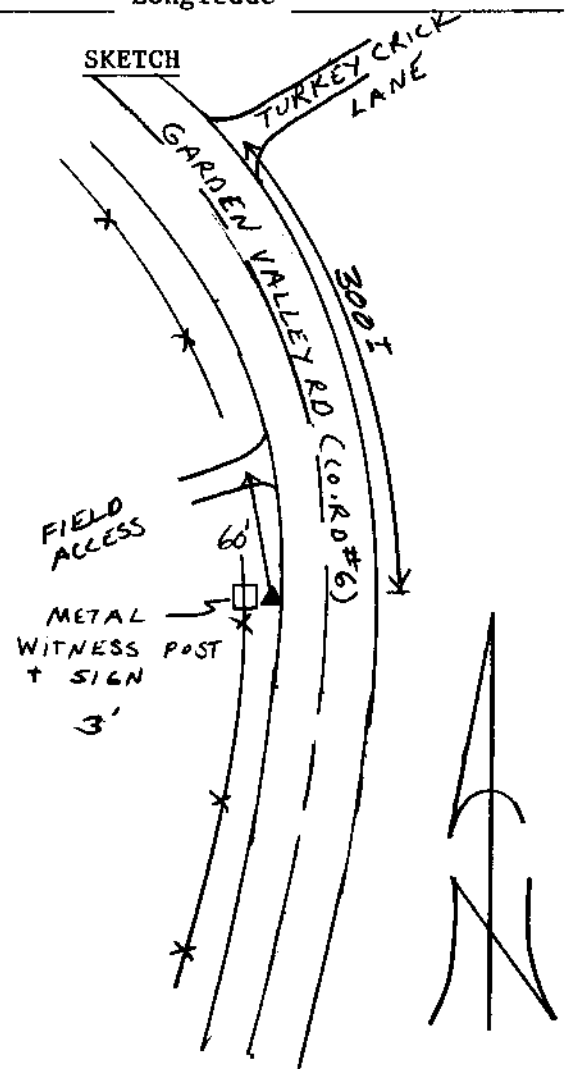
SKETCH

Found: A standard DCSO cap stamped "Jane 1974" set flush in top of 8" O.D. 42" concrete-filled belltile. Mon. protrudes approx. 6" above ground and is approx. 2 ft. higher than road surface near the westerly R/W fenceline
 To reach: From the intersection of Upper Cleveland Rapids Rd. (Co. Rd. #208A) and Garden Vly. Rd. (Co. Rd. #6) in T26S, R6W, sec. 20. proceed northerly along Garden Valley Rd. 1.05 mi. to mon. on lt. at approx. milepost 9.6 and about 300 ft. southerly from intersection with Turkey Crk. Ln.
