**DOUGLAS COUNTY SURVEYOR'S OFFICE**

Designation: K-052 Station: KINDA T 22S R 07W S 19 ¼ D

Date Set: OCTOBER, 2008 Set by (Agency): DCSO

Date Recovered: 12/10/08 Recovered by: SJF, JAP

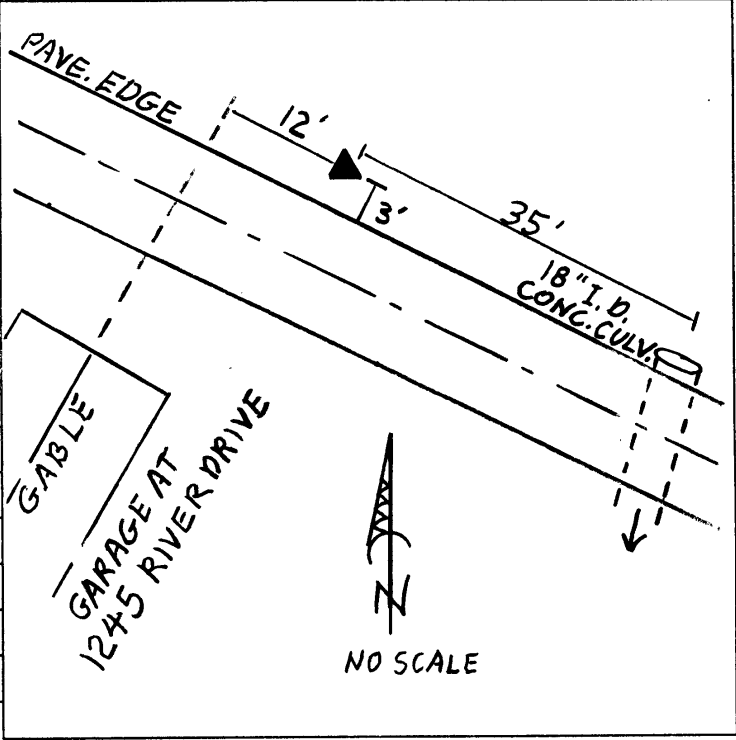
FROM THE INTERSECTION OF STATE HIGHWAY 138 W AND STATE HIGHWAY 38 IN T22S, R07W, SECTION 29 PROCEED NW'LY ALONG STATE HIGHWAY 38 APPROX. 0.5 MILES TO MONUMENT ON RIGHT.

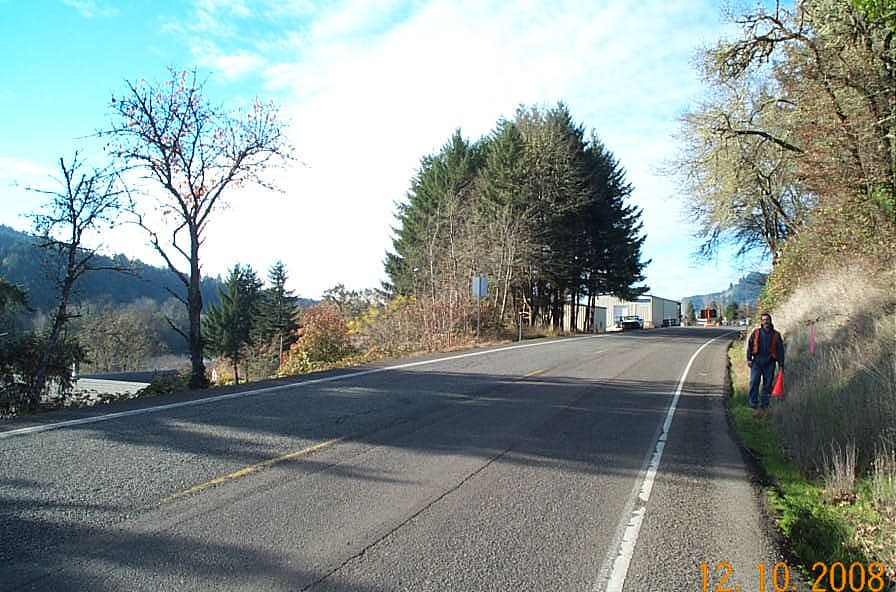
100-1358 (7/22/09 renamed)  
to K-052

A 3 INCH DIAM. PCSO DRILL CAP STAMPED "KINDA 2008" SET IN EXPOSED SECTION OF ROCK LEDGE JUST OFF OF, AND 10 INCHES HIGHER THAN NARROW PAVED HIGHWAY SHOULDER.
