OFFICE OF THE
DOUGLAS COUNTY SURVEYOR

N-059

Station: NANDY

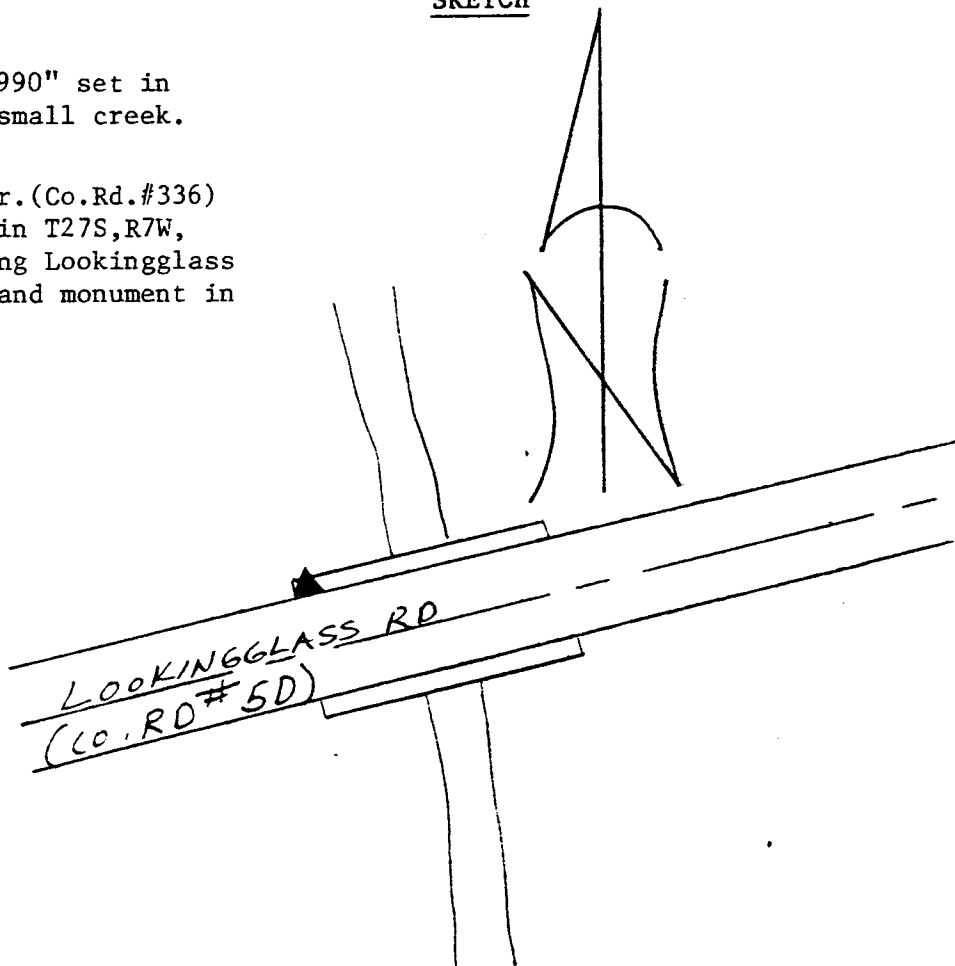
SKETCH

A DCSO drill cap stamped "NANDY 1990" set in northwest corner of bridge over small creek.

Go to the intersection of Nandy Dr. (Co.Rd.#336) and Lookingglass Rd. (Co.Rd.#5D) in T27S,R7W, Sec.25, proceed northeasterly along Lookingglass Rd. approx. 0.08 miles to bridge and monument in northwest corner.
