DOUGLAS COUNTY SURVEYOR'S OFFICE

Designation: R-113 Station: R76 RESET T 29S R 8W S 20 1/4 NW

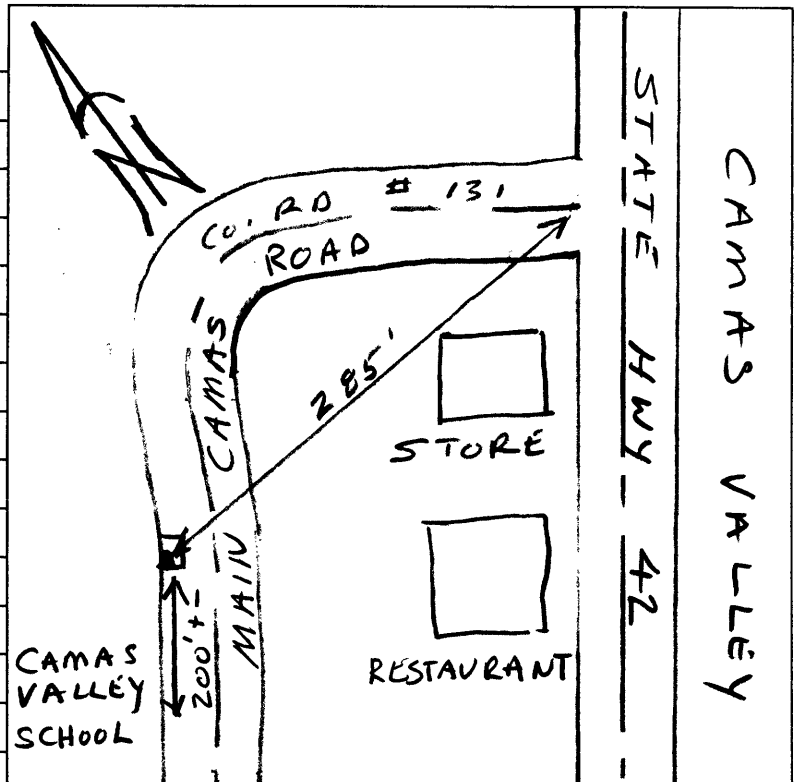
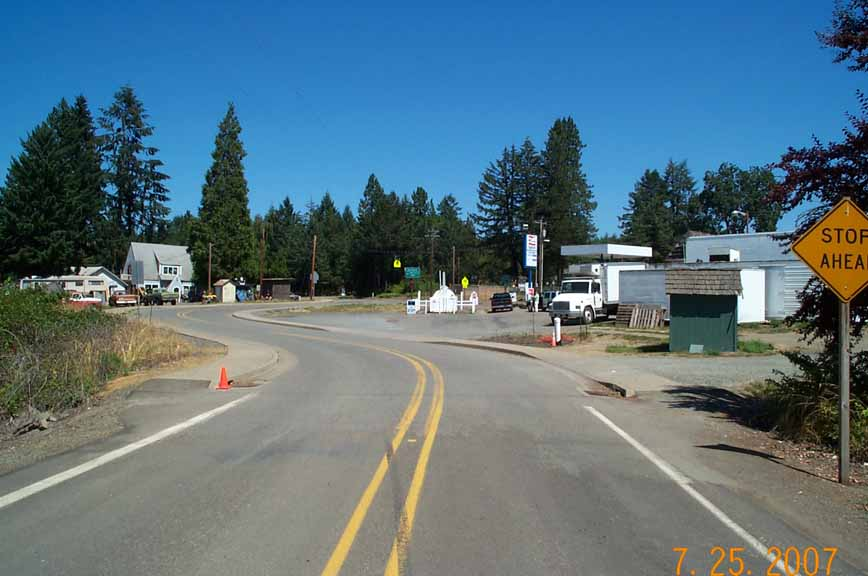
DCSO DRILL CAP STAMPED "R76
RESET 2007" SET AT NW
CORNER OF CONCRETE CATCH
Basin.

FROM THE INTERSECTION OF
STATE HWY 42 AND MAIN
CAMAS ROAD IN T29S R8W
SEC 20 (AT CAMAS VALLEY)
PROCEED SOUTHWESTERLY ALONG
MAIN CAMAS ROAD APPROX.
300 FT TO MONUMENT ON
RIGHT IN CONCRETE
CATCH BASIN.
