OFFICE OF THE
DOUGLAS COUNTY SURVEYOR

Station: STENCH T 28 S, R 6W, Sec 2
 Set By (Agency): DCSO
 Date Set: 1985
 Recovered By RWS, SJF
 Date Recovered APRIL 18, 1985
 Recovered By _____
 Date Recovered _____
 Recovered By _____
 Date Recovered _____

S-131

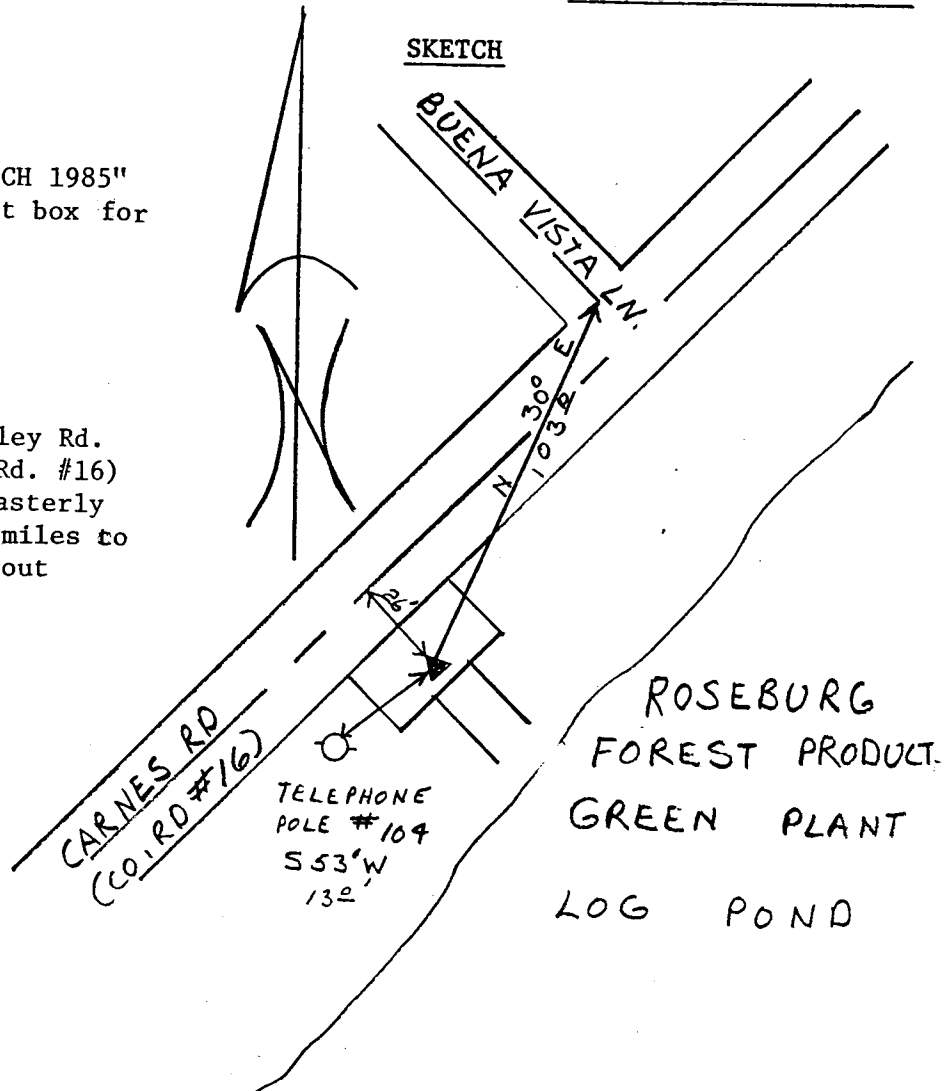
Reference Marks:

A standard DCSO disk stamped "STENCH 1985" set flush on top of concrete outlet box for log pond.

From the intersection of Happy Valley Rd. (Co. Rd. #26) and Carnes Rd. (Co. Rd. #16) in T28S R6W Sec. 2, proceed northeasterly along Carnes Rd. approximately 0.5 miles to monument on right. Monument lies about 2 1/2 ft. lower than road surface.
