S-152

VERTICAL CONTROL NGVD 29

A DCSO brass cap set in wingwall at the northwest corner of bridge over Lookingglass Creek stamped "SWAN 1985."

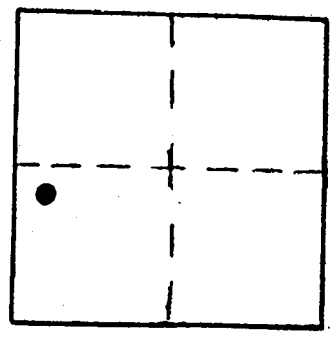
SKETCH

From the intersection of Lookingglass Rd. (Co. Rd. #47) and Happy Valley Rd. (Co. Rd. #26) in T28S, R6W, Sec. 7, proceed southerly along Lookingglass Rd. 1.0 miles to monument on right.

A DCSO disk stamped "SWAN RM1 1985" bears S30°E, 315± ft. (geod.), elev. 548.714 ft.
