OFFICE OF THE
DOUGLAS COUNTY SURVEYOR

Station: TERESA

T 25 S, R 5 W, Sec 7

7-028
TERESA

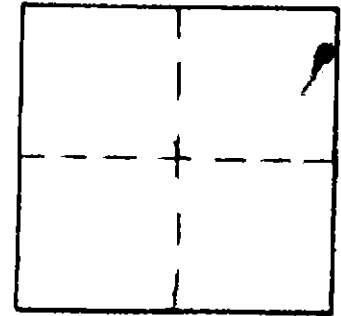
SKETCH

A drilled hole in concrete with a brass stem 1/2 inch below overcrossing surface (brass cap broken off).

Go to the I-5 overcrossing of Stearns Lane (Co. Rd. #10A) in T25S, R5W, Sec. 7. Monument lies in southwest corner of structure.

MONUMENT 0 1/2 FT EAST OF
CONCRETE CURB
18 3/4 FT. TO END
OF CONCRETE STRUCTURE

22 FT TO C OF
SOUTHBOUND LANES

STEARNS LANE
(CO. RD. # 10A)
