OFFICE OF THE
DOUGLAS COUNTY SURVEYOR

Station: W 499 SW T 30 S, R 4 W , Sec 9
Set By (Agency): DCED
Date Set: 1989
Recovered By RWS, SJF
Date Recovered 11/15/89
Recovered By _____
Date Recovered _____
Recovered By _____
Date Recovered _____

W-047 NGVD 29
VERTICAL CONTROL

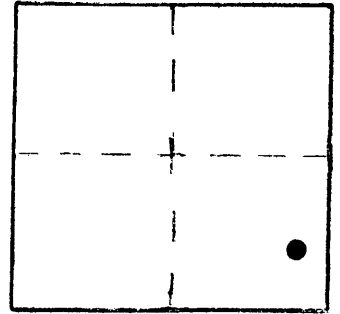
SKETCH

Found an unstamped DCED brass cap near the southwest corner of concrete bridge rail, we stamp "W 499 SW 1989".

From the intersection of State Hwy. 277 and Beals Creek Rd. (Co.Rd.#94) in T30S,R4W,Sec.9, proceed northeasterly along State Hwy. 277 0.1 miles to bridge over South Umpqua river. Monument is at southwest corner of bridge.
