OFFICE OF THE
DOUGLAS COUNTY SURVEYOR

Station: MELINDA
Date Set: 1991
Set By (Agency): DCSO
Date Recovered: 3/7/91
Recovered By: RWS,SJF
Date Recovered: _____
Recovered By: _____
Date Recovered: _____
Recovered By: _____

DESIG. M-094

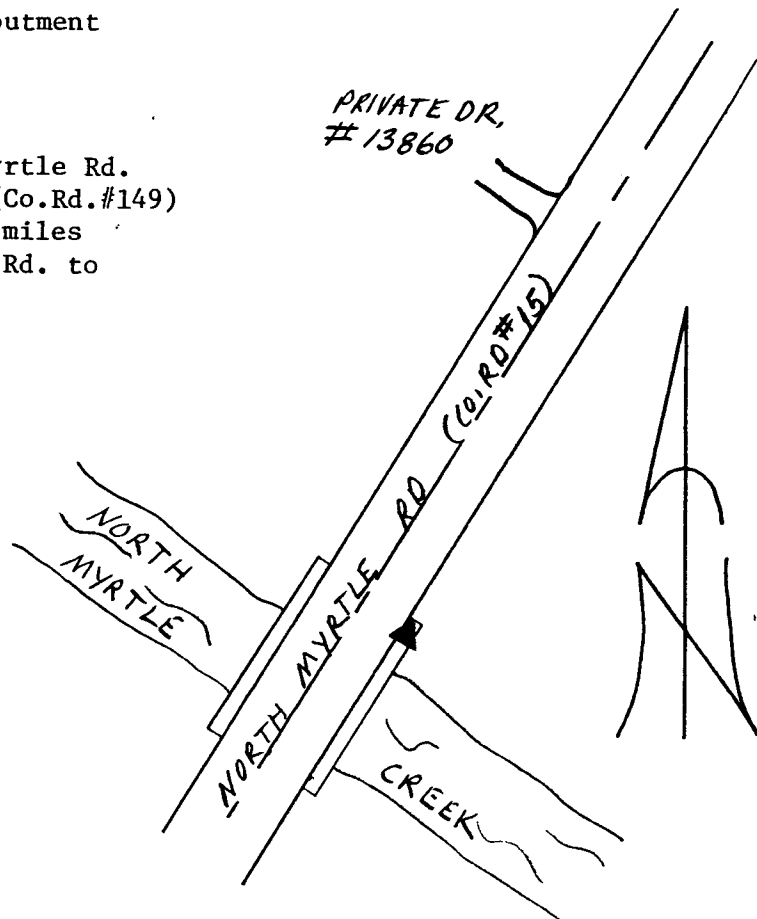
SKETCH

A DCSO disk stamped "MELINDA 1991" set in the southeast corner of bridge abutment crossing North Myrtle Creek.

From the intersection of North Myrtle Rd. (Co.Rd.#15) and Slide Creek Rd. (Co.Rd.#149) in T28S,R4W,Sec.33, proceed 4.25 miles northeasterly along North Myrtle Rd. to monument on the right.
