OFFICE OF THE  
DOUGLAS COUNTY SURVEYOR

Station: Jane  
Date Set: 1974  
Set By (Agency): DCSO  
Date Recovered: 8-19-91  
Recovered By: SJF  
Date Recovered: \_\_\_\_\_  
Recovered By: \_\_\_\_\_  
Date Recovered: \_\_\_\_\_  
Recovered By: \_\_\_\_\_

J-017  
JANE  
26S 6W 18

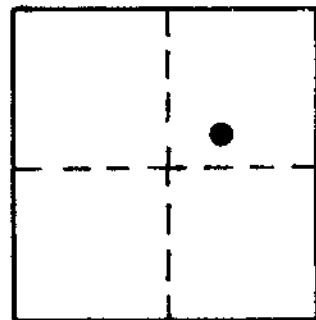
Found: A standard DCSO cap stamped "Jane 1974" set flush in top of 8" O.D. 42" concrete filled belltile. Mon. protrudes approx. 6" above ground and is approx. 2 ft. higher than road surface near the westerly R/W fenceline

To reach: From the intersection of Upper Cleveland Rapids Rd. (Co. Rd. #208A) and Garden Vly. Rd. (Co. Rd. #6) in T26S, R6W, sec. 20. proceed northerly along Garden Valley Rd. 1.05 mi. to mon. on lt. at approx. milepost 9.6 and about 300 ft. southerly from intersection with Turkey Crk. Ln.
