DOUGLAS COUNTY SURVEYOR'S OFFICE

Designation: 70-166 Station: 26+15.07 T 27S R 6W S 14 $\frac{1}{4}$ NE

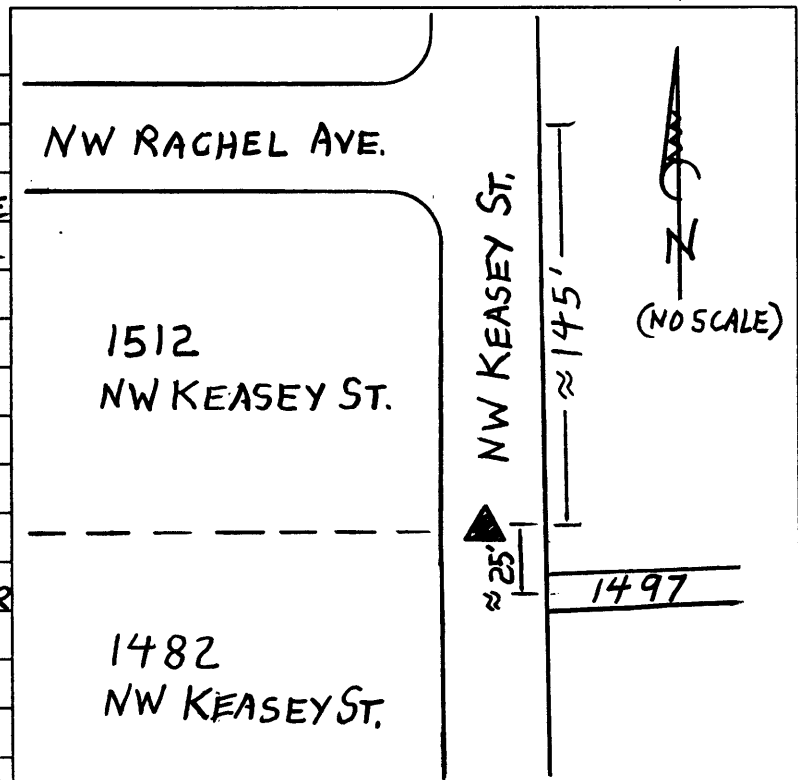
A 2 5/8 INCH DIAM. BRASS CAP
STAMPED "AA SURVEYING INC" ON
A 1 1/2 x 36 INCH GALV. IRON PIPE
SET BELOW ASPHALT ROAD SUR-
FACE, UNDER A 7 INCH DIAM.
ALUMINUM MONUMENT COLLAR
AND COVER.

GO TO THE INTERSECTION
OF NW RACHEL AVE. AND NW
KEASEY ST. IN THE NE QUARTER
OF SECTION 14, T27S, R6W.
MONUMENT IS NEAR $\frac{1}{4}$ OF
KEASEY ST. AND APPROX. 145 FT.
SOUTH OF INTERSECTION WITH RACHEL
