OREGON CORNER RESTORATION FORM

Section 34 **Township** 19S **Range** 9W

N.E. Corner
Section 34

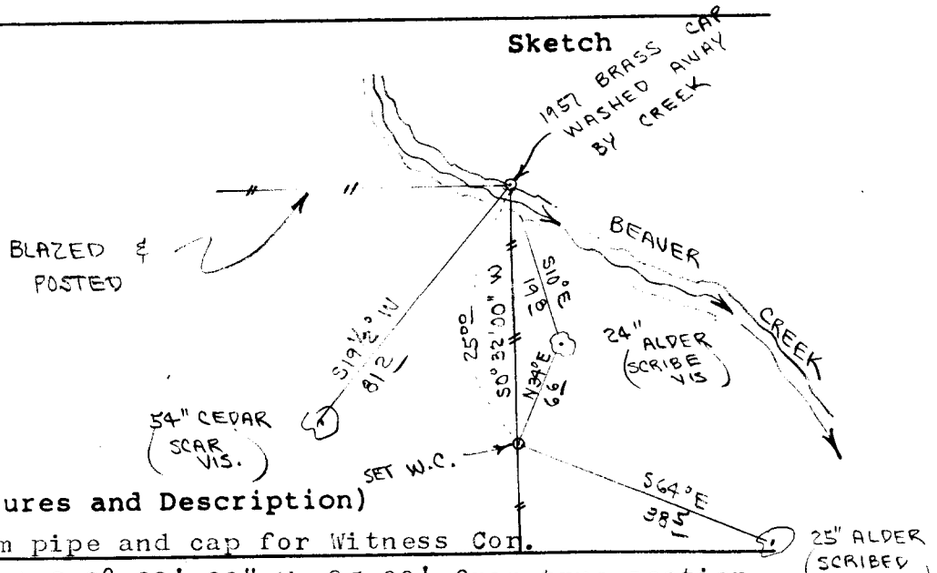
Sketch

Found 1957 B.L.M. Brass Cap laying on creek bank. Brass Cap had been washed away by Beaver Creek.
24" Alder, S10E, 19.8'(Bark Scribed), 1899 BT. Rec. S14E, 19.3'
54" Cedar, S19½W, 81.2'(Scar Vis.) , 1957 BT. Rec. S19½W, 81.2'
20" Alder set in 1899 and found in 1957 is now destroyed.
22" Alder bearing N49E and set in 1957 is now destroyed.
18" Alder bearing N71W and set in 1957 has been up-rooted by creek.

Set 2" x 30" Aluminum pipe and cap for Witness Cor. Witness Corner was set S 0° 32' 00" W, 25.00' from true section corner, see sketch. See filed survey in Section 34 for survey procedures. Buried purple magnetic marker under 30" aluminum pipe.

25" Alder, S64E, 38.5' (Bark Scribed/Painted/Brass Washer)
24" Alder, N34E, 6.6' (BarkScribed /Painted/Brass Washer)
Set metal fence post beside brass cap. Wired survey attention sign to fence post.
