OREGON CORNER RESTORATION FORM

Section 34 Township 20S Range 9W

N.W. Corner
Section 34

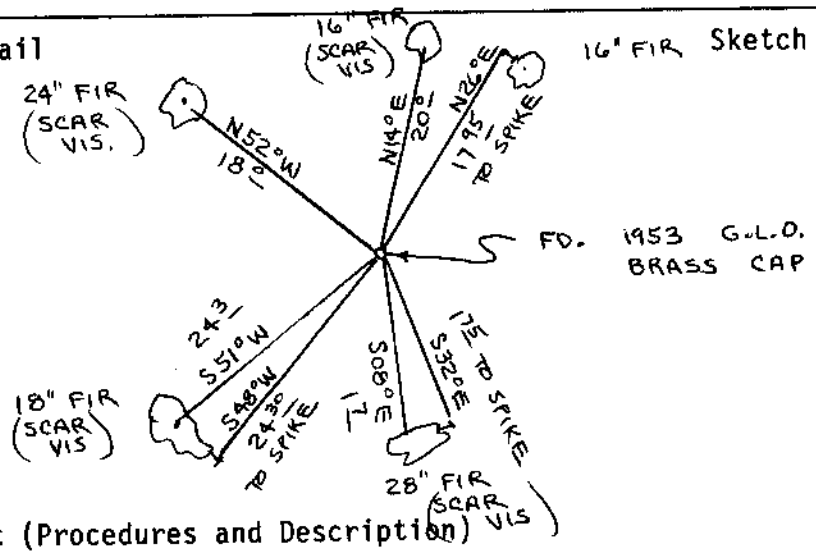
Monument Detail

Found 1953 G.L.O. Brass Cap set firmly in the ground.
16" Fir, N14E, 20.0' (Scar Vis.), 1953 BT. Rec. N13½E, 19.8'
18" Fir, S51W, 24.3' (Scar Vis.), 1953 BT. Rec. S56¼W, 25.7'
24" Fir, N52W, 18.0' (Scar Vis.), 1953 BT. Rec. N51 3/4W, 17.8'
28" Fir, S08E, 1.7' (Scar Vis.), 1953 BT. Rec. S10E, 2.3'

16" FIR Sketch

Because of planned logging activity in this area in the near future, I set the following R.P.'s.
16" Fir, N26E, 17.95' to 6" steel spike.
18" Fir, S48W, 24.30' to 6" steel spike.
28" Fir, S32E, 1.75' to 6" steel spike.
