COUNTY SURVEYOR'S OFFICE

G.S. FILE NO 57/26-1 (OVER)

COUNTY OF DOUGLAS

We would like to have your opinion on a problem concerning an original government survey corner, more particularly the southeast corner of Section 32, Township 27 South, Range 5 West, Willamette Meridian. We were requested by an interested party to remonument this corner based on their discovery of an original bearing tree and scribing.

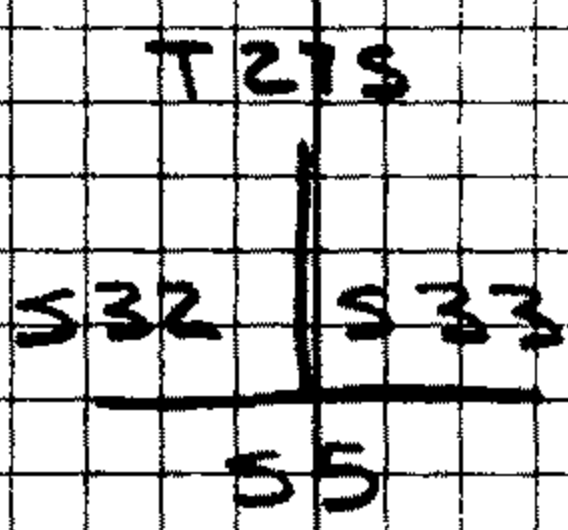
AT THE CORNER POINT DETERMINED BY
THE RECORD BEARING & DISTANCE FROM THE
ABOVE NOTED ORIGINAL BT, N42°E
5 ³/₄ FT. WE SET A 1" X 30" I. PIPE WITH
BRASS CAP ATTACHED, MARKED;

#141 T275 ✓
 #139 T285 ✓
 T285 R5W
