**RE-ESTABLISHMENT
OF CORNER COMMON TO
SECTIONS 4, 5, 8, & 9, T. 26 S., R. 2 W.**

SCALE: 1"=1000'

JANUARY, 1952

Weyerhaeuser Timber Company
By Lester Calder
Oregon Professional Engineer
Registration No. 2149

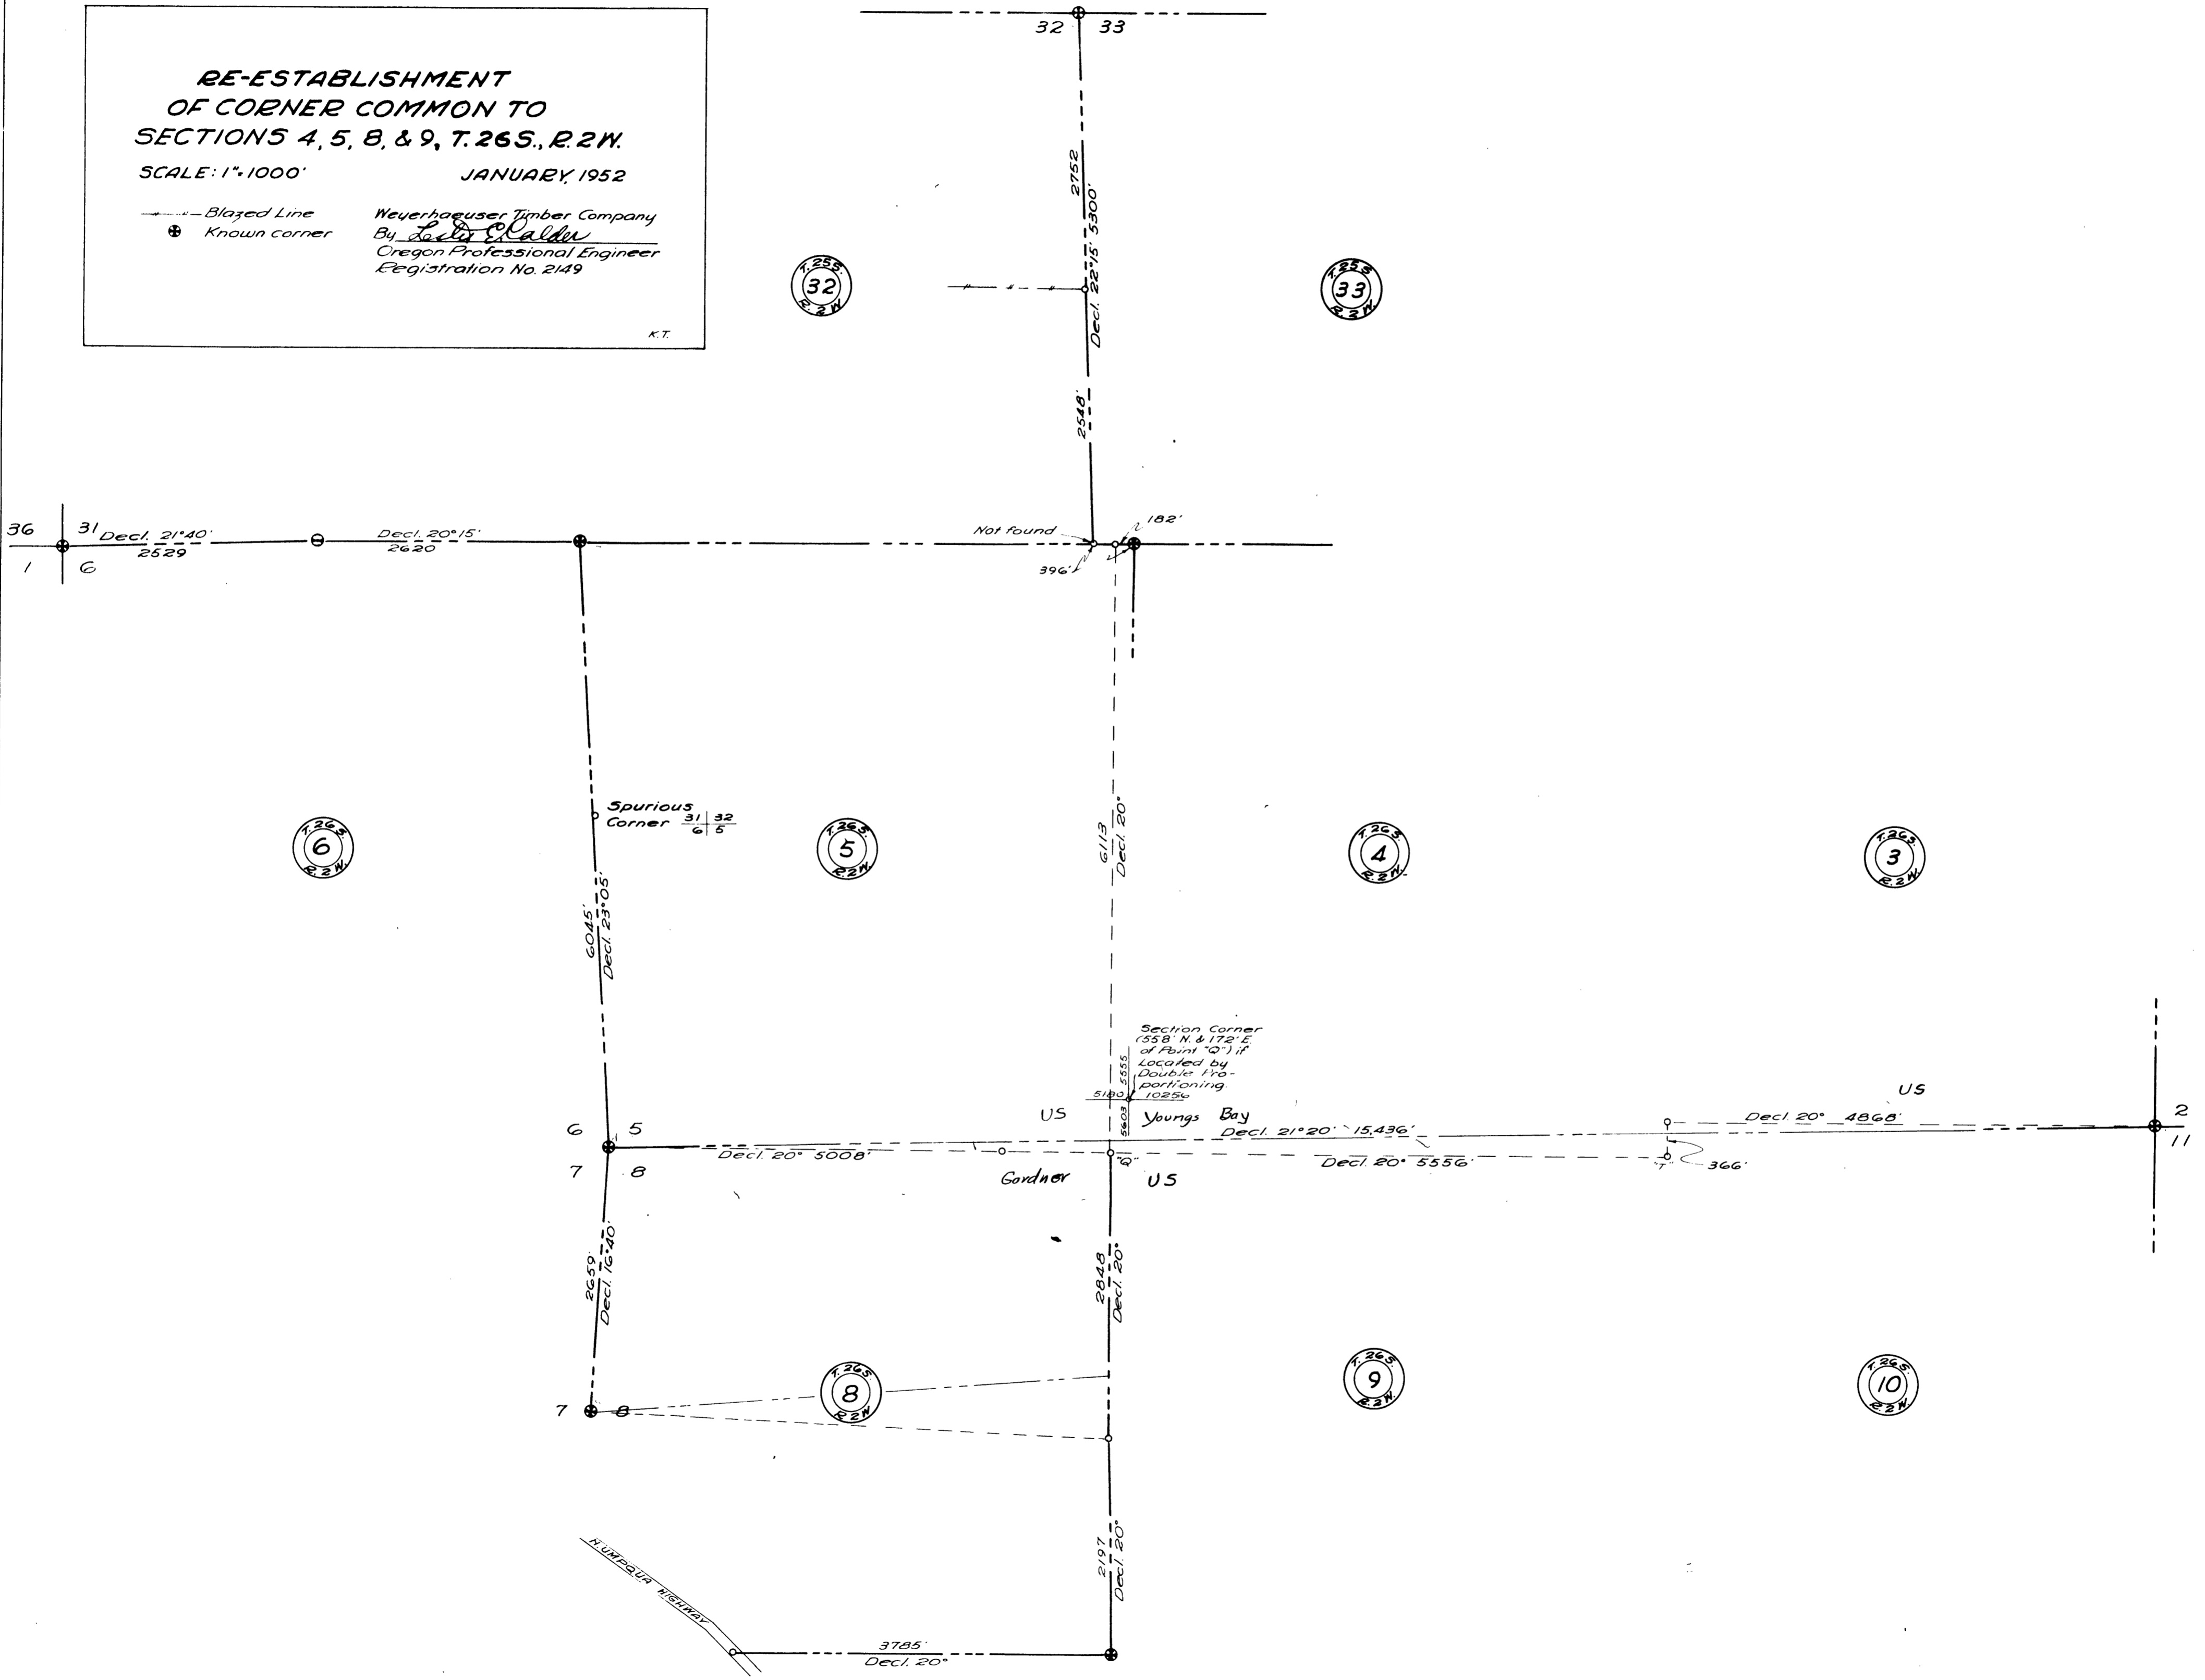
--- Blazed Line
+ Known corner

Staff compass and abney slope chaining survey.

This plat shows the reconnaissance work and is supplied for the purpose of study to determine future procedure.

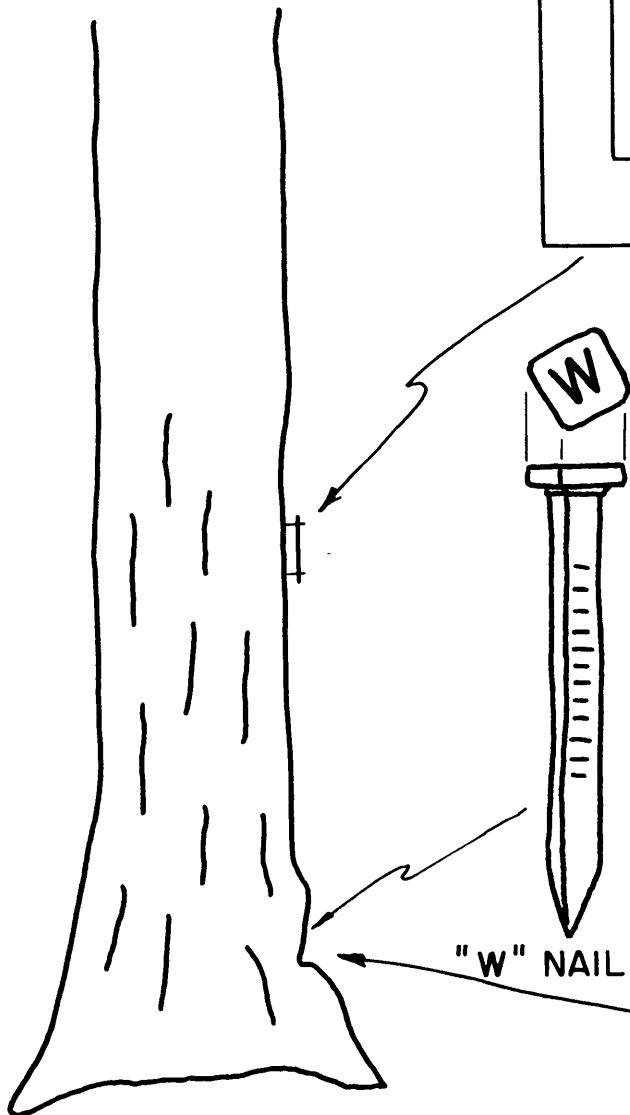
ALUMINUM PLATE.

Scale : Actual Size
