DOUGLAS COUNTY SURVEYOR

GOVERNMENT CORNER RESTORATION FORM

Township 26 S Range 3W Sec. 9 County DOUGLAS

C.S. 1/16 SEC. 9

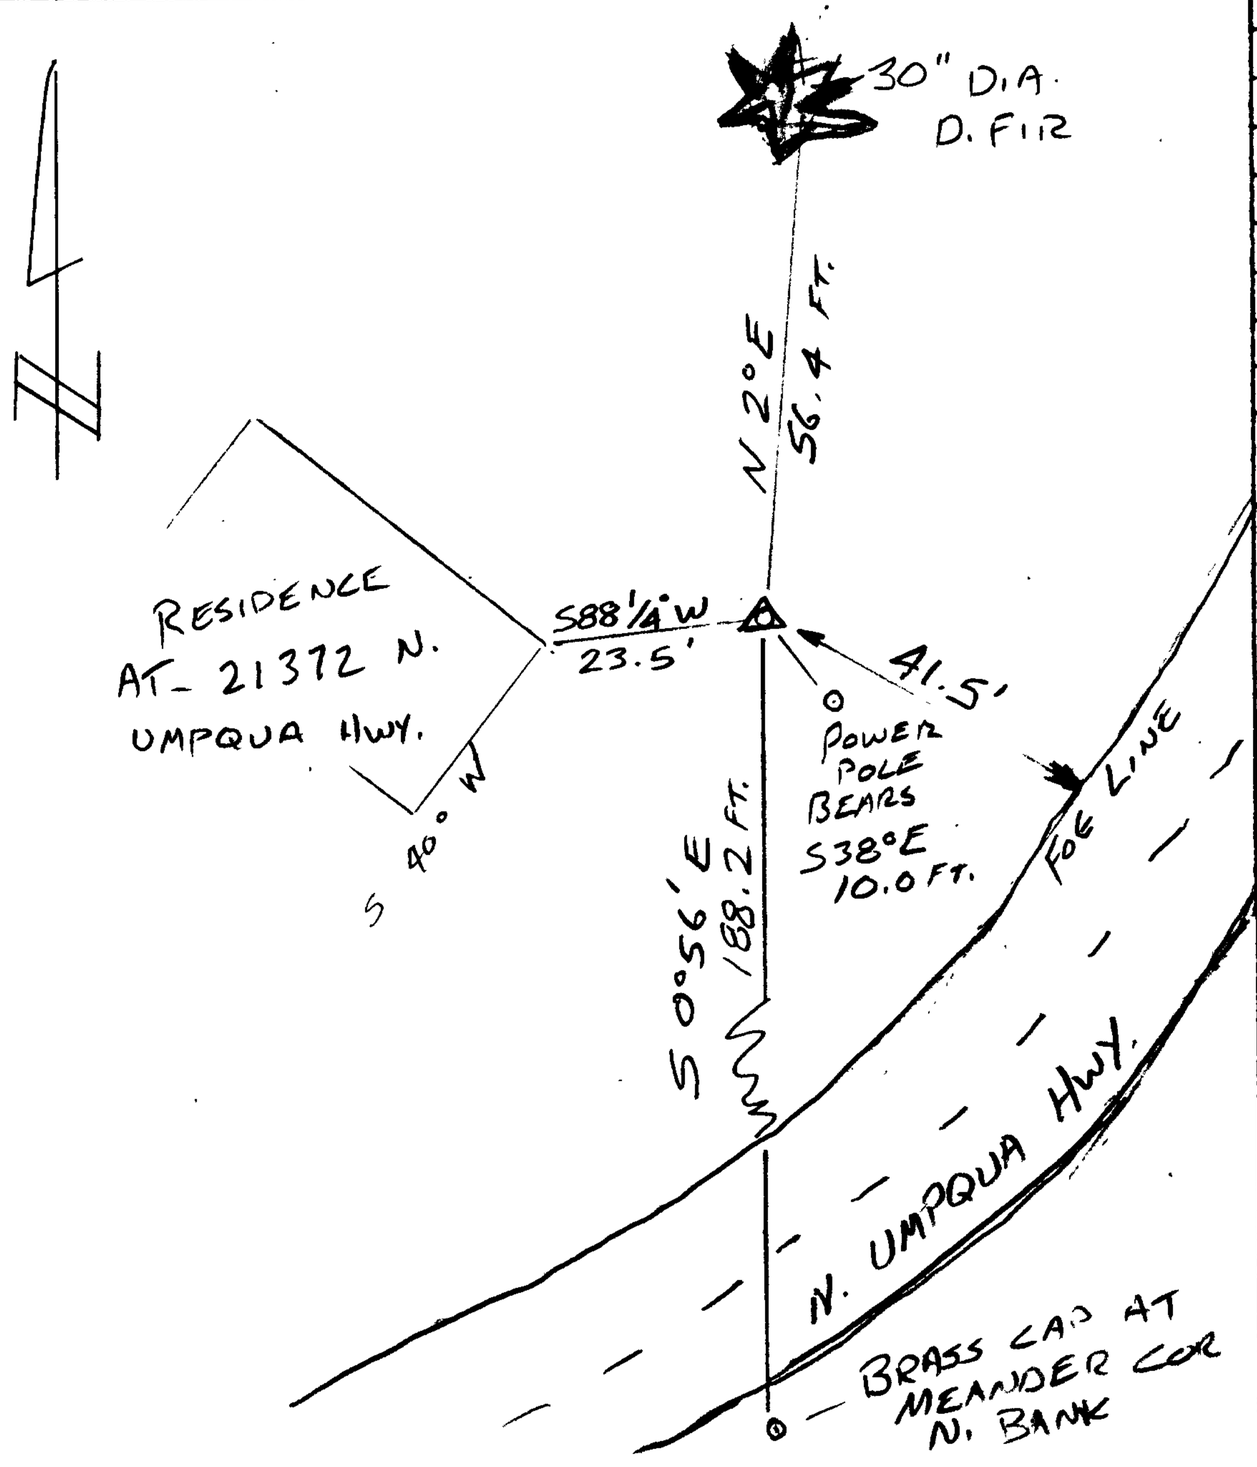
Sketch of Monument, Acessories, and General Area

2 1/2" DIA. BRASS CAP MARKED AS SHOWN ON 1" O.D. IRON PIPE, SET FLUSH WITH TOP OF GROUND.

- 8" NOW 30" DIA. D. FIR, FULLY HEALED DOUBLE BLAZE BEARS N 2°E, 56.4 FT. (REC. N 6°E, 56.4 FT.)
- POWER POLE "B 20720" BEARS S 38°E, 10.0 FT. (REC. S 34°W, 10.2 FT.)
- SE CORNER OF RESIDENCE AT 21372 N. UMPQUA HWY BEARS S 88 1/4°W, 23.5 FT. REC. N 88°W, 23.5 FT. TO SE CORNER ROYAL COACHMAN CAFE

2½" DIA BRASS CAP ON IRON PIPE AT MEANDER CORNER NORTH BANK OF N. UMPQUA RIVER ON N-S CENTERLINE SECTION 9 BEARS S 0°56' E 188.2 FT. (REC. S 0°56'E, 190.1 FT.)

LIES APROX S 60°E, 41.5 FT FROM FOG LINE ON N. UMPQUA HWY. SEE SKETCH
