WEYERHAEUSER TIMBER COMPANY

Section 24 Township 26 S. Range 3 W.

Staff compass and abney slope chain survey.

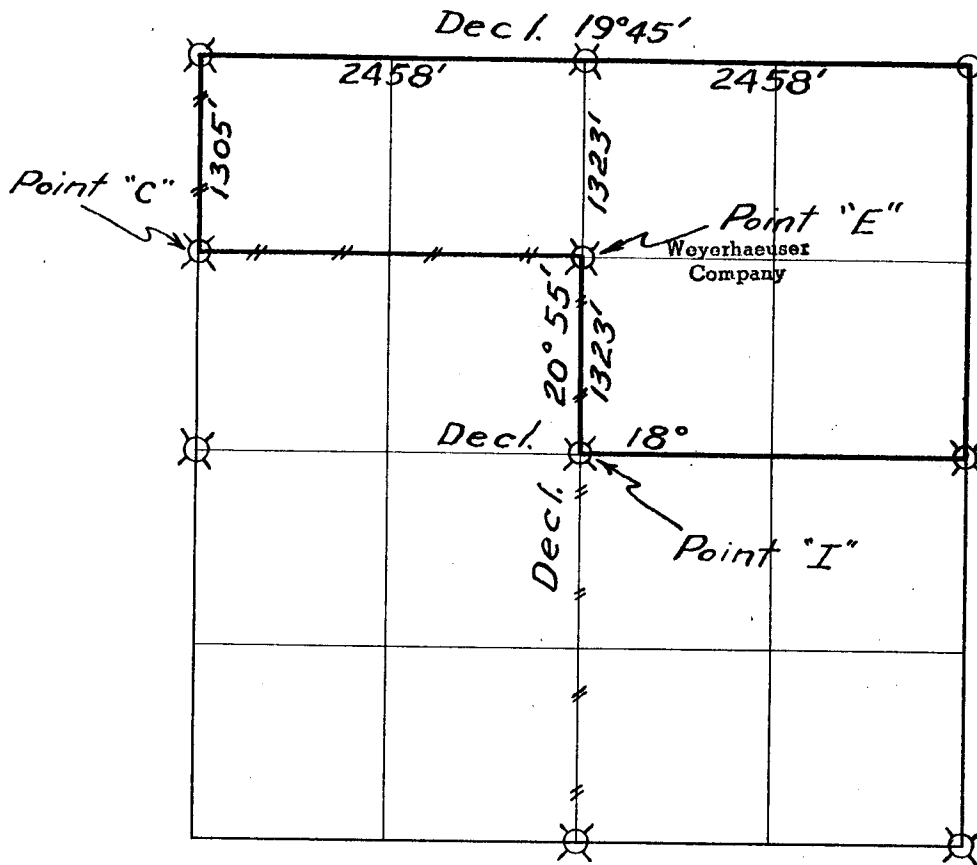
// // Line marked by notch cut in blaze

Known corner

Referenced corner

This survey was made for Weyerhaeuser Timber Company and Youngs Bay Lumber Company by Curtis Price, William Semmler, and Charles Stanfield in a 1950-51 joint survey, and for Weyerhaeuser Timber Company and U. S. Plywood by Glen McChesney, Tom Shrum, and Don Wright in a 1959 joint survey. Both of these surveys were done under the supervision of Lester E. Calder, Oregon Licensed Engineer, Registered Professional Engineer.

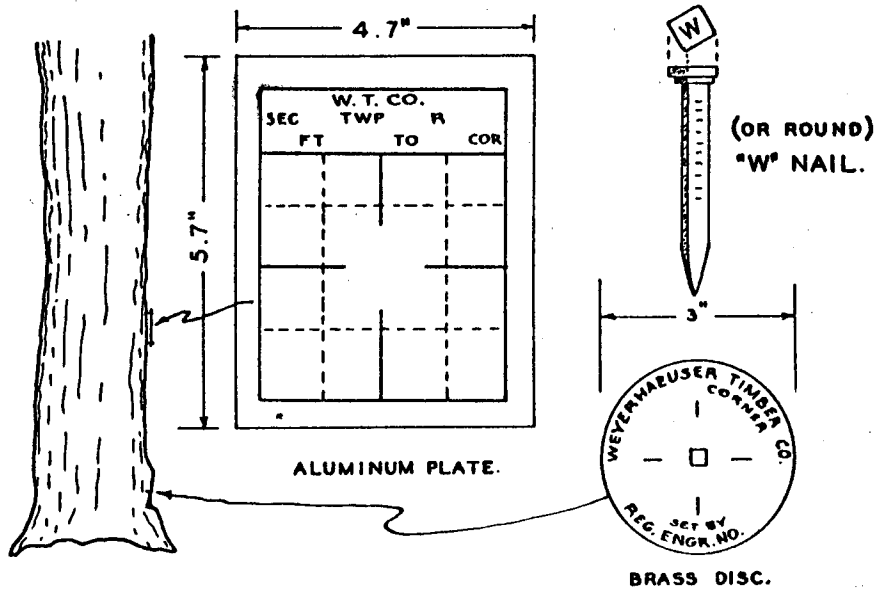
WEYERHAEUSER TIMBER COMPANY CORNER REFERENCE METHOD

A "W" nail driven thru the hole in a brass disc, into a notch cut low on a tree, stamped with the Oregon registered land surveyor or professional engineer registration number. An embossed aluminum plate nailed head high on same tree with 8d aluminum nails, with distance and bearing from the "W" nail to the corner stamped on it.
