UNITED STATES
DEPARTMENT OF THE INTERIOR
BUREAU OF LAND MANAGEMENT

Detailed consideration has been given by our staff to the problems involved in the restoration of corners along the second meridional section line in Township 23 South, Range 7 West, of the Willamette Meridian. The following method, while not the only possible one, is in our belief the most practicable, and is most likely to restore the conditions of the original surveys.

C. S. File No. 51/201

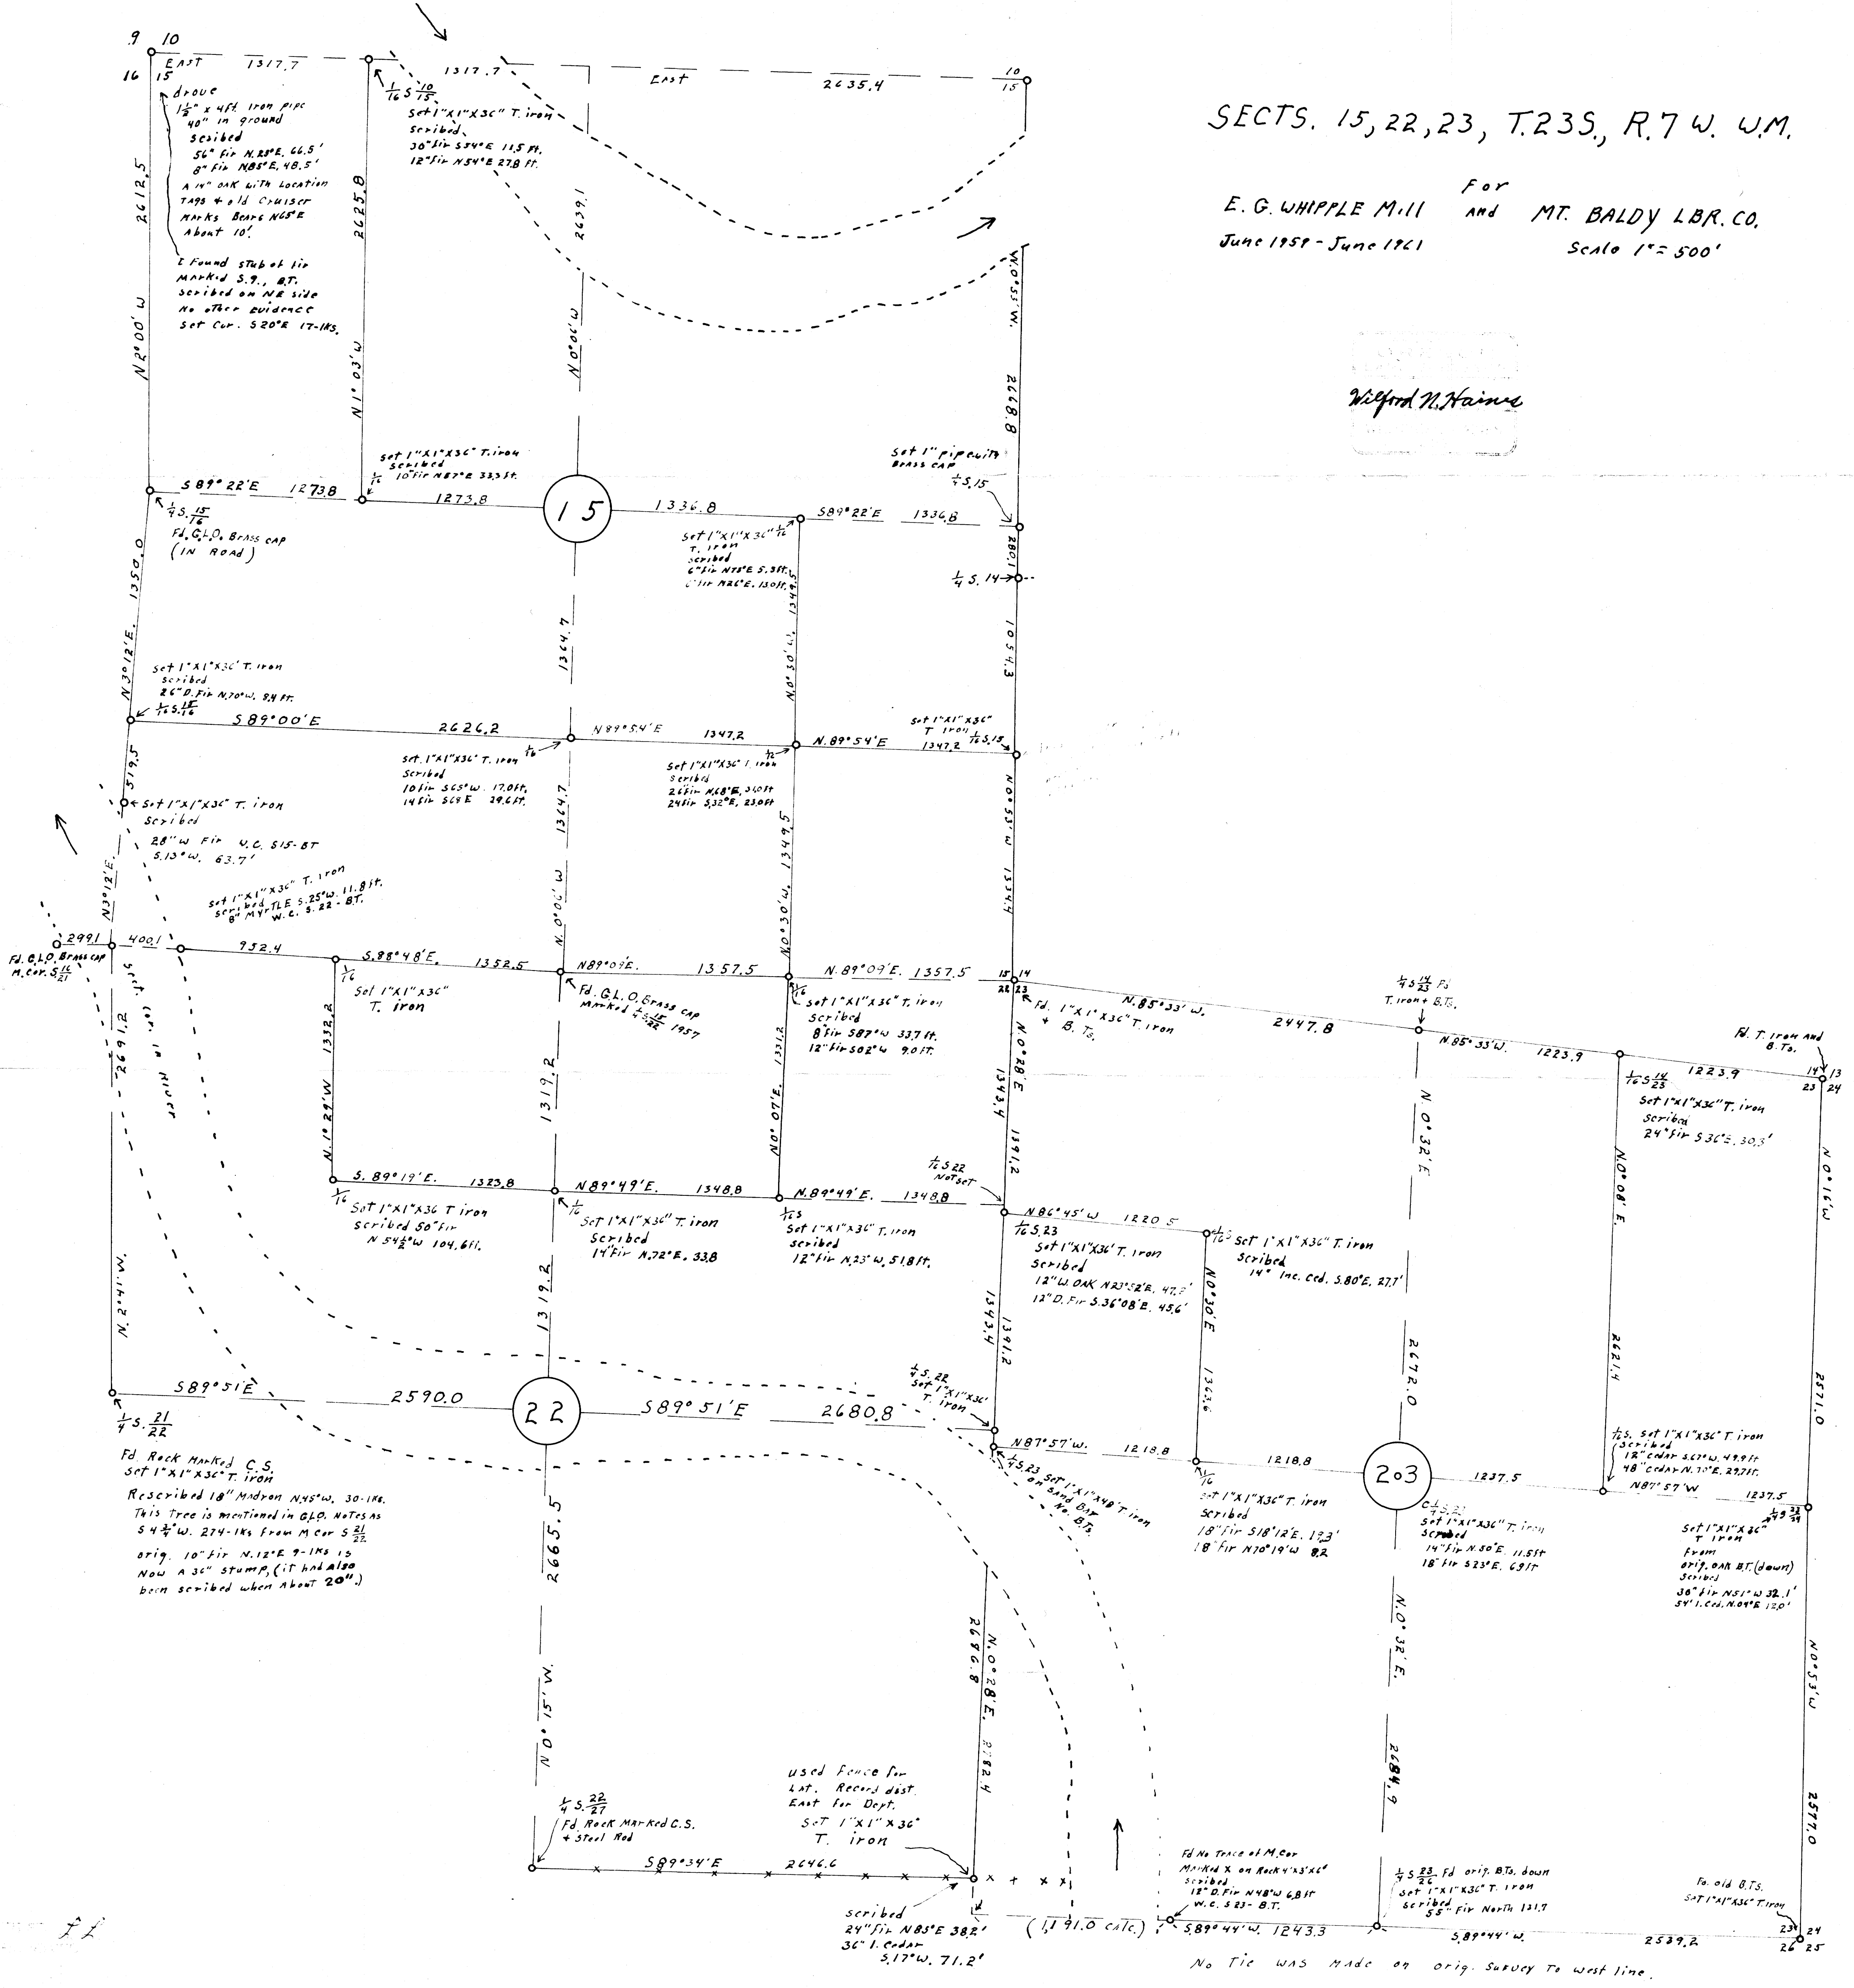
For
E. G. WHIPPLE Mill and MT. BALDY LBR. CO.
June 1959 - June 1961
Scale 1" = 500'

No Tie was made on orig. survey to west line.
