# PUBLIC LAND CORNERS

**WEYERHAEUSER COMPANY  
SPRINGFIELD BRANCH**

TOWNSHIP 25S RANGE 2W  
 SECTION 4 CORNER SE Cor. Parcel 41  
 COUNTY Douglas OREGON

**GLO SURVEY RECORD**

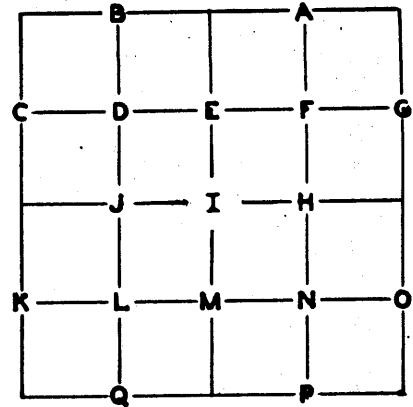
Civil No. 60-135

Set 3/4" Iron pipe

8" Fir - S61 1/4 W 46 lks.

9" Fir - N4 3/4 W 69 lks.

8" Hemlock (not Fir) scribing visible

CORNER SET: Pipe as found MAG. DECL.: 20°

BEARING-	FEET-	SURVEY -
S62W	30.0	to face
N4W	45.1	to face

BEARING	FEET	ORIG. B.T.	"W" NAIL	PLATE	BRASS DISC
22" Red Cedar	N78W	31.6	-	x	x	-
34" Red Cedar	S14W	41.4	-	x	x
