SURVEY in DLC 44 & 45

NW & SW 1/4 SEC. 13

T 22 S - R 9 W, W. M.

Purpose of this survey was to establish the common boundary between Donation Land Claims 44 & 45, T22S - R9W, Will. Mer.

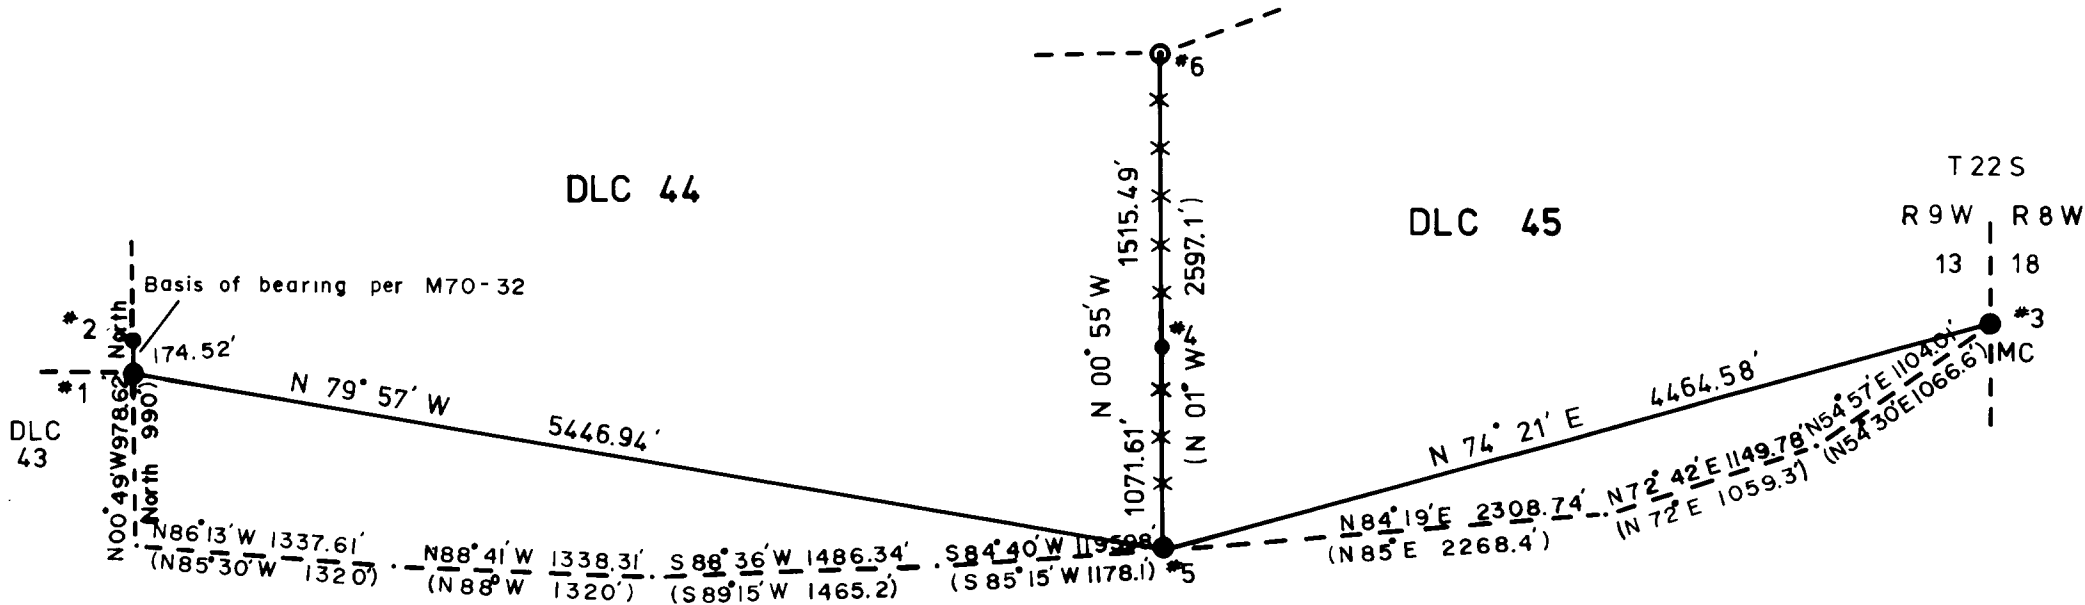
SEE NARRATIVE FOR CORNER DESCRIPTION AND SURVEY INFORMATION

The following is a record of all corners found or set as shown on the plat of this survey.

A thorough search was made for the common corners NE DLC 44/NW DLC 45 and SE DLC 44/SW DLC 45 with no acceptable evidence found. A fence line exists as the accepted boundary between the two DLCs as stated by the adjoining landowners, whose families have had continuous ownership of these lands for approximately one hundred years. The landowners to the east have personal recollection that the fence line has been used in its present location for more than seventy years.

I ran a control survey from the meander corner on the north bank of the Umpqua River between section 13, T22S - R9W and section 18, T22S - R9W (an angle point for DLC 45) to the NE corner DLC 43 (a point on the west boundary DLC 44). Proportioning the common corner SE DLC 44/SW DLC 45 between the two control corners per instructions in para. 5-43, Manual of Surveying Instructions, 1973 would have established this corner approximately 20 ft. west of the fence line. With this proportioning to substantiate the testimony of the landowners, I accept the fence line as the original DLC line and re-establish the SE DLC 44/SW DLC 45 using the fence line for departure control and proportioning as latitudinal control.

I then re-established the NE DLC 44/NW DLC 45 at record distance northerly along the fence line.
