M 90-29

November 22, 1982

This letter is in response to your inquiry of November 16, 1982, regarding the corner positioning and proportions of section 2, T. 23 S., R. 8 W., Willamette Meridian, Oregon, as shown on the plat submitted by you. The problem to be addressed is somewhat complex due to the chain of original surveys, retracements, and/or resurveys in this area.

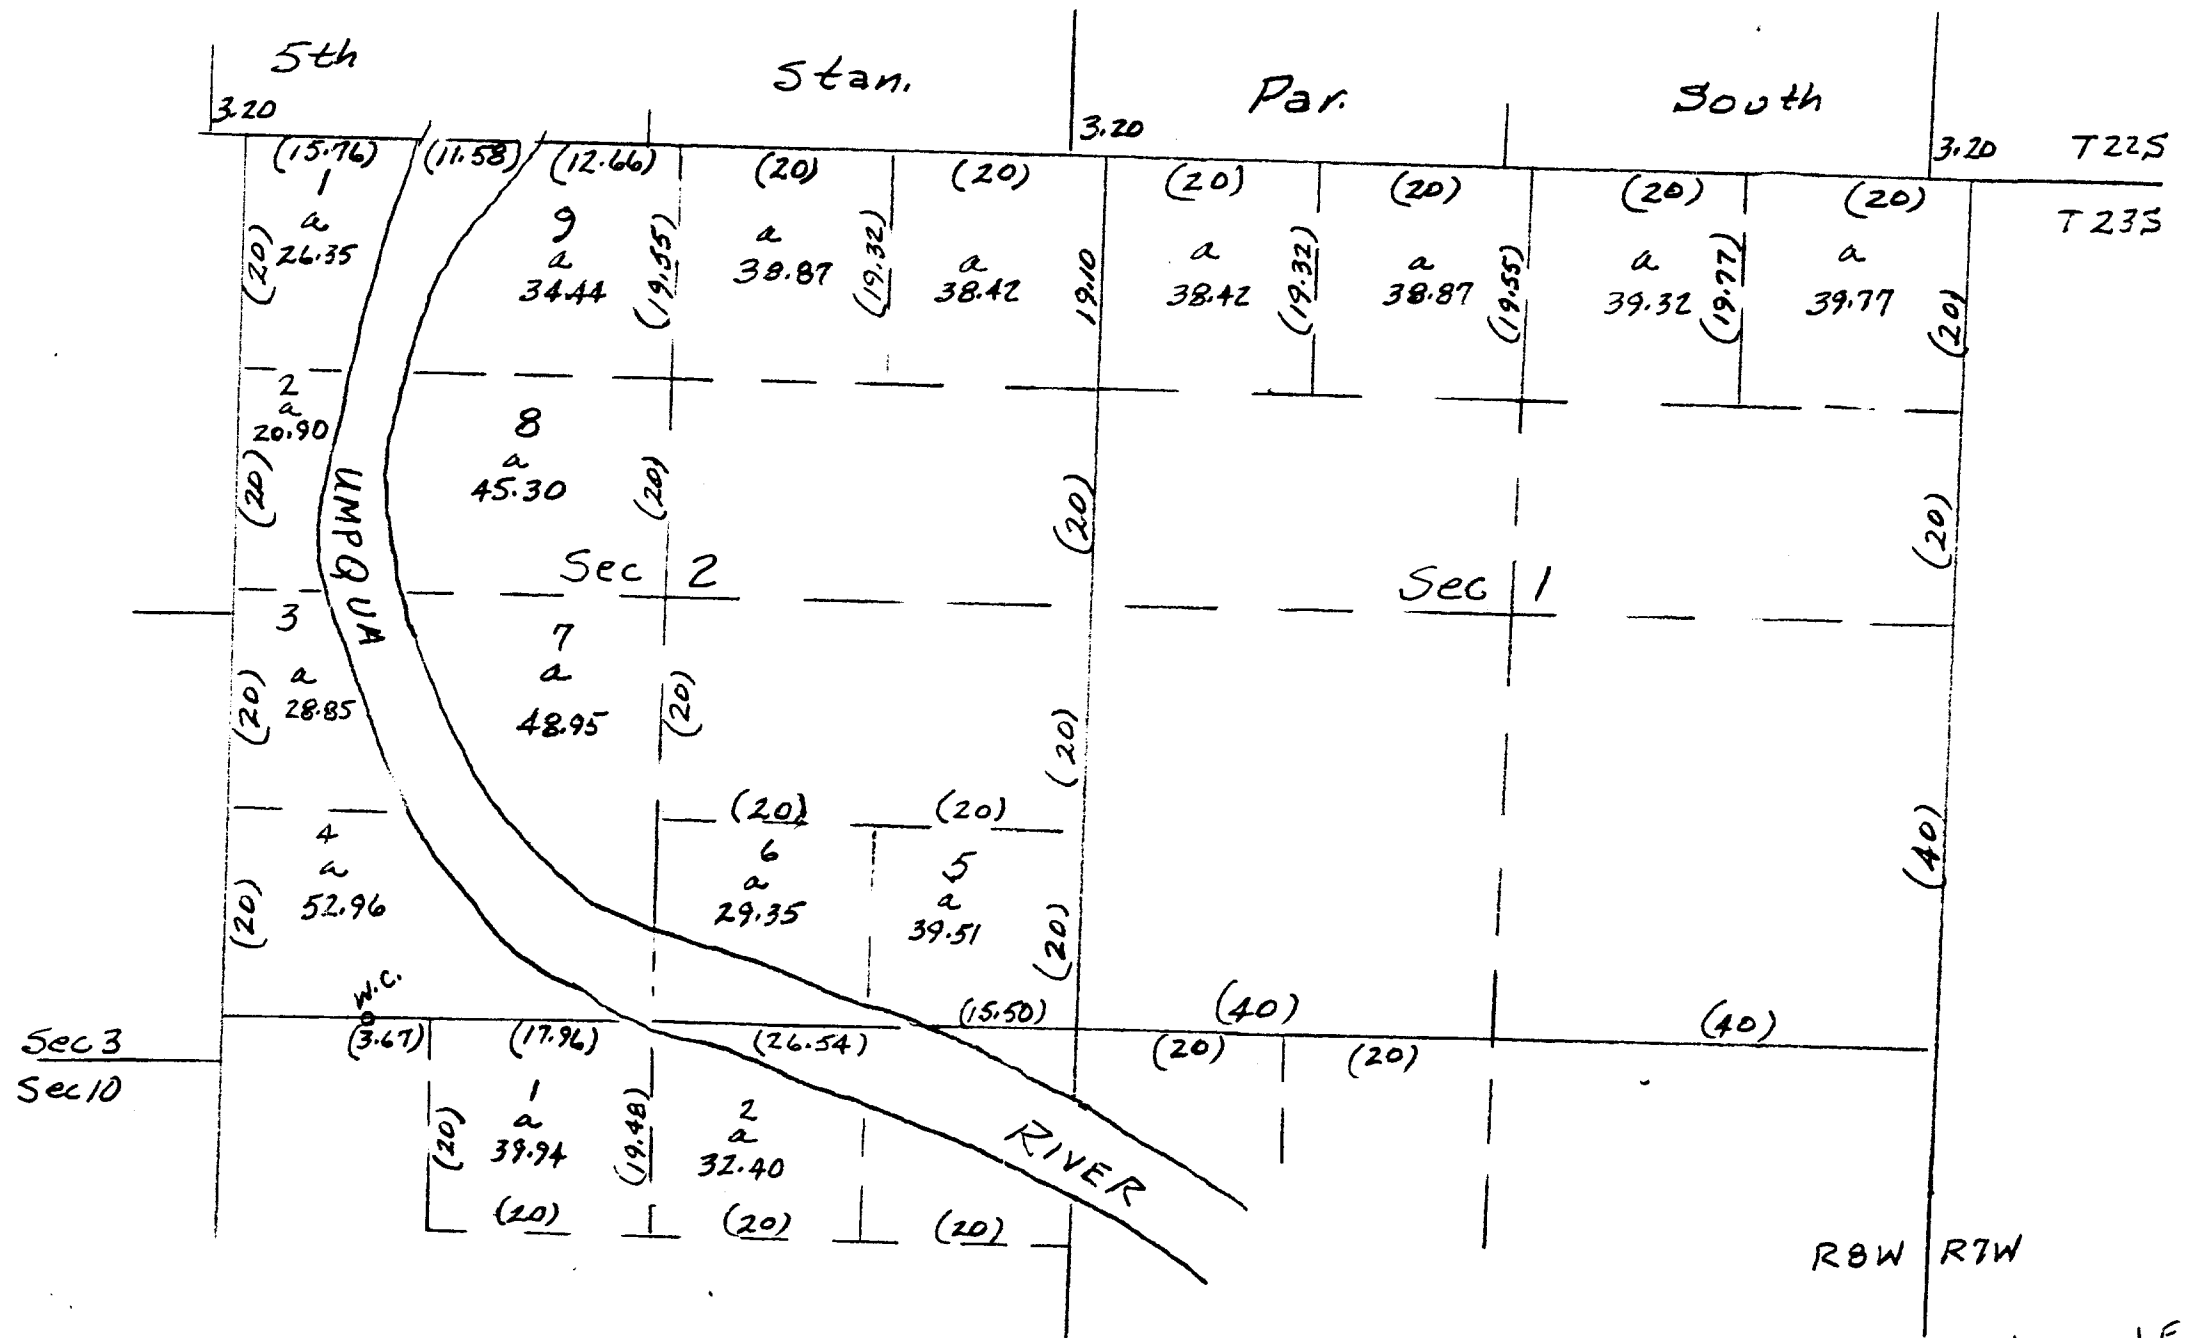
S. File No. 58/280-1E

( ) Parenthetical Distances,  
Hathorn Plat

In 1857, Dennis Hathorn surveyed the east boundary, the east 63.67 chains of the south boundary of section 2, and other subdivisional lines, as shown on the plat approved April 24, 1858. After surveying the subdivisional lines, Hathorn surveyed Donation Land Claims in sections 1, 2, 11, and 12 as shown on the plat approved August 1, 1860. The Hathorn plat(s) protract all of section 2 as surveyed, using a total length of 80 chains for the north, south, and west boundaries of the section, and 79.10 chains for the east boundary. The boundaries of section 2, and the lots and areas within the section were fixed by the Hathorn plat(s) and they fully control the patents within the section.

Lastly, Hathorn is known to have been an excellent surveyor. The distance from the corner of sections 1, 2, 11, and 12 to the closing corner on the west boundary of D.L.C. No. 40 is very nearly the record. There is no reason it shouldn't be because it is over nearly level open land and the Umpqua River. Although that fact isn't a deciding factor, it is supportive of the recommended procedure. The distance from the west boundary of the D.L.C. to the left bank of the Umpqua is also close to the record, allowing for some obvious erosion of the left bank. If the meander corners were not lost, they would, of course, control the position of the south  $\frac{1}{4}$  section corner of section 2, but they are no longer in existence.
