- Condition Report On
- Not Found
- Renewed
- Unrecorded
- Surveyed In
- Referenced Out

WEYERHAEUSER COMPANY
 SPRINGFIELD BRANCH

TOWNSHIP 23S RANGE 2W
 SECTION 26 CORNER SE
 COUNTY Lane-Douglas OREGON

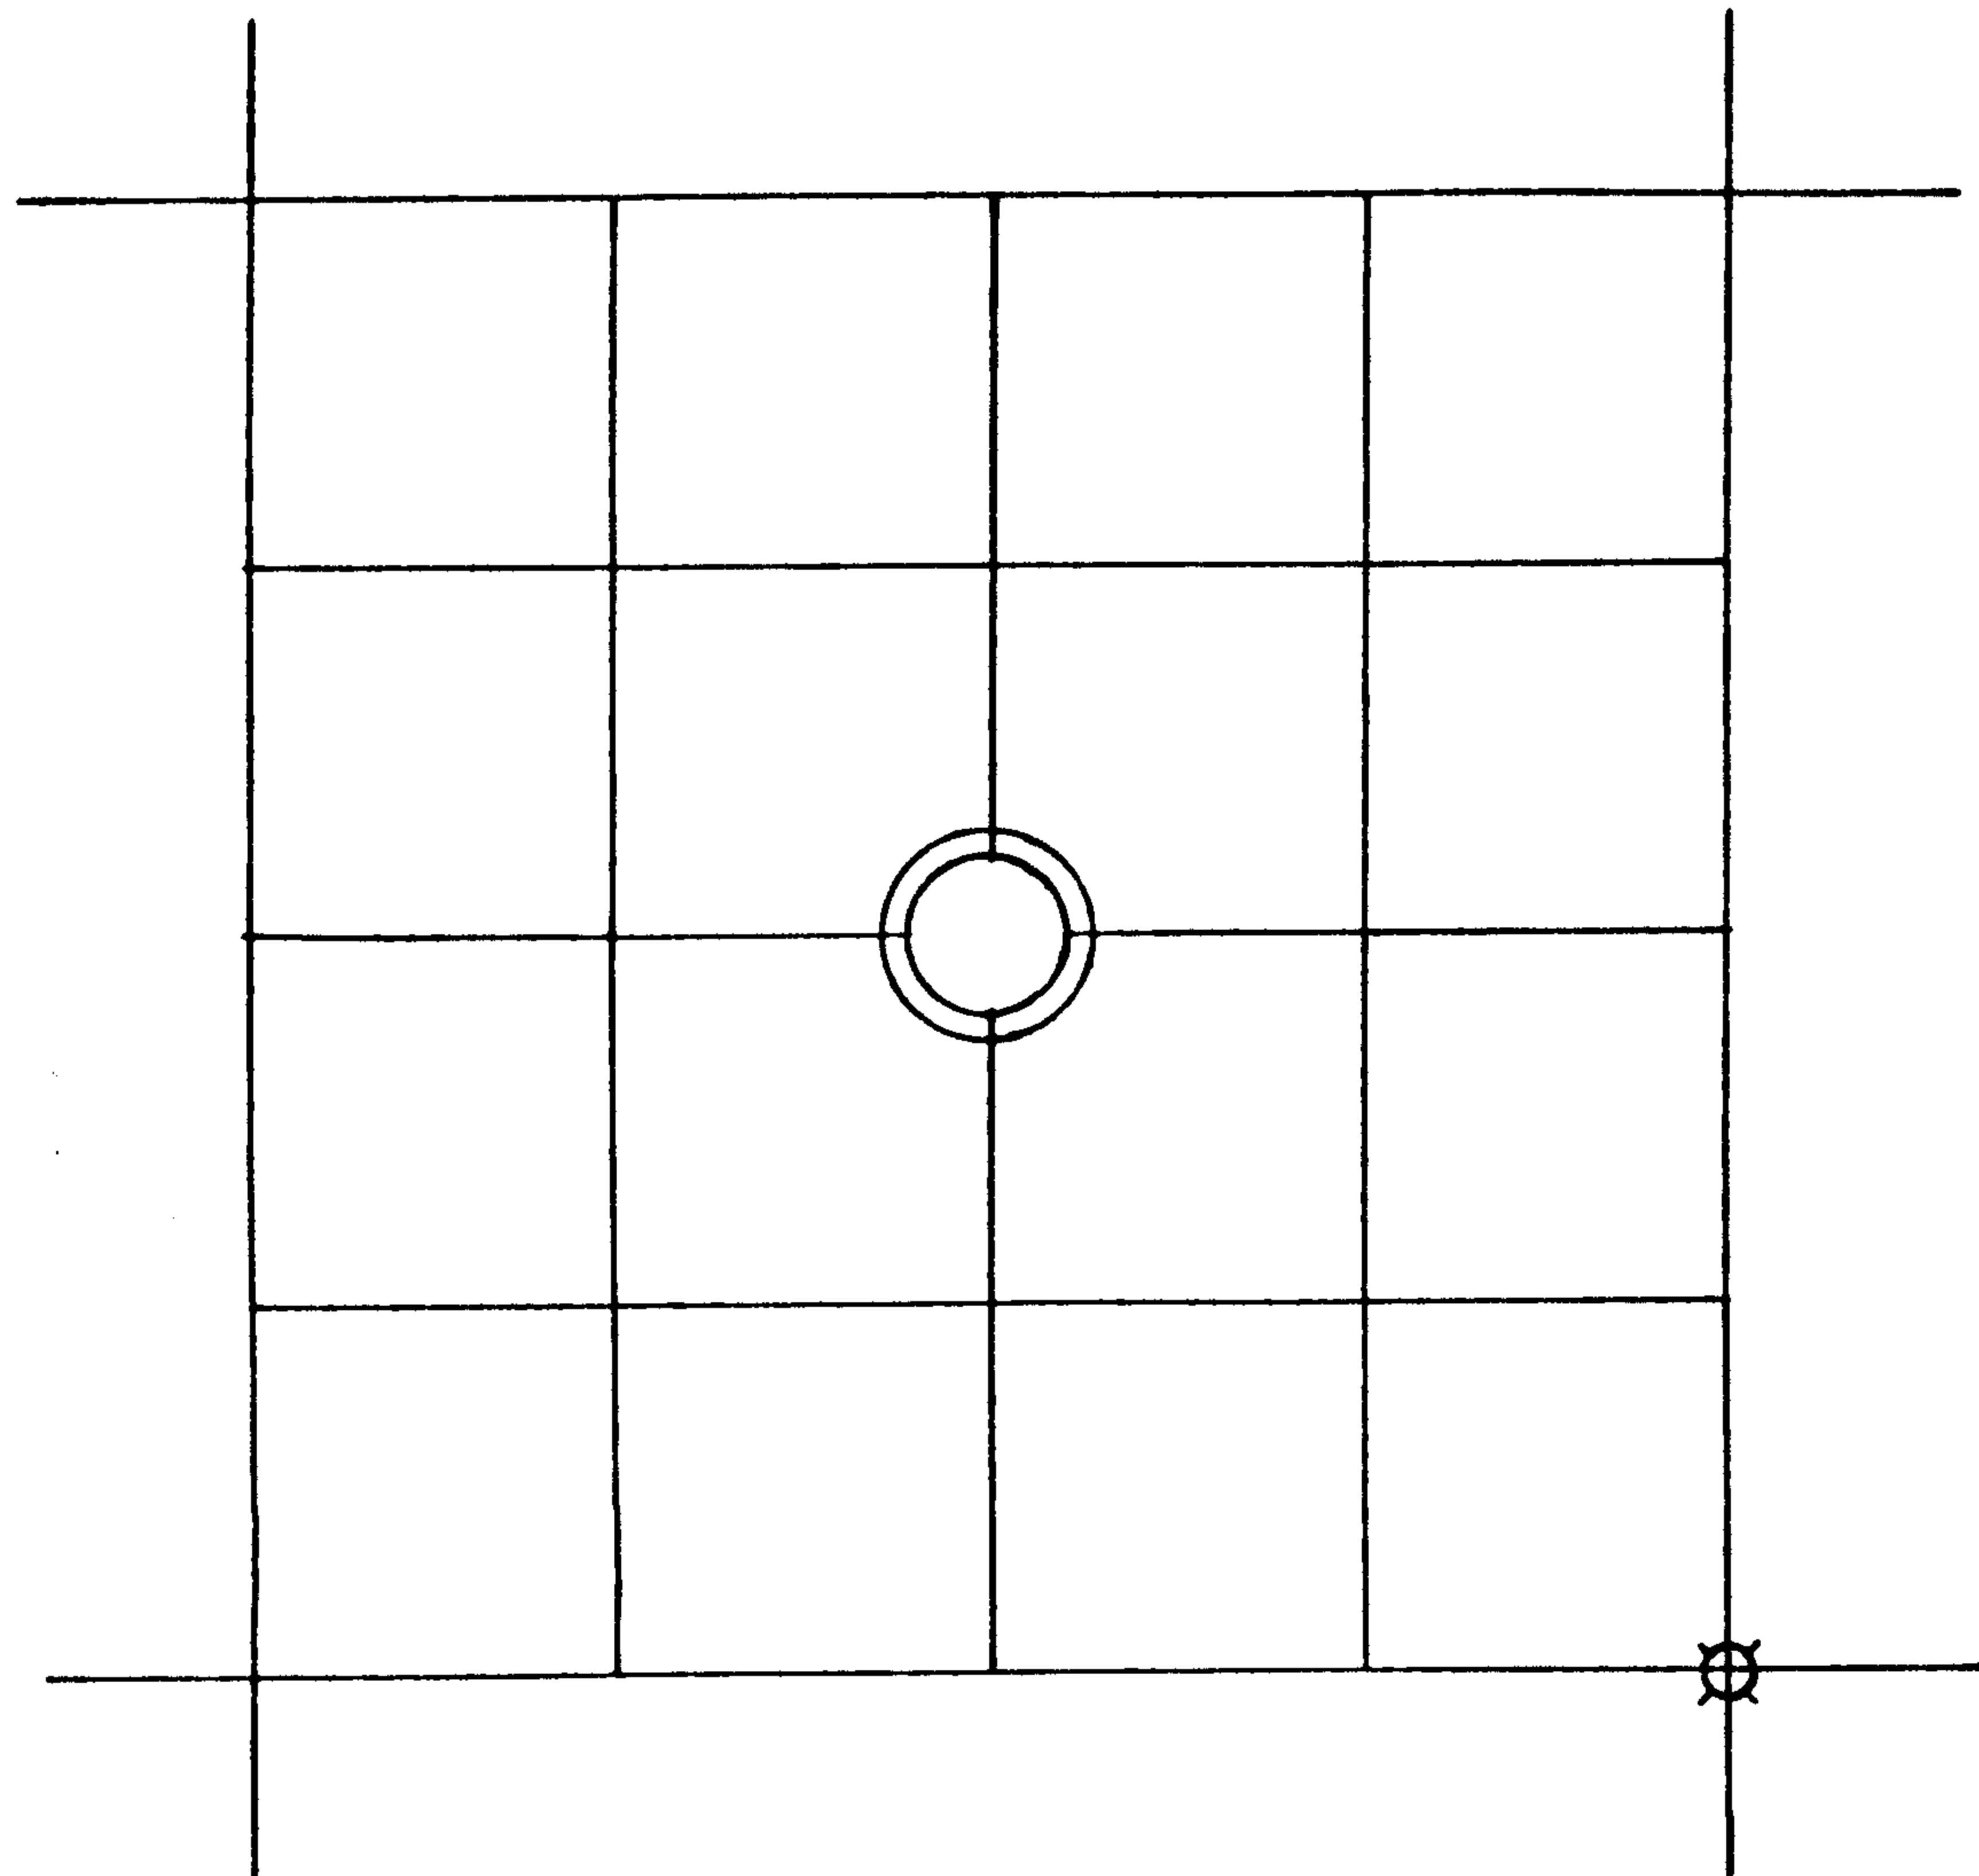
LINE MARKED BY NOTCH CUT IN BLAZE.

KNOWN CORNER.

REFERENCED CORNER BY WEYERHAEUSER METHOD.

CORNER REFERENCE METHOD CONSISTS OF:

A "W" NAIL DRIVEN THRU THE HOLE IN A BRASS DISC, INTO A NOTCH CUT LOW ON A TREE, STAMPED WITH THE OREGON REGISTERED LAND SURVEYOR OR PROFESSIONAL ENGINEER REGISTRATION NUMBER.

AN EMBOSSED ALUMINUM PLATE, NAILED HEAD HIGH ON SAME TREE WITH 8D ALUMINUM NAILS, WITH DISTANCE AND BEARING FROM THE "W" NAIL TO THE CORNER STAMPED ON IT.
