Book 27, Page 225

T28S
S25 | S30
R9W | R8W

Warren Knight Staff Compass - declination 17°E

December 8, 2014

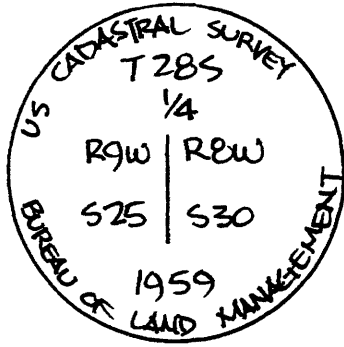
OLD MONUMENT

Found 3/4" brass cap, on a 2 1/2" iron pipe, 0.4' tall, in good condition and solid in the ground. We find a steel fence post 2' North.

Found 33" Hemlock, N44°W, 22.00' (N39°30'W-23.1' rec.) to right side center. We find a healed blaze and a BLM tag in place. We paint the face and a band around the tree in blue. GOOD CONDITION

Found 11" Grand Fir, dead snag, N85°W, 48.00' (N80°W-47.3' rec.) to right side center. We find visible scribes in a chain saw blaze and a 1993 BLM tag in place. We paint the blaze, face and a band around the tree in blue. FAIR CONDITION

Found 35" Grand Fir, S11°30'W, 1.8' to face, 3.5, to right side center (S1°E-2.3' rec.). We find a healed blaze with 2 BLM tags in place. We paint the face and a band around the tree in blue. GOOD CONDITION

Found 32" Hemlock, tall stump, 5' tall, S32°30'E, 41.00' (S28°E-40.2' rec.) to heart center. We find visible scribes in a chain saw blaze and a BLM tag in place. We paint the blaze, face and a band around the stump in blue. GOOD CONDITION

A 44" Red Cedar stump, N11°E, 14.98' to a spike w/Coos County washer driven (offcenter) into the top. We chop an "X" into the face. We paint the "X" in blue and attach a yellow Coos County tag.
