SURVEY FOR PROPERTY CORNERS
 IN SEC. 5, T.29S., R.7W., W.M.
 FOR MR. PAUL SLAMA
 BY BAUGHMAN SURVEYING SERVICE

MAY 1973

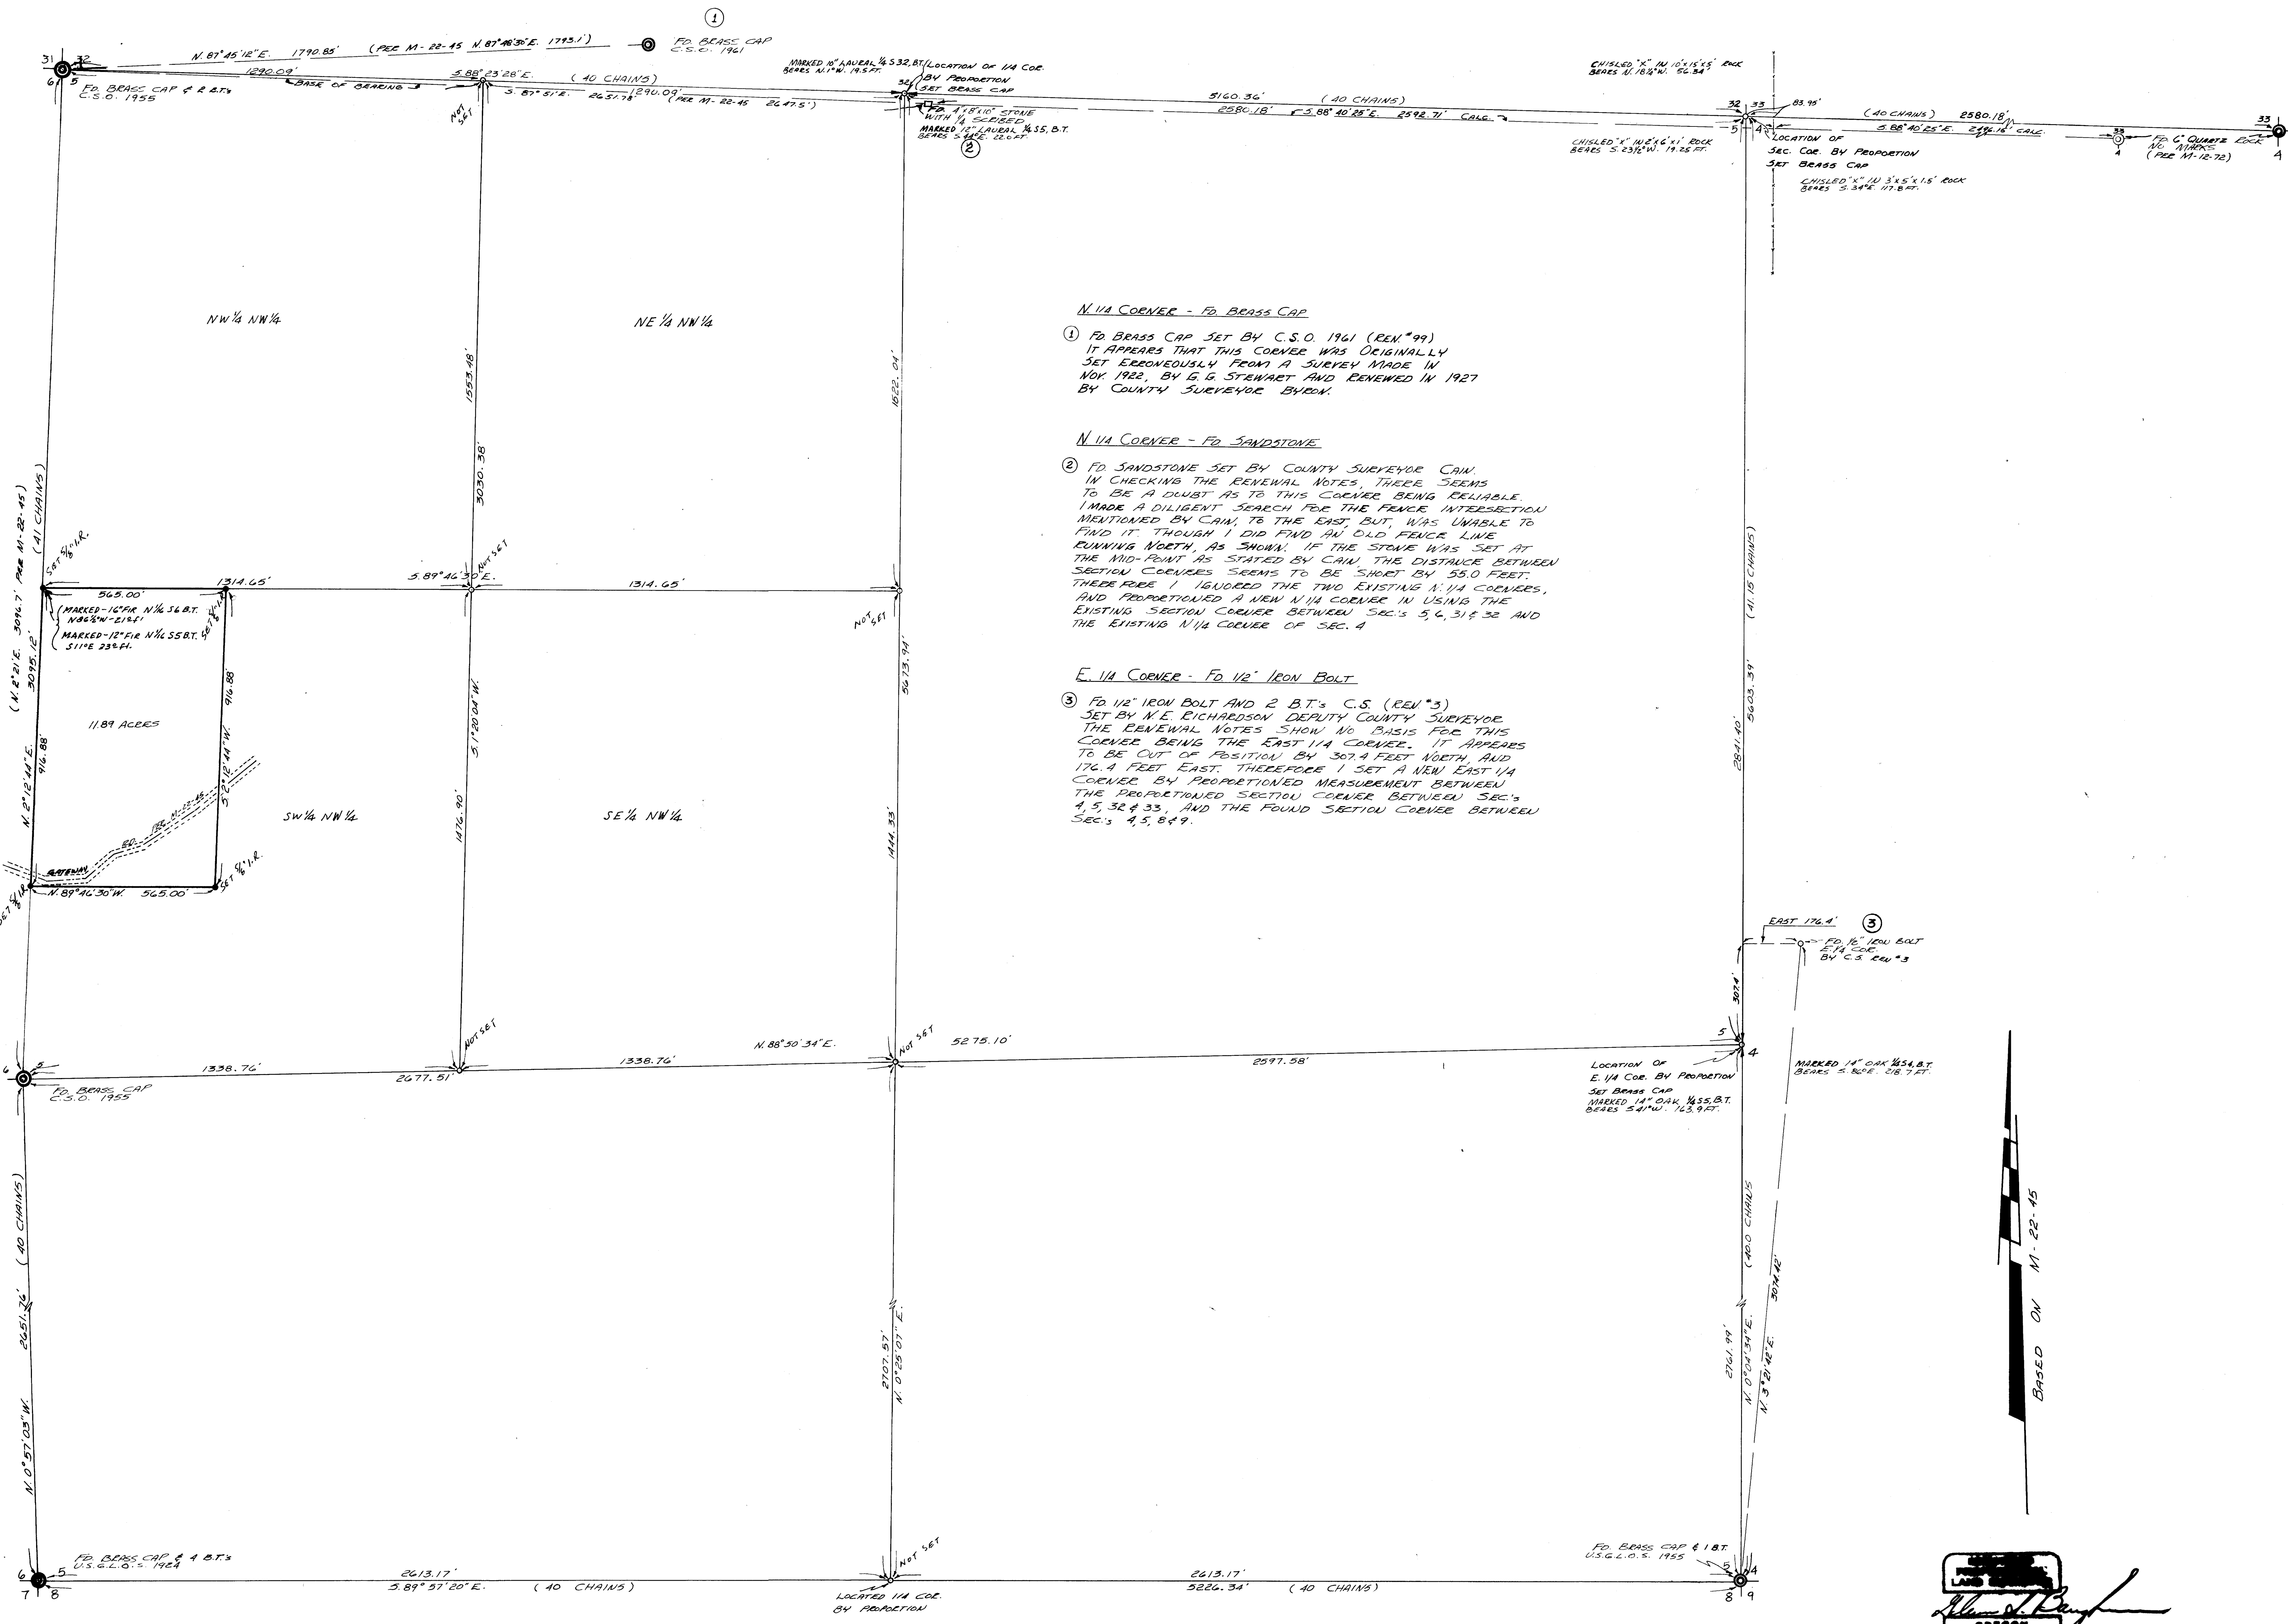
SCALE 1" = 200'

N 1/4 CORNER - FD BRASS CAP
 ① FD BRASS CAP SET BY C.S.O. 1961 (REN #99)
 IT APPEARS THAT THIS CORNER WAS ORIGINALLY
 SET ERRONEOUSLY FROM A SURVEY MADE IN
 NOV. 1922, BY G.G. STEWART AND RENEWED IN 1927
 BY COUNTY SURVEYOR BYRON.

N 1/4 CORNER - FD SANDSTONE
 ② FD SANDSTONE SET BY COUNTY SURVEYOR CAM.
 IN CHECKING THE RENEWAL NOTES, THERE SEEMS
 TO BE A DOUBT AS TO THIS CORNER BEING RELIABLE.
 I MADE A DILIGENT SEARCH FOR THE FENCE INTERSECTION
 MENTIONED BY CAM, TO THE EAST, BUT, WAS UNABLE TO
 FIND IT. THOUGH I DID FIND AN OLD FENCE LINE
 RUNNING NORTH, AS SHOWN. IF THE STONE WAS SET AT
 THE MID-POINT AS STATED BY CAM, THE DISTANCE BETWEEN
 SECTION CORNERS SEEMS TO BE SHORT BY 55.0 FEET.
 THEREFORE I IGNORED THE TWO EXISTING N 1/4 CORNERS,
 AND PROPORTIONED A NEW N 1/4 CORNER IN USING THE
 EXISTING SECTION CORNER BETWEEN SEC'S 5, 6, 31 & 32 AND
 THE EXISTING N 1/4 CORNER OF SEC. 4

E 1/4 CORNER - FD 1/2" IRON BOLT
 ③ FD 1/2" IRON BOLT AND 2 B.T.'s C.S. (REN #3)
 SET BY N.E. RICHARDSON DEPUTY COUNTY SURVEYOR.
 THE RENEWAL NOTES SHOW NO BASIS FOR THIS
 CORNER BEING THE EAST 1/4 CORNER. IT APPEARS
 TO BE OUT OF POSITION BY 307.4 FEET NORTH, AND
 176.4 FEET EAST. THEREFORE I SET A NEW EAST 1/4
 CORNER BY PROPORTIONED MEASUREMENT BETWEEN
 THE PROPORTIONED SECTION CORNER BETWEEN SEC'S
 4, 5, 32 & 33, AND THE FOUND SECTION CORNER BETWEEN
 SEC'S 4, 5, 8 & 9.
