PROPERTY LINE SURVEY IN SECTION 23, T22S, R12W, W.M. DOUGLAS COUNTY, OREGON

For: Moore Mill & Lumber Co.
 P.O. Box 277
 Bandon, Oregon 97411

By: Shaner Engineering, Inc.
 P.O. Box 1430
 Roseburg, Oregon 97470

February, 1987

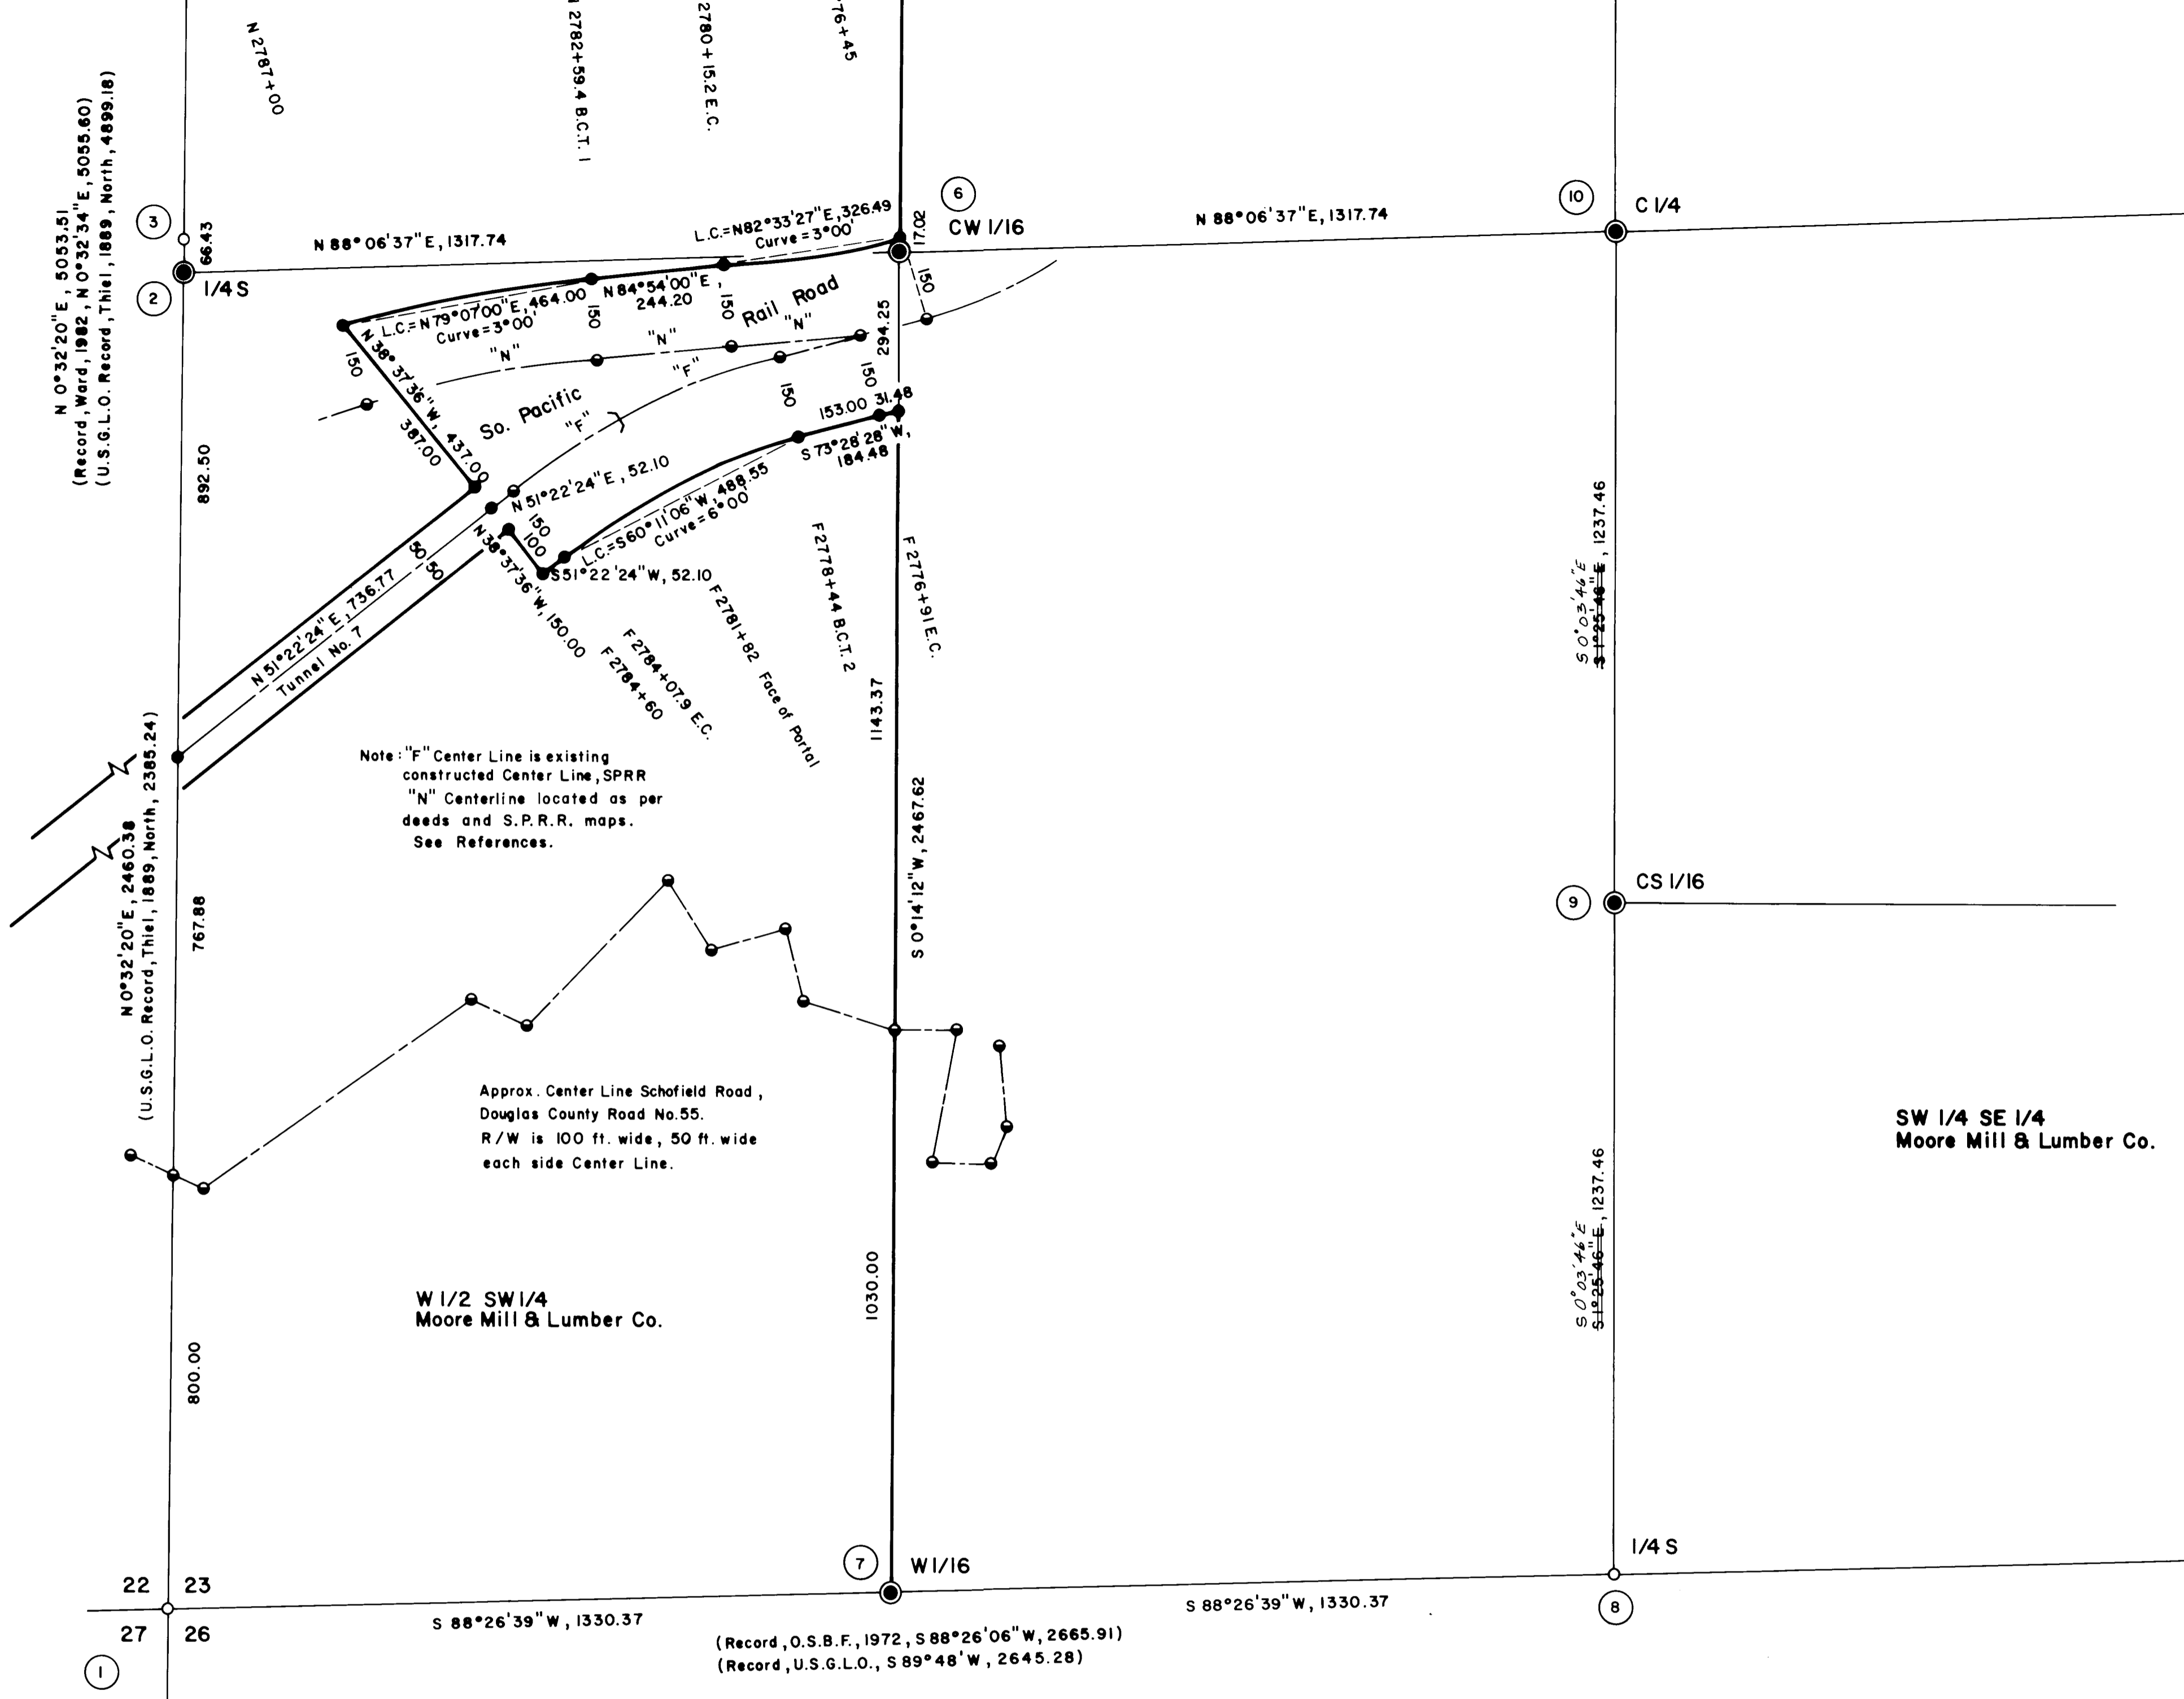
Sheet 1 of 2

1/4 S, Sec. 23 only, East 29.25 feet of true line & North 201.25 feet from Proper Location. Obviously an error in setting this by O.S.B.F.
