SEC. 7, 18, T. 22 S, R. 9 W, W.M.

OREGON DEPARTMENT OF TRANSPORTATION
 HORIZONTAL CONTROL, RECOVERY, RETRACEMENT AND
 RIGHT OF WAY BOUNDARY MONUMENTATION MAP
 OR38: SCOTTSBURG - WELLS CREEK CURVE REALIGNMENT
 UMPQUA HWY. NO. 45 M.P. 17.1 TO 19.1
 DOUGLAS COUNTY
 FILE: 16207RW.DGN

SEPTEMBER 9, 2014
 SCALE: 1" = 100'
 SHEET 3 OF 6

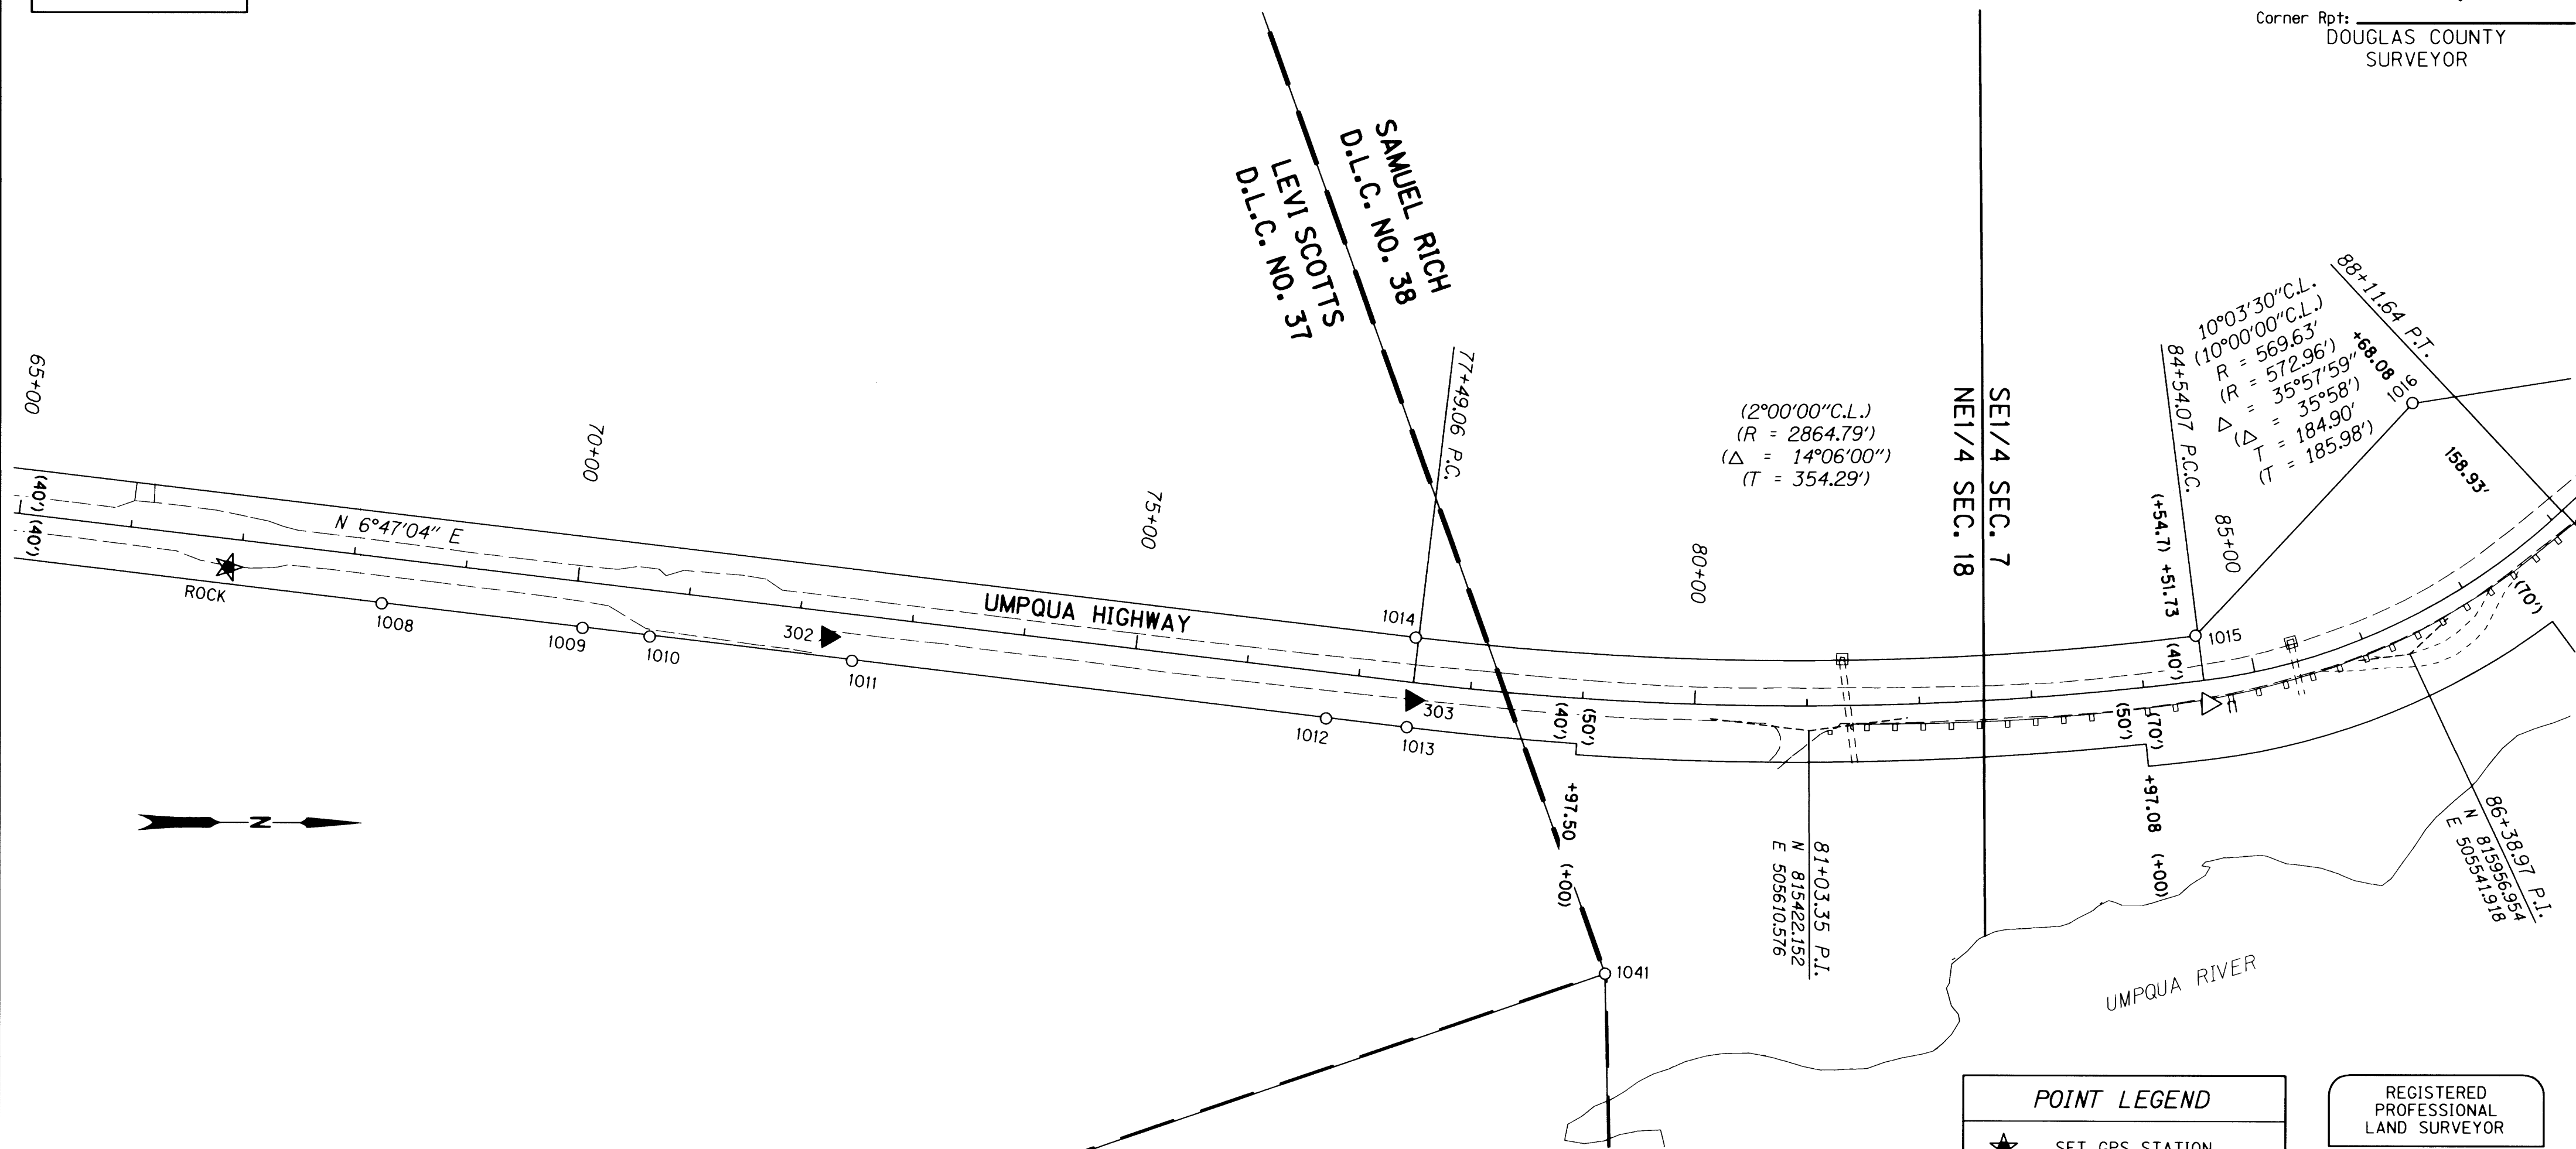
POINT LEGEND	
★	SET GPS STATION
▲	SET NETWORK POINT
△	FOUND NETWORK POINT
○	FOUND MONUMENT
