SE1/4 SEC.2, T.28 S., R.6 W., W.M.

FILED
 Date: 1-28-19 By: *Di*
 This survey consist of:
 Map: ST HWY 15-031 A-K
 Narrative:
 Corner Rpt: DOUGLAS COUNTY SURVEYOR

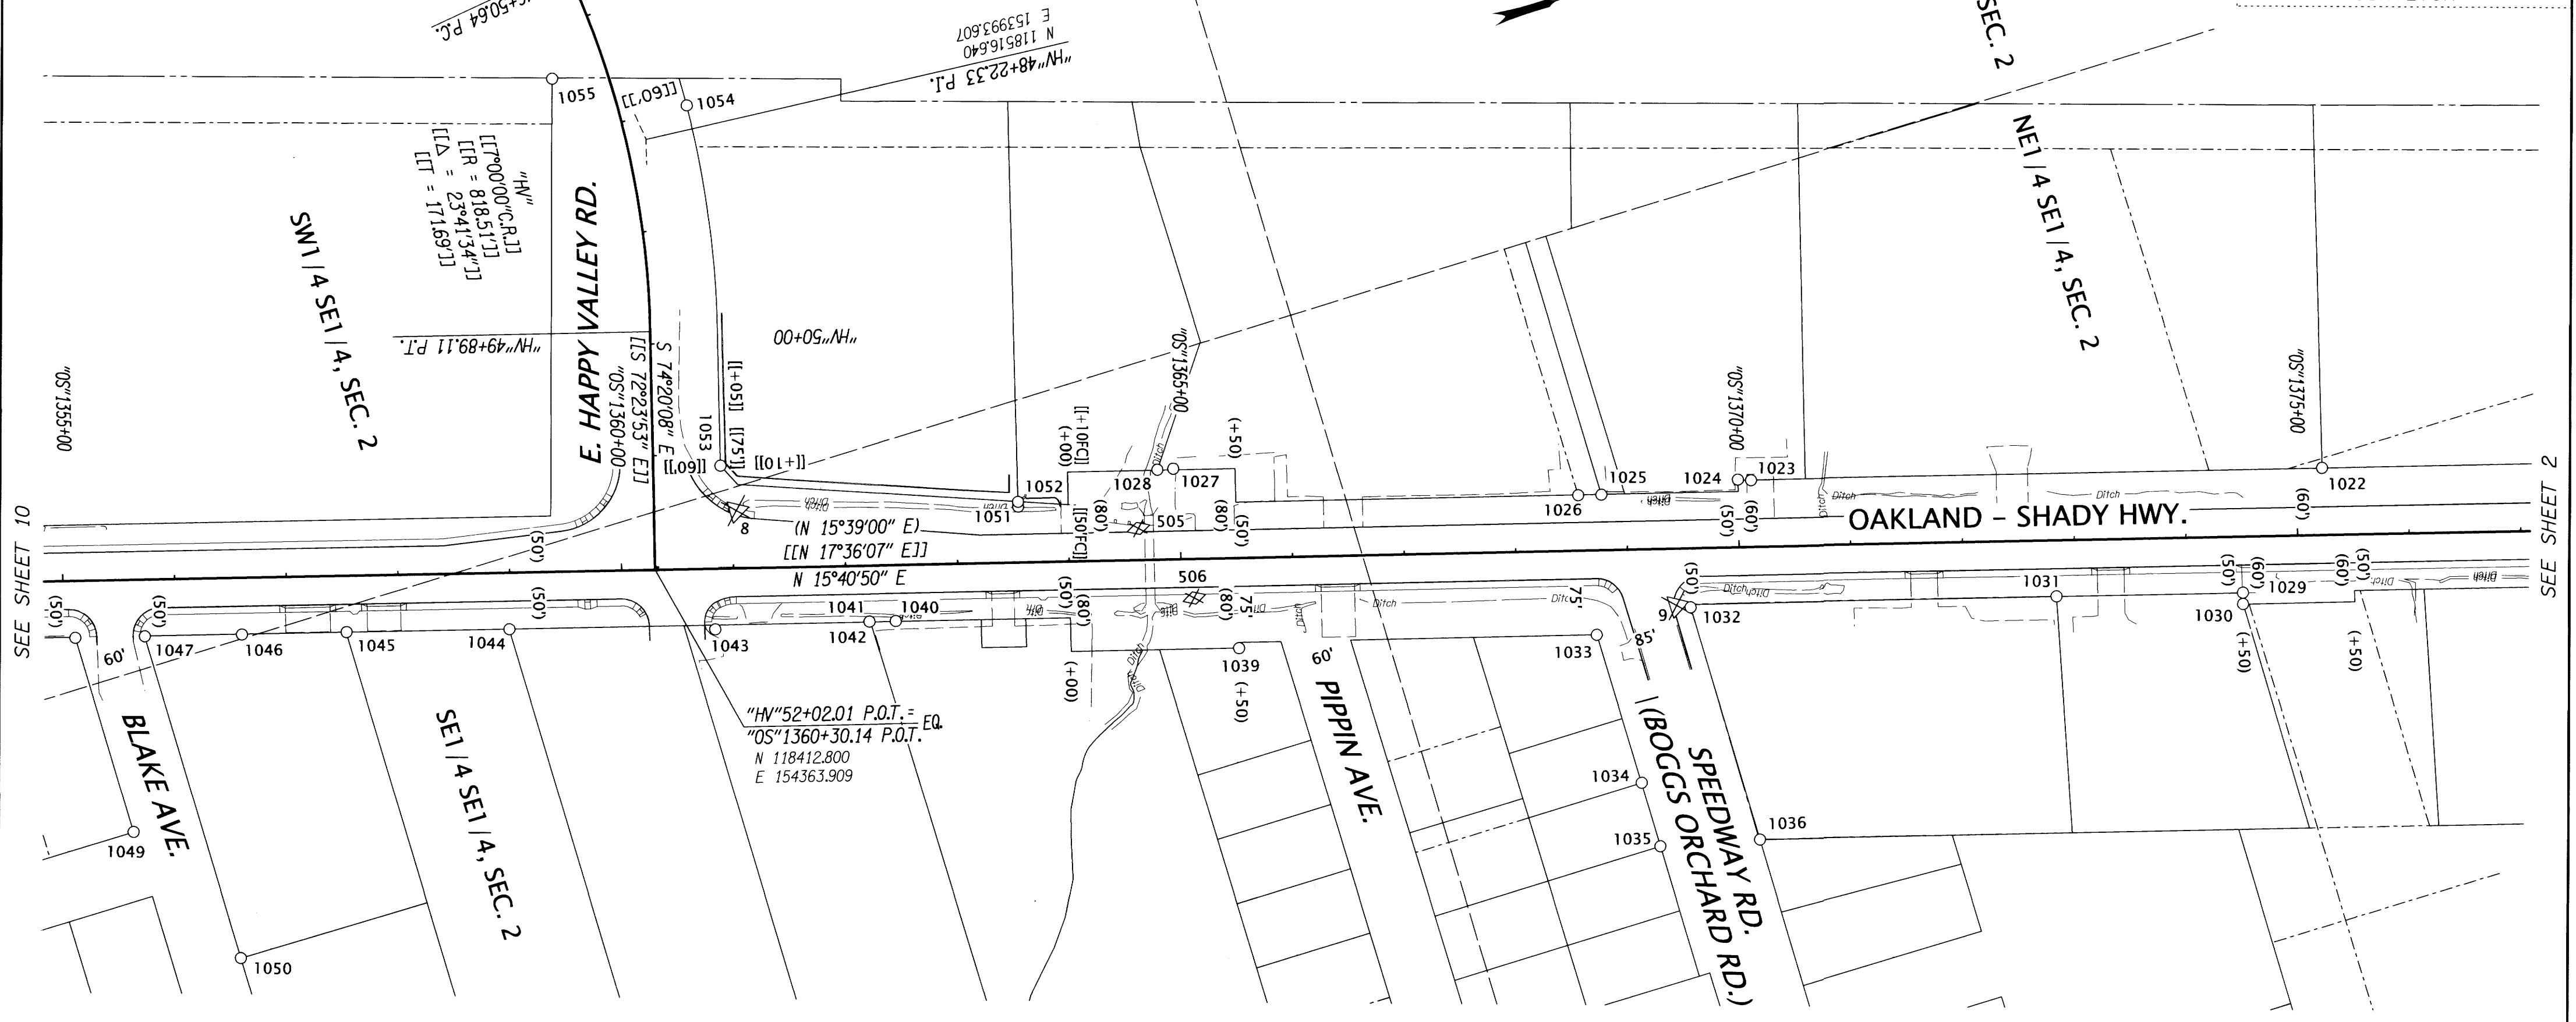
POINT LEGEND

- FOUND MONUMENT
- ⊗ DESTROYED NETWORK POINT
- ⊗ DESTROYED STRATEGIC POINT

SEE SHEET 2 FOR LINE LEGEND
