SURVEY in SEC. 32 & PORTION of SOUTH LINE of T.24S., R.7W., W.M.

Surveyed for B.N. Glanville  
Scale 1"=100'

Surveyed by Larry Bishop  
Mar. 9, 1970

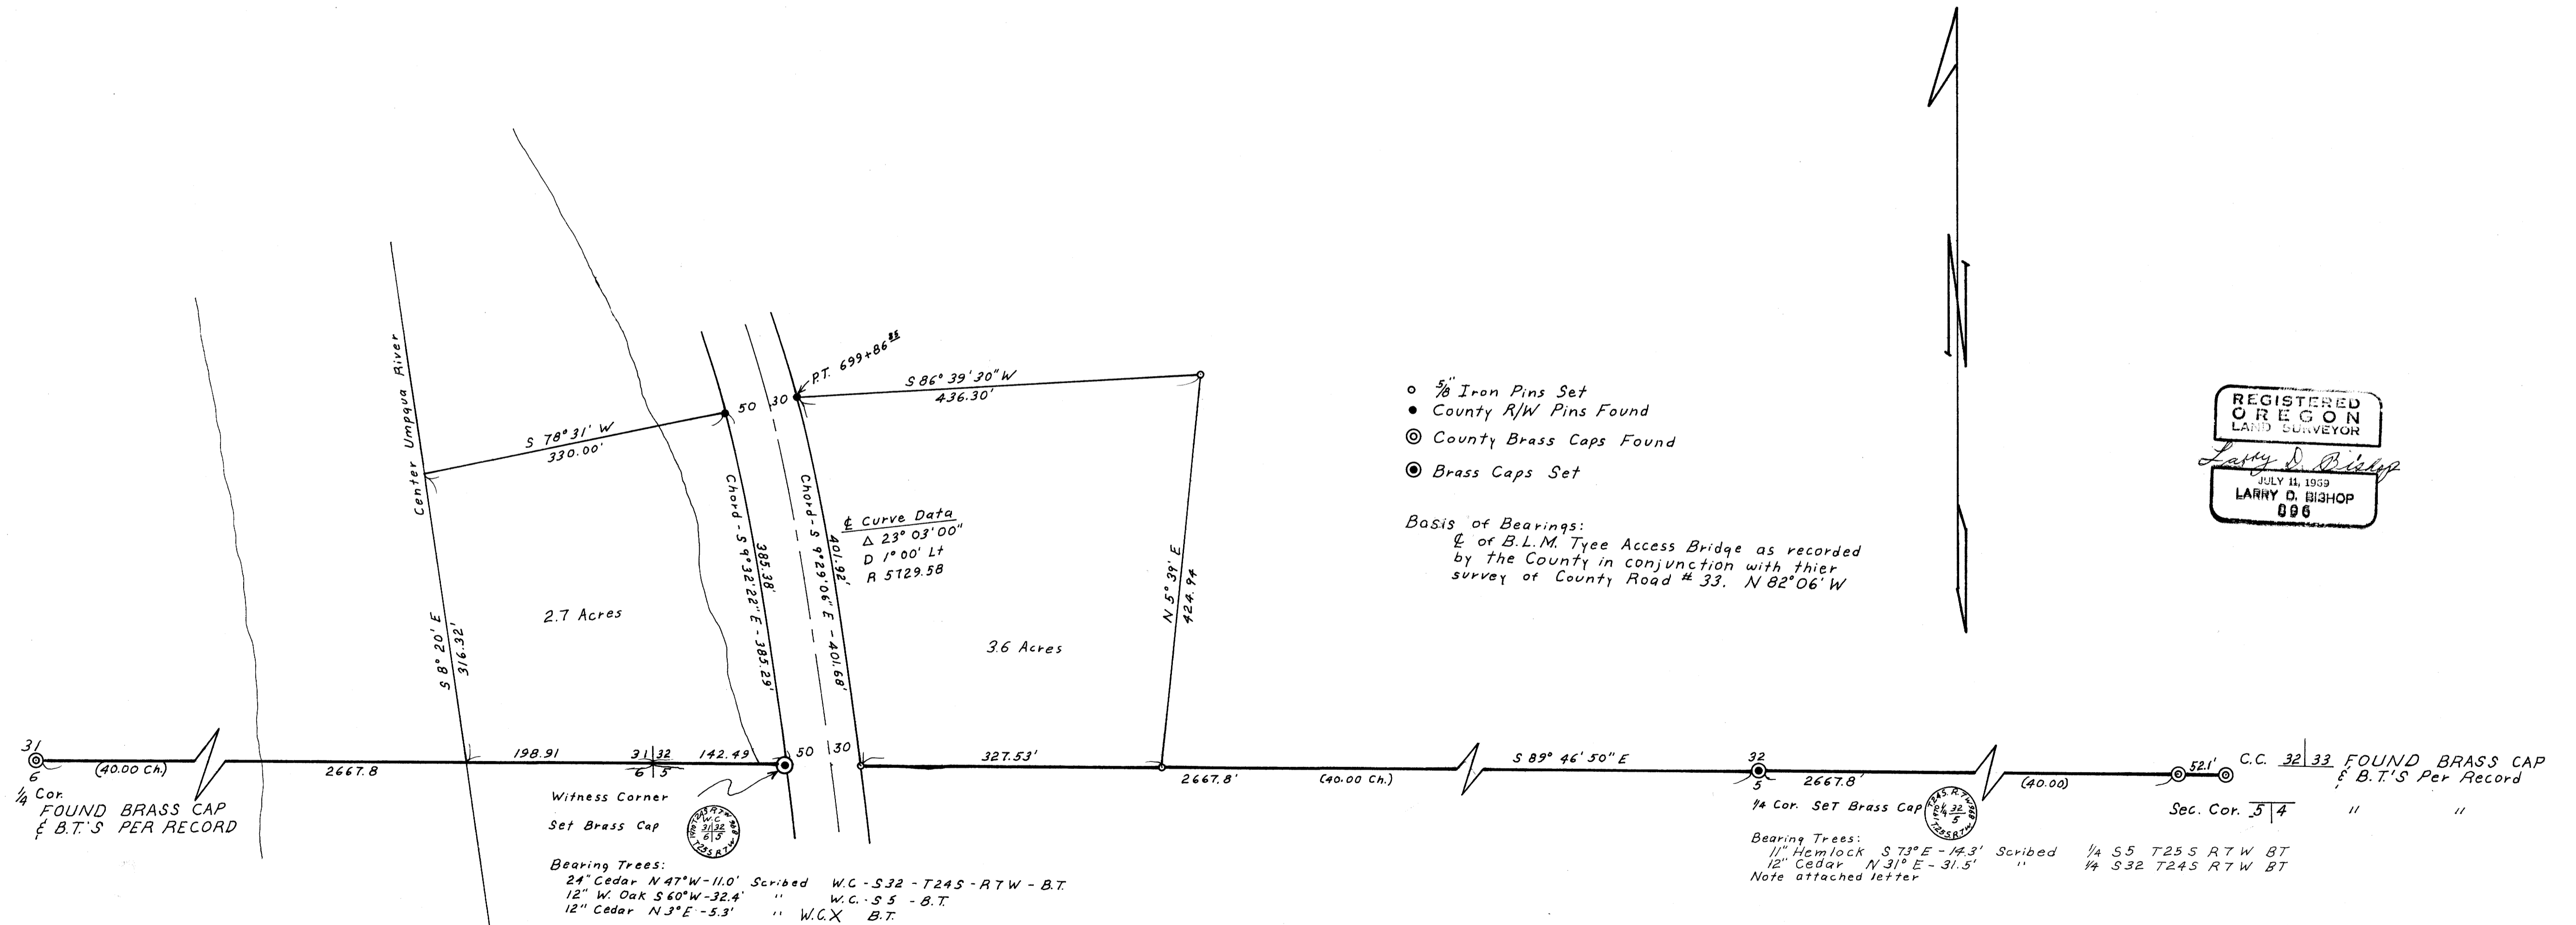
- 3/8" Iron Pins Set
- County R/W Pins Found
- ⊙ County Brass Caps Found
- ⊙ Brass Caps Set

Basis of Bearings:  
 ☉ of B.L.M. Tye Access Bridge as recorded  
 by the County in conjunction with their  
 survey of County Road # 33. N 82° 06' W

31  
 6  
 (40.00 Ch.)  
 1/4 Cor.  
 FOUND BRASS CAP  
 & B.T.'S PER RECORD

Bearing Trees:  
 24" Cedar N 47° W - 11.0' Scribed W.C. - S 32 - T 24 S - R 7 W - B.T.  
 12" W. Oak S 60° W - 32.4' " " W.C. - S 5 - B.T.  
 12" Cedar N 3° E - 5.3' " " W.C.X B.T.

32  
 5  
 (40.00)  
 1/4 Cor. SET Brass Cap  
 52.1' C.C. 32 33 FOUND BRASS CAP  
 & B.T.'S Per Record  
 Sec. Cor. 5 4 " "

Bearing Trees:  
 11" Hemlock S 73° E - 14.3' Scribed 1/4 S 5 T 25 S R 7 W B.T.  
 12" Cedar N 31° E - 31.5' " " 1/4 S 32 T 24 S R 7 W B.T.  
 Note attached letter

This is in reply to your letter of February 10, 1970, requesting an opinion on the procedure for reestablishing the  $\frac{1}{2}$  section corner of sections 5 and 32, on the south boundary of T. 24 S., R. 7 W., Willamette Meridian, Oregon.

It is the opinion of this office that the  $\frac{1}{2}$  section corner is common to both sections. The areas in section 5, T. 25 S., R. 7 W., were on a plat approved April 24, 1858. The areas of the NE., NW., and SW., quarters of section 32, T. 24 S., R. 5 W., were returned on a plat also approved April 24, 1858. Land disposals of areas returned on these two plats were based on the common  $\frac{1}{2}$  section corner established by Dennis Hathorn in 1857. We feel the subsequent survey by William R. Whipple, in which the SE. quarter of section 32 was returned as surveyed cannot change the status of a corner previously used for disposals.

The areas in the SE. quarter of section 32 were returned on a plat approved June 27, 1895. These areas appear to be erroneous and are probably a reversal of the areas shown for the lots in the SW. quarter of section 33.
