LOT 6 SEC. 11 T. 23 S., R. 8 W., W.M.

Scale: 1" = 100 ft.
October 1973
Corners Set 11/17/73

Surveyed For Hazel G. Clark
Basis of survey: B.L.M. Subdivision of Sec. 11 in 1967-1968. Basis of bearings: East line of Lot 6, N.00°11'E. Corners found are shown thus: ● Corners Set, shown thus: ○ The B.T.s at the S.W. Corner D.L.C. No. 40 were: A 14" Fir with tag N.56½°W. 31± ft. (31±). No evidence that pipe was moved. A white Fir, 18" diam. N 41°00'E 123± ft. (125±). From Brass cap north of S.W. Corner D.L.C. No. 40: A 14" Fir with tag bears S 79°W 29± ft. (S 79°W 29±). A 18" Fir with tag bears N 16°W 56± (56±). This corner and the C.S. 1/16 were used for control.

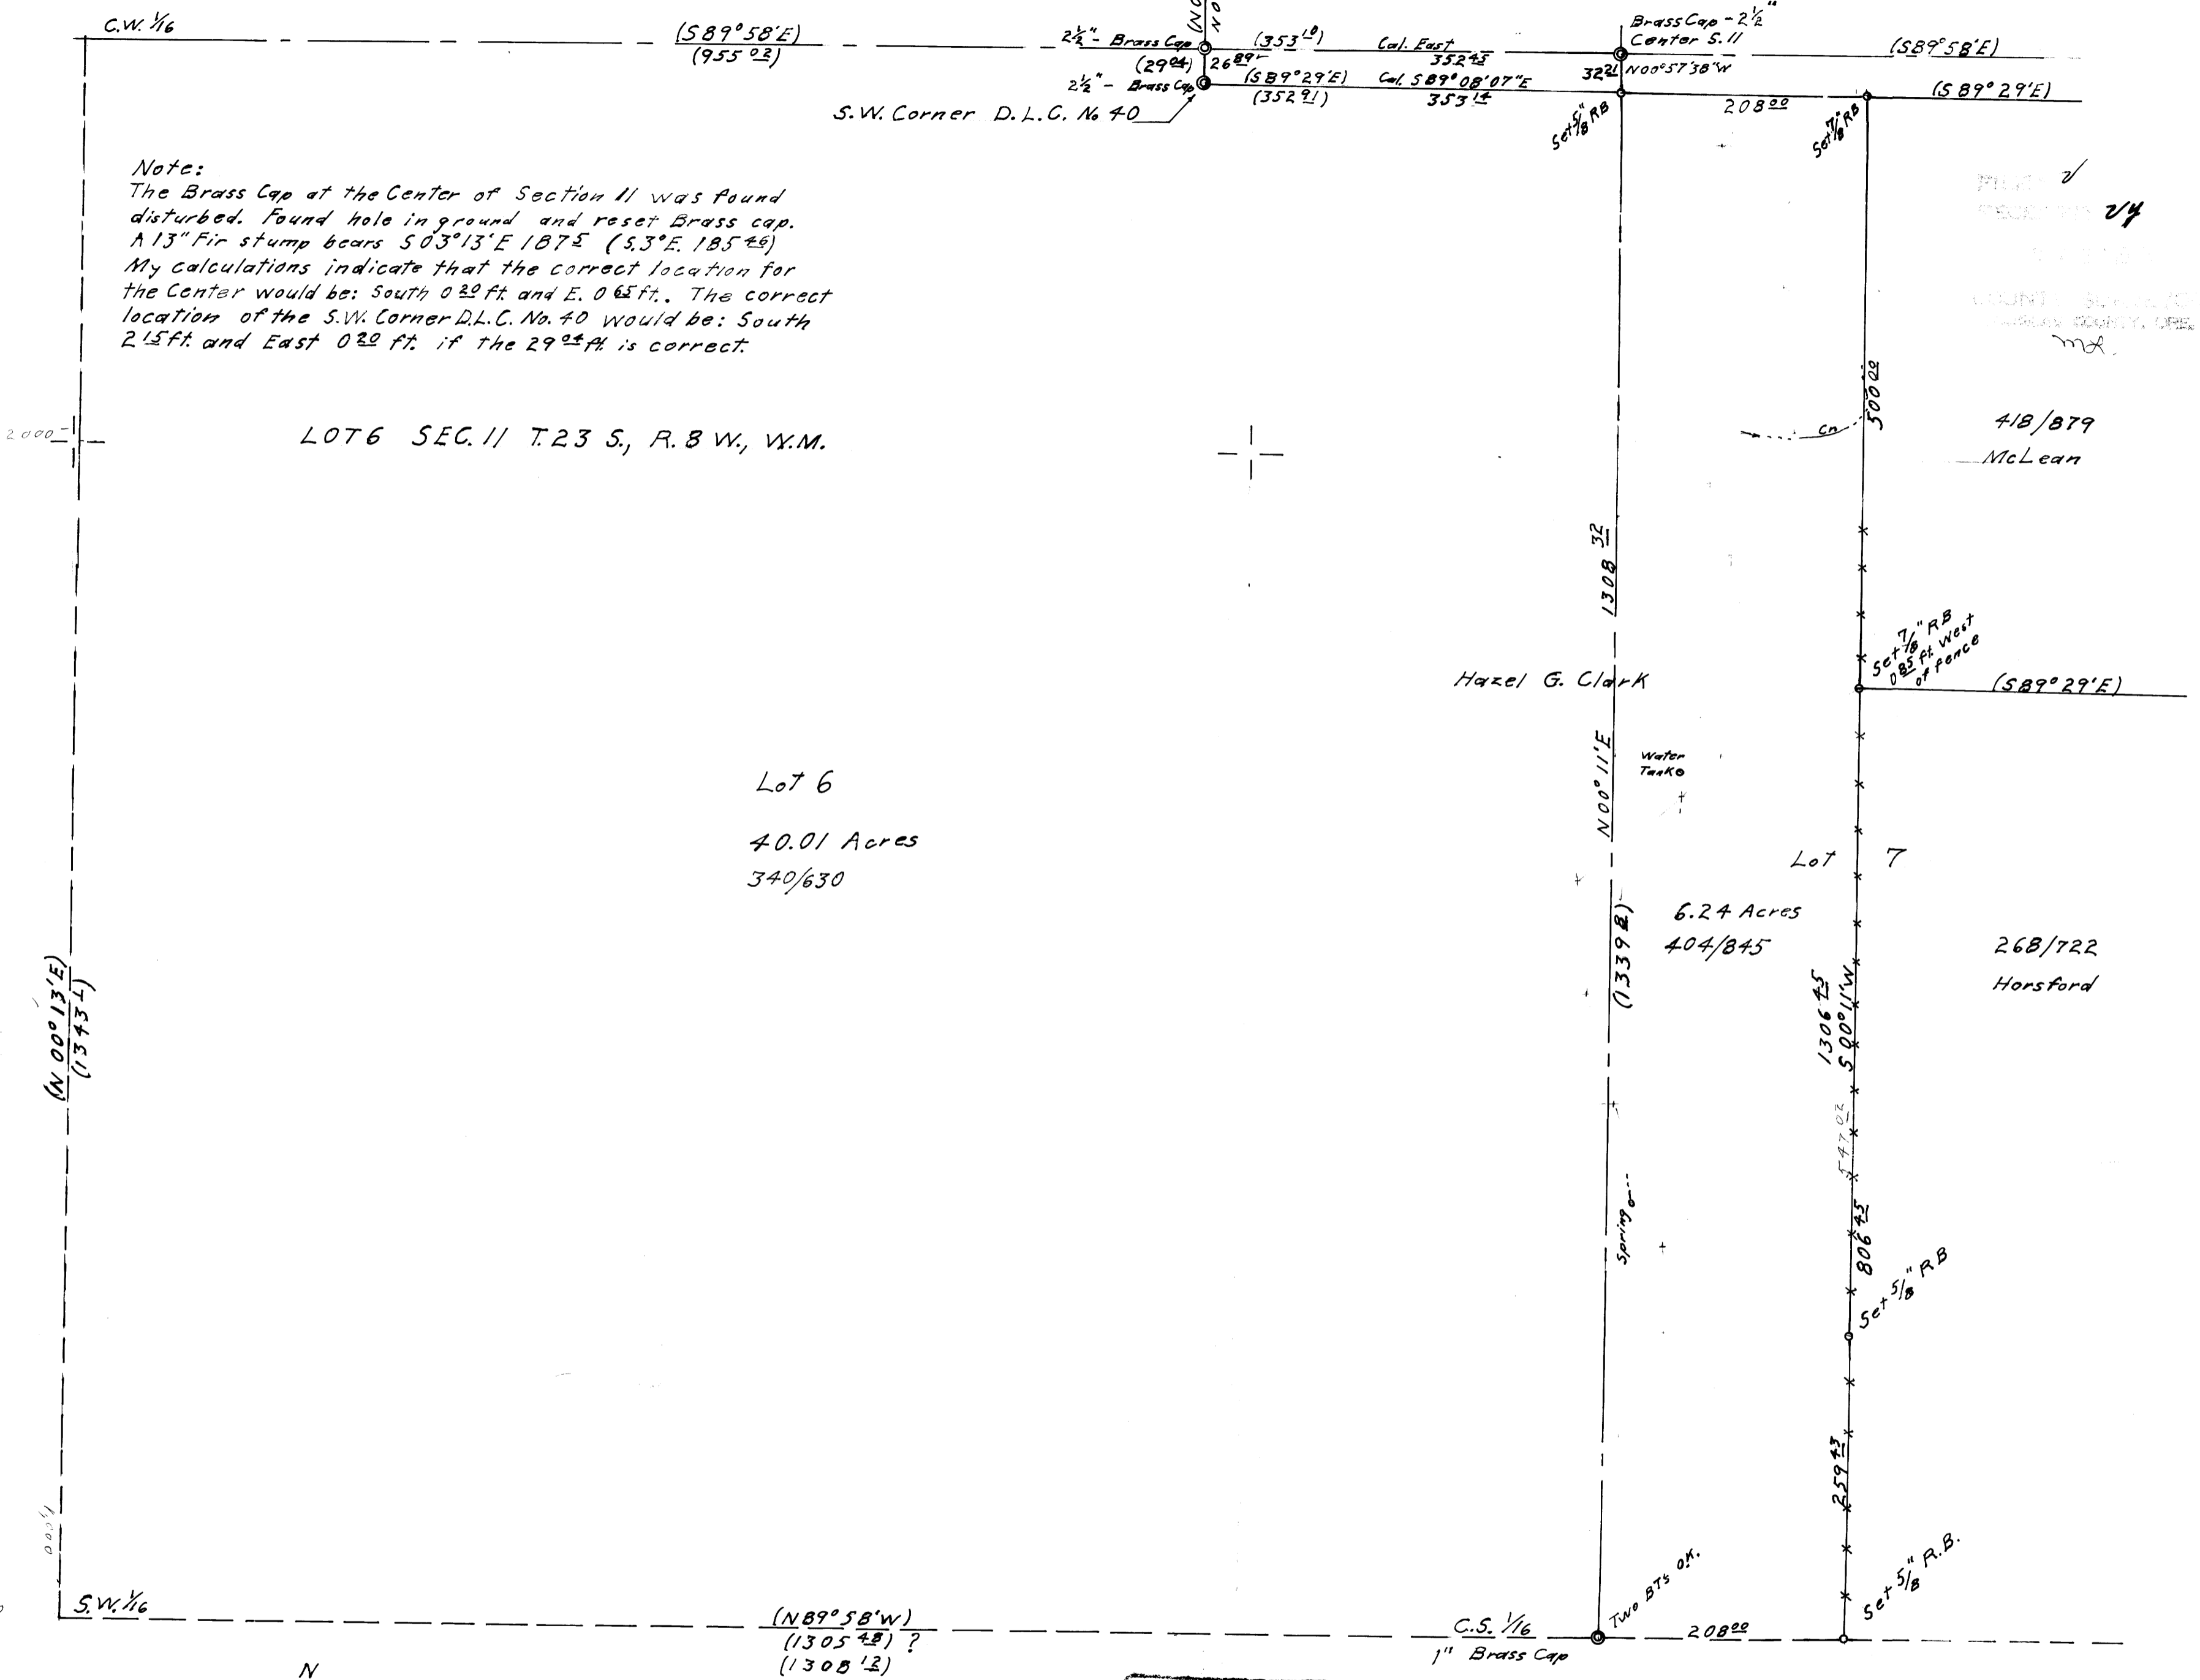
Note:
The Brass Cap at the Center of Section 11 was found disturbed. Found hole in ground and reset Brass cap. A 13" Fir stump bears S03°13'E 187± (S.3°E. 185±). My calculations indicate that the correct location for the Center would be: South 0.20 ft. and E. 0.65 ft. The correct location of the S.W. Corner D.L.C. No. 40 would be: South 2.15 ft. and East 0.20 ft. if the 29°± is correct.
