Sec. 13, T.22S., R.13W., W.M.
OREGON STATE PARKS
SURVEY
UMPUQUA LIGHTHOUSE STATE PARK
DOUGLAS COUNTY
SCALE: 1" = 400'
AUGUST 26, 1977

UMPQUA LIGHTHOUSE STATE PARK
Section 13, T.22S., R. 13W., W.M.

SURVEY NARRATIVE

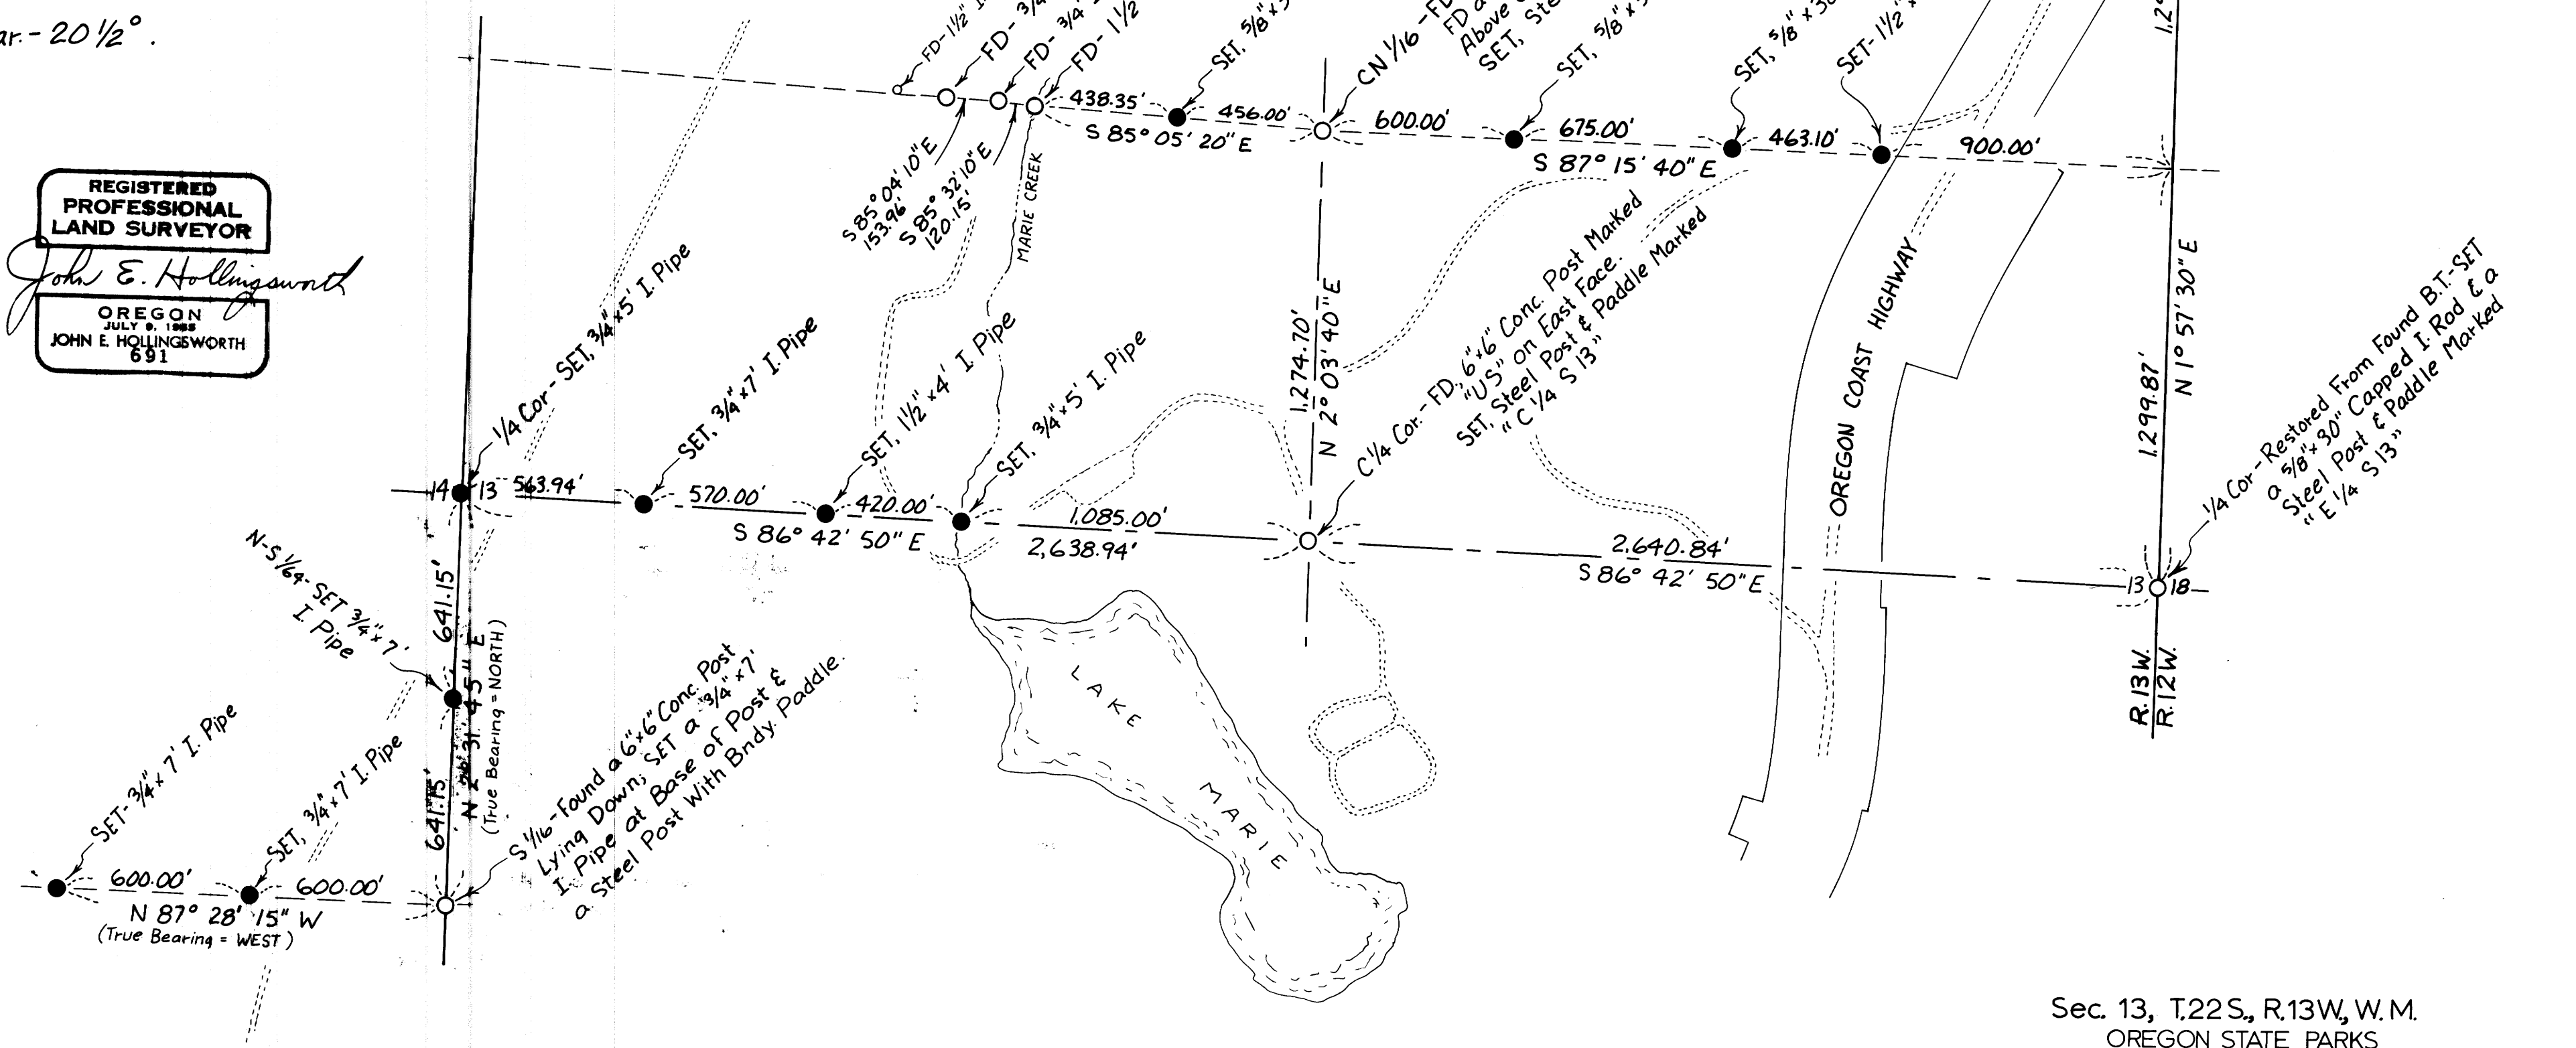
○ Indicates Monuments Found OR Restored.

● Indicates Set Monuments and Steel Posts With White Boundary Paddle.

Aluminum Caps on Set Iron Rods Marked "OREGON STATE PARKS". Boundary Paddles Marked "OREGON STATE PARK BOUNDARY DO NOT DISTURB".

Grid Bearing Obtained Between Station 75+00 & 85+00 Which Are Brass Disk Monuments on The South Jetty Survey Line as Established by The U.S. Army Corps of Engineers. That Grid Bearing Being N 65° 32' 37" W. Station 75+00 is 1,399.28' South & 7,047.16' West of The Section Corner Common to Sections 7, 12, 13 & 18.

TRUE = N 2° 31' 45" W
GRID = North

The Quarter Corner between Sections 13 and 14 was reestablished by producing the East-West centerline of Section 13 from the East Quarter through the Center Quarter and intercepting this line with a line due North out of the found South 1/16th between Sections 13 and 14.
