SURVEY NARRATIVE

SURVEY in the Northwest Quarter of Section 14, Township 30 South, Range 6 West of the Willamette Meridian, Douglas County, Oregon.

PURPOSE OF SURVEY: To establish the Northwest corner of the SW $\frac{1}{4}$ NW $\frac{1}{4}$ of Sec. 14 and to determine the approximate location of the North, South and East boundaries for fencing purposes.

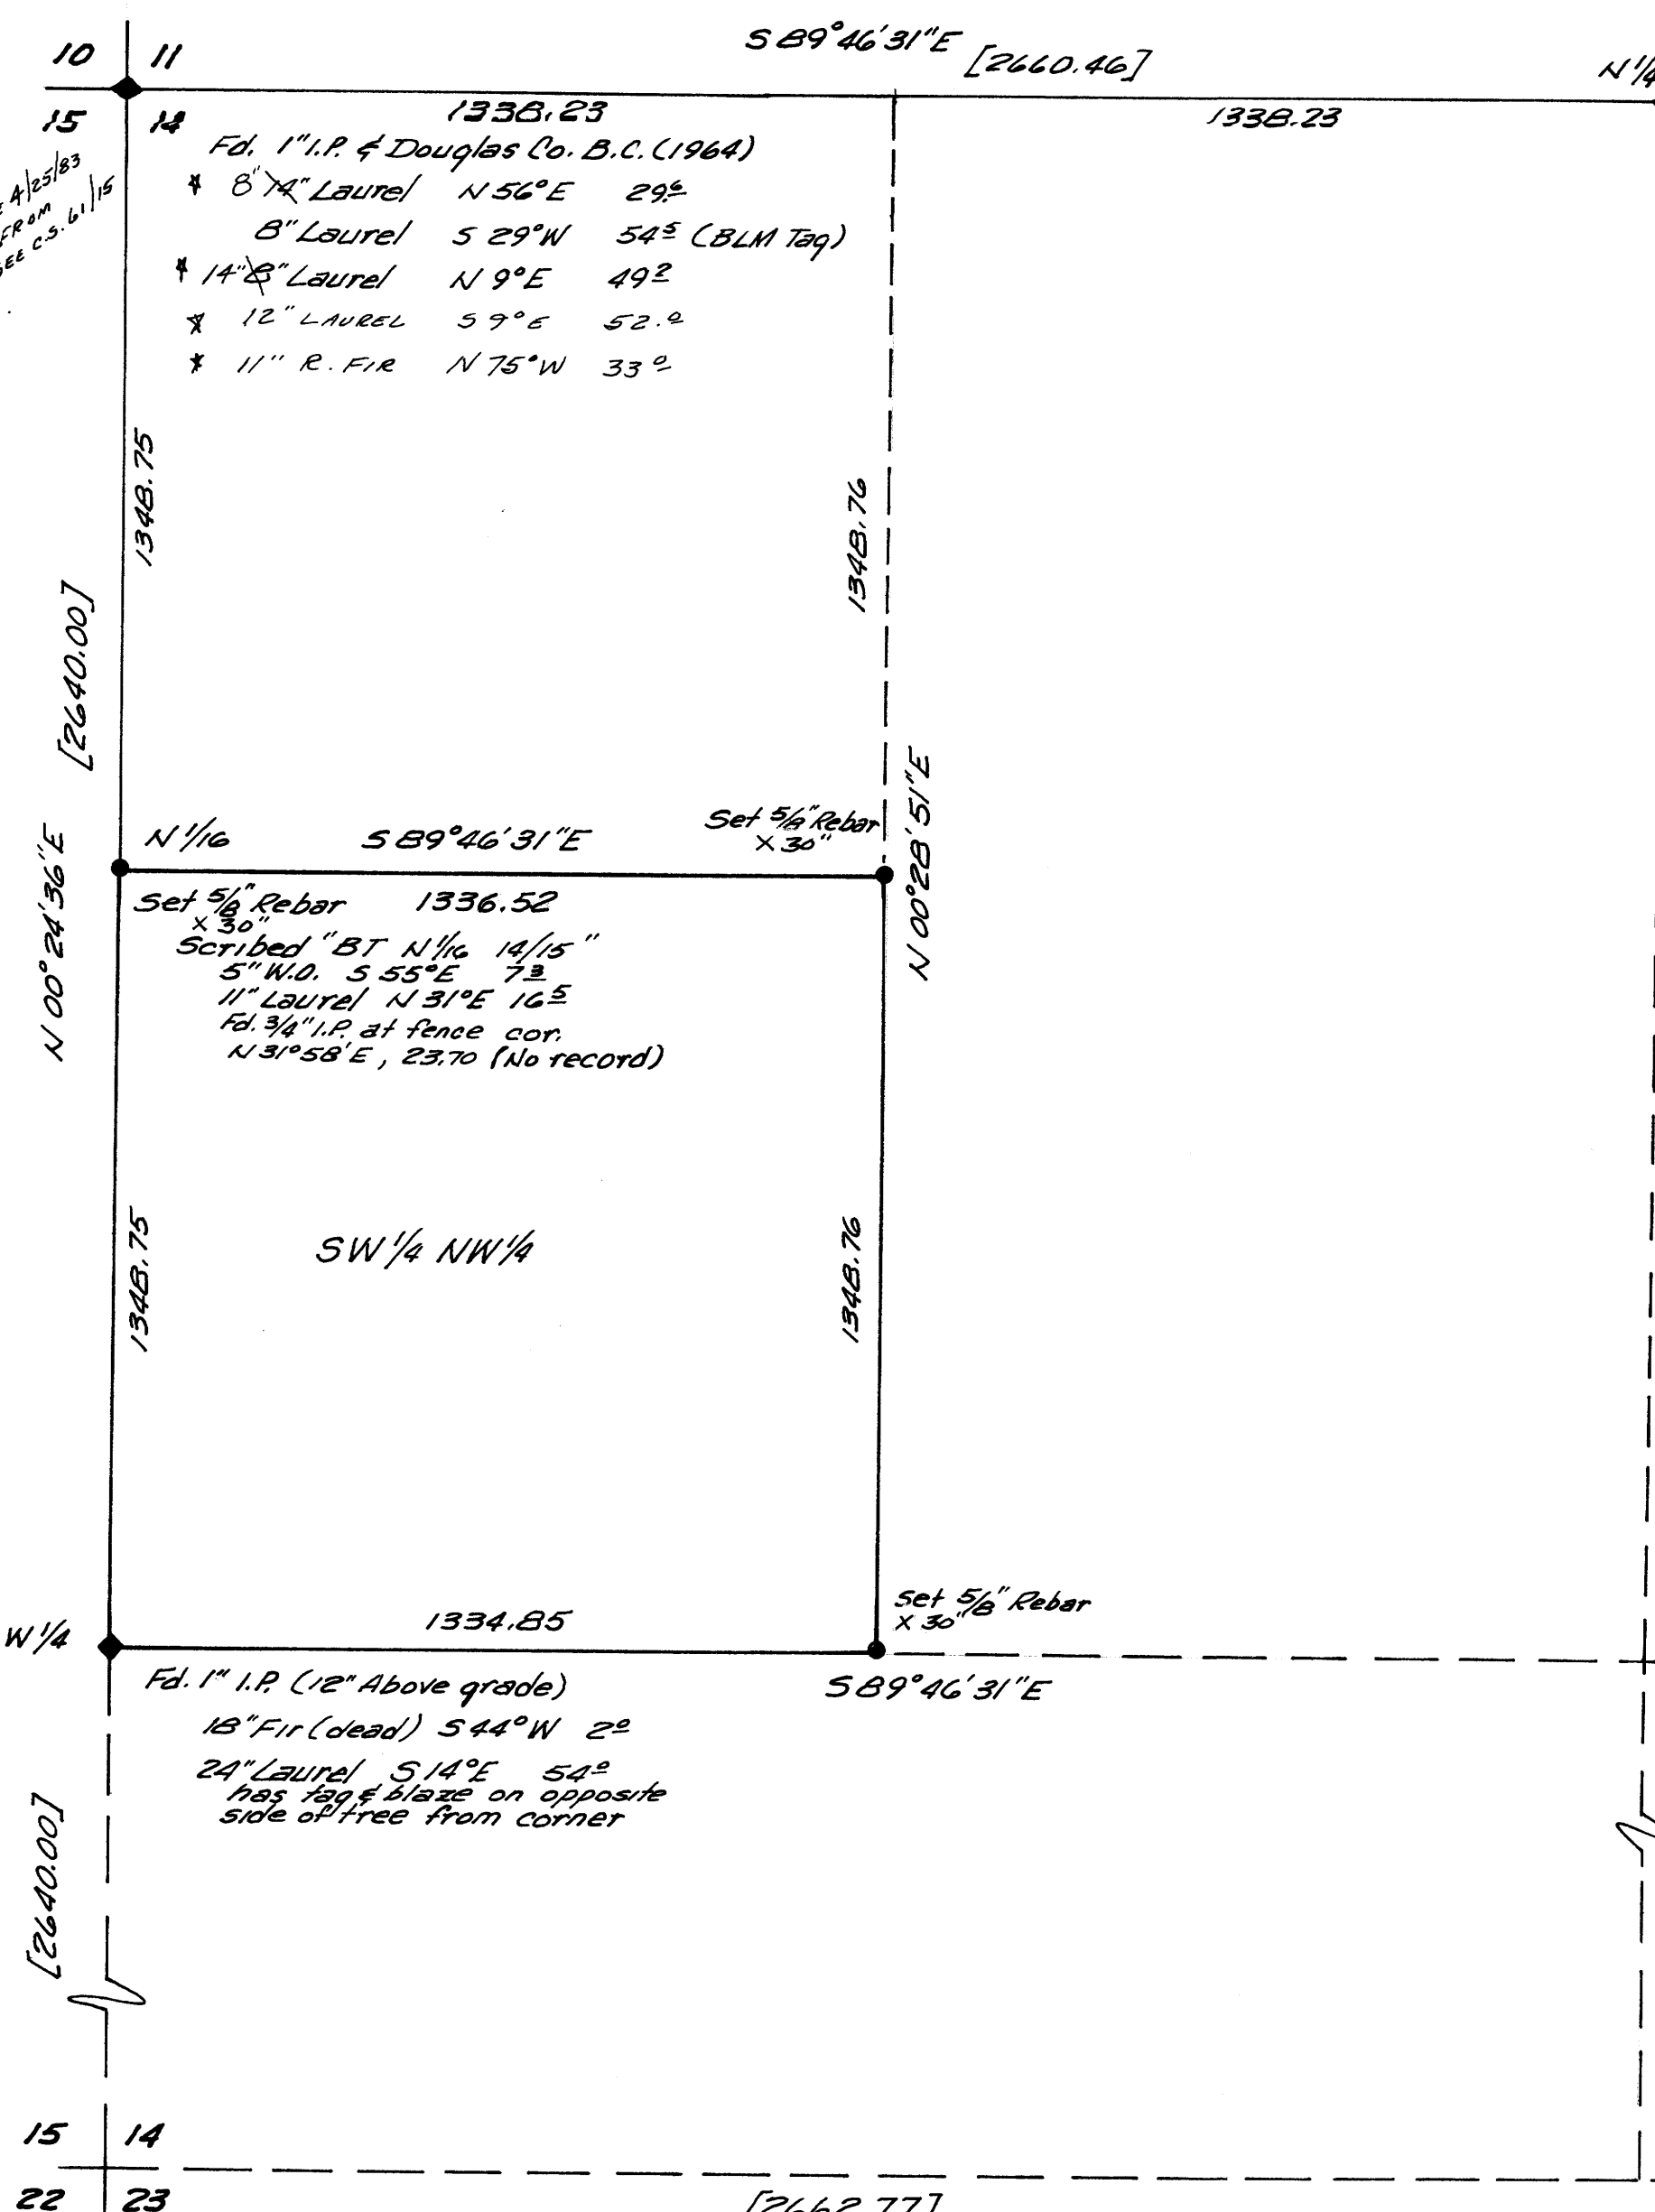
N 1/4 Fd. Douglas Co. B.C.
 on 1" I.P. (1963)
 36" W.O. S 41 1/2° W 155'
 42" B.O. N 41 1/2° W 248'
 FILED BS
 RECEIVED
 MAR 27 1981
 COUNTY SURVEYOR
 DOUGLAS COUNTY, ORE.
 BS

Bearings based on
 Solar Observation
 Scale 1" = 300'
 FEB. 14, 1981

——— Lines Measured
 - - - - - Calculated and Gov't Notes
 [Gov't Measure]
 Note: The SE & NE Corners of
 the SW 1/4 NW 1/4 are not in true
 position - the location shown, derived
 from field measurements and original
 survey notes.

All measurements, corners used and related accessories are shown on the accompanying plat.

I began the survey at a 1" iron pipe marking the W $\frac{1}{4}$ corner of Sec. 14. I then measure Northerly to the corner common to Sections 10, 11, 14 and 15, then Easterly to the N $\frac{1}{4}$ corner of Sec. 14. I then close on the W $\frac{1}{4}$ corner.

I then set a 5/8" rebar to monument the NW corner of said SW $\frac{1}{4}$ NW $\frac{1}{4}$. I then traverse around the subject parcel and again close on the W $\frac{1}{4}$ corner.

For the purpose of this survey, lines were marked parallel to the North line of the section and the East line being from measured distances and Government notes. 5/8" rebar was set for reference as shown on the plat and there is no intent that these represent the true position of the corners.
