SURVEY FOR  
**U. S. FOREST SERVICE**  
SMITH - UMP CADASTRAL  
CONTRACT NO. 53-04TO-3-0935N  
SECTION 27, T21S, R11W, W. M.  
DOUGLAS COUNTY, OREGON

SECTION 27, T21S, R11W, W. M.

SMITH-UMP CADASTRAL

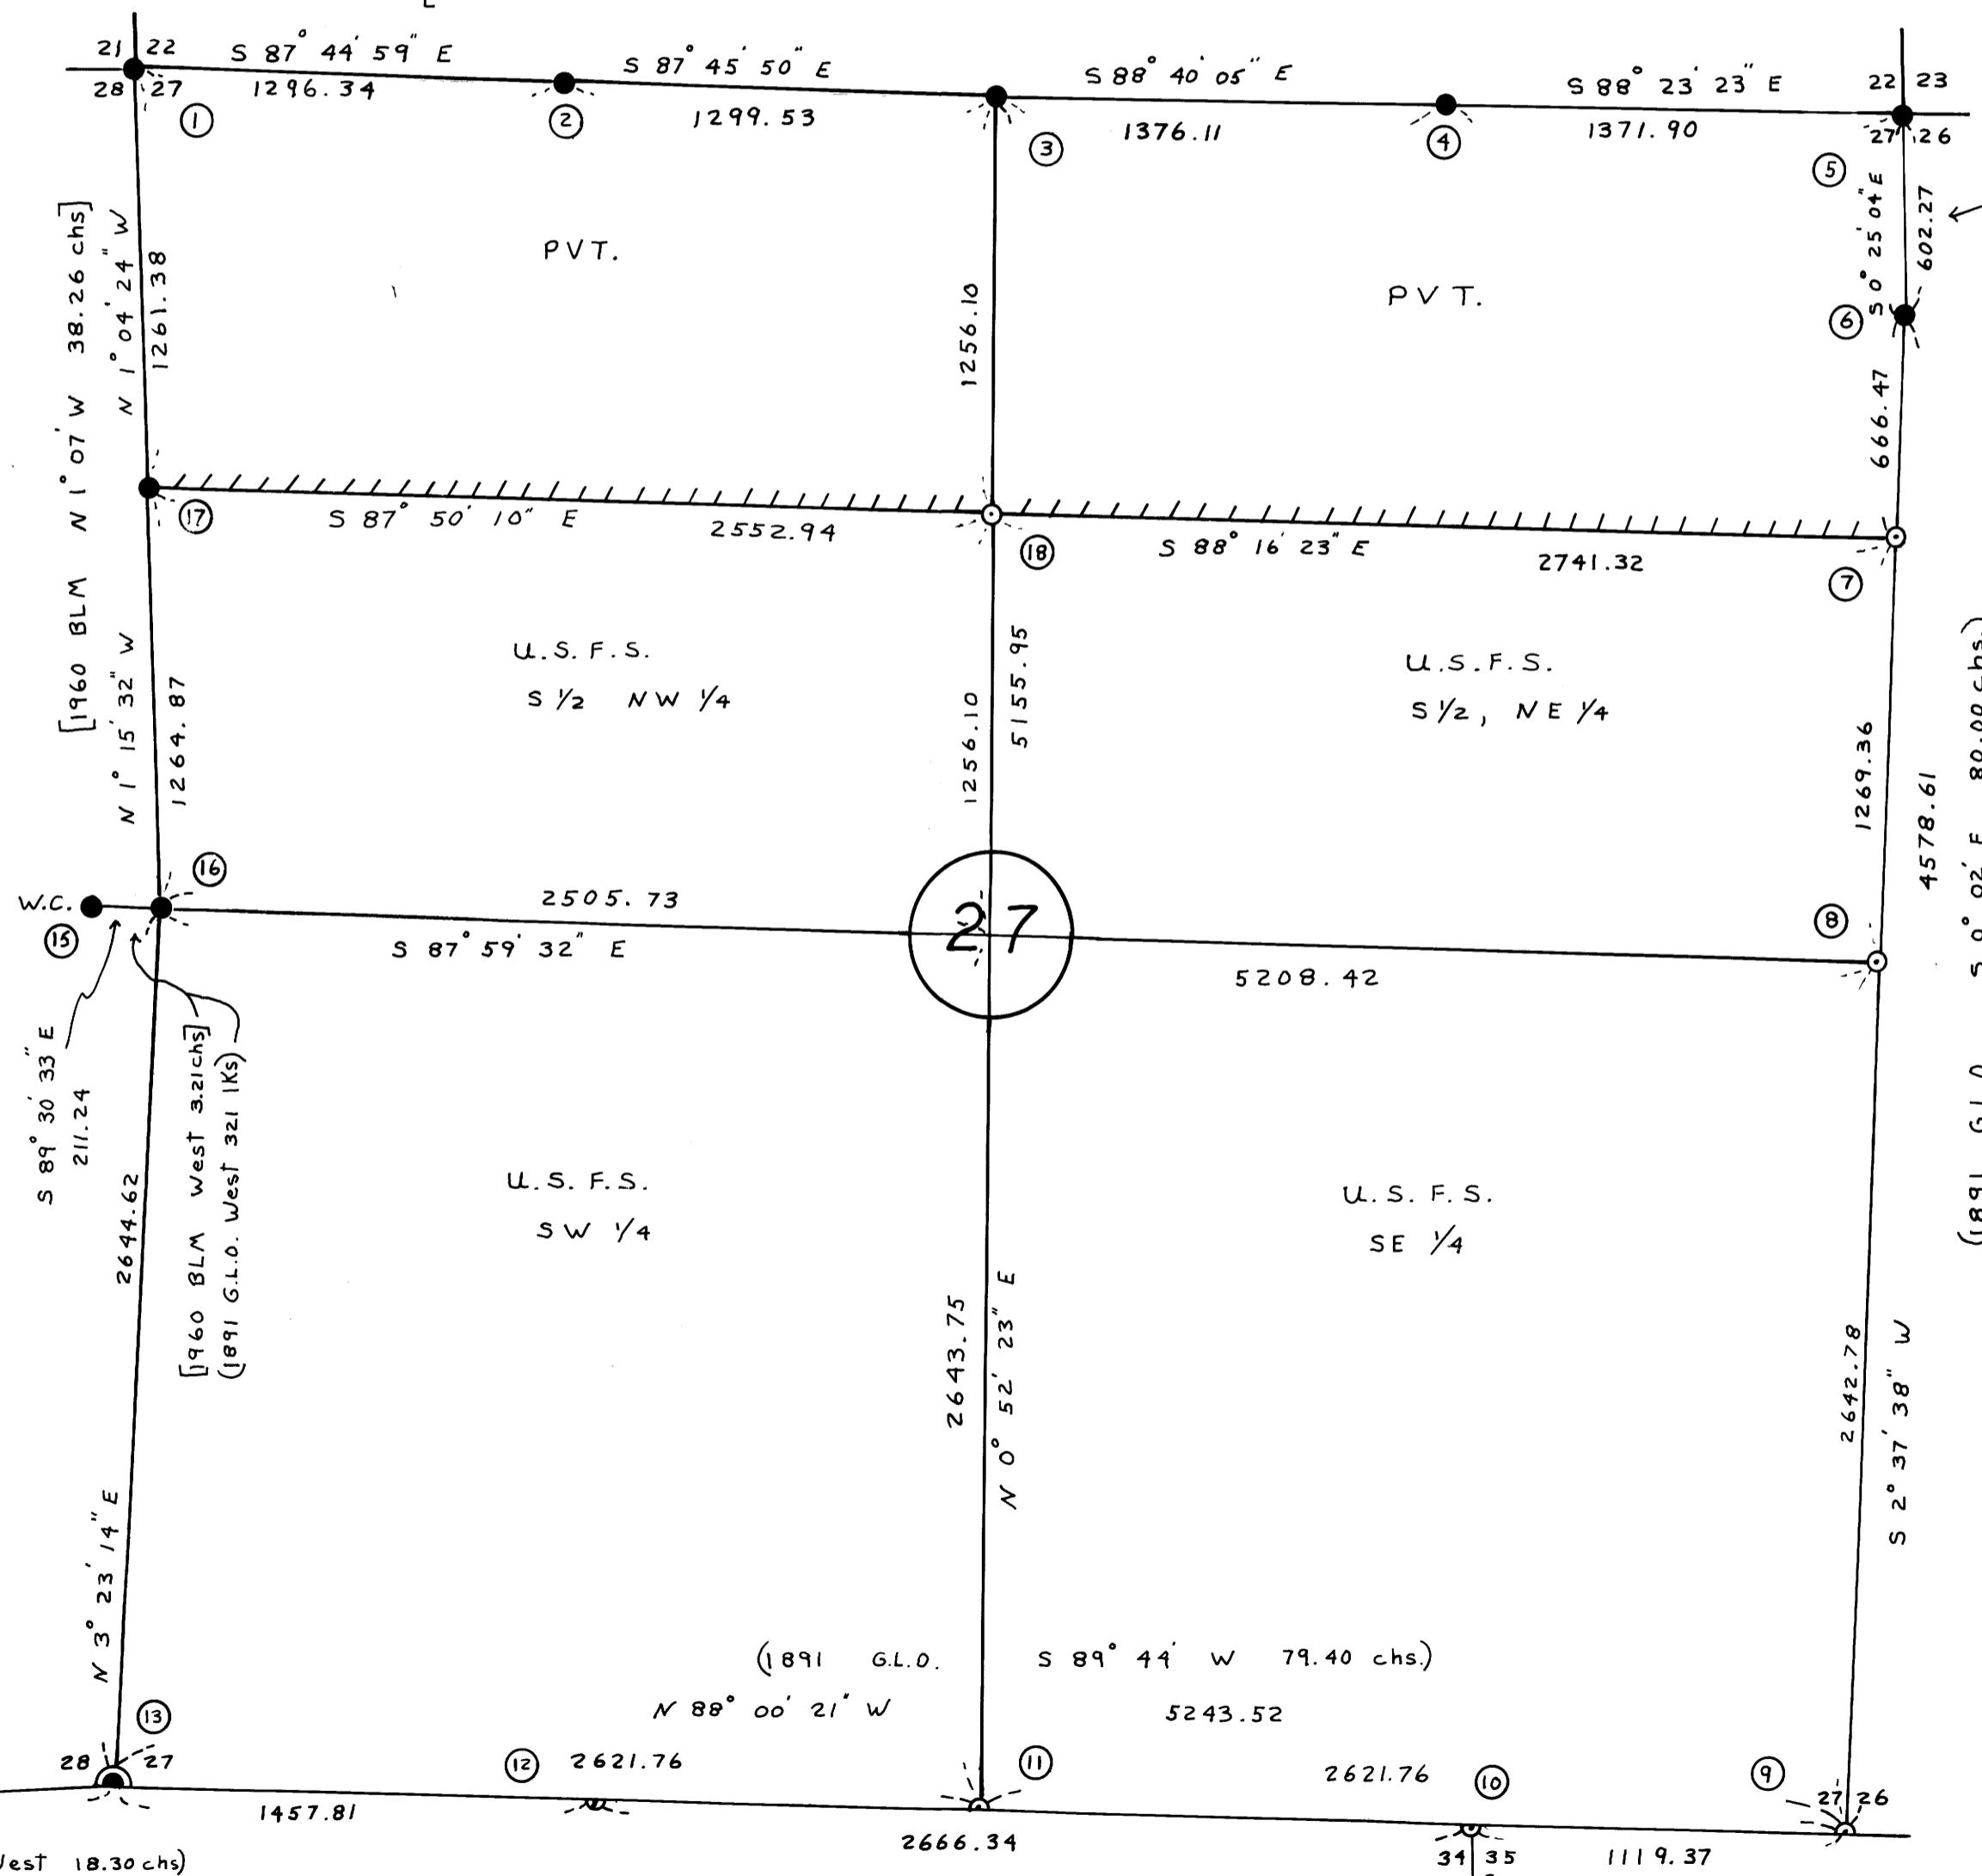
(1891 G.L.O. N 89° 56' W 79.90 chs.)

[1960 BLM N 87° 38' W 39.44 chs. N 88° 34' W 41.64 chs.]

[1960 BLM S 0° 01' E 9.21 chs.]  
(1891 G.L.O. 10.70 chs.)

**NARRATIVE:** This survey is a closed traverse by T-16 theodolite and DI-4 EDM, and T1-A theodolite and Citation 450 EDM, made by Jackson & Prochnau, Inc., P.O. Box 177, Albany, Oregon, 97321. The original subdivisions in this portion of the township were done by William Thiel in 1891. The Southeast corner of Section 27, corner ④ was set at the record latitude from the witness point, corner ⑥ and at record departure from the Southwest corner, ③, as recommended by the BLM. The N 1/16 27/26, corner ⑦ was set at the mid-point in latitude between the NE corner, ⑤, and the 1/4 27/26, corner ⑧, on line between ⑥ and ⑧. Corner numbers ⑧ ⑩ ⑪ and ⑫ were set by single proportion measure.
