SURVEY FOR  
**U.S. FOREST SERVICE**  
**SMITH-UMP CADASTRAL**  
**CONTRACT NO. 53-04T0-3-0935N**  
**SECTION 33, T21S, R11W, W. M.**  
**DOUGLAS COUNTY, OREGON**

SMITH - UMP CADASTRAL

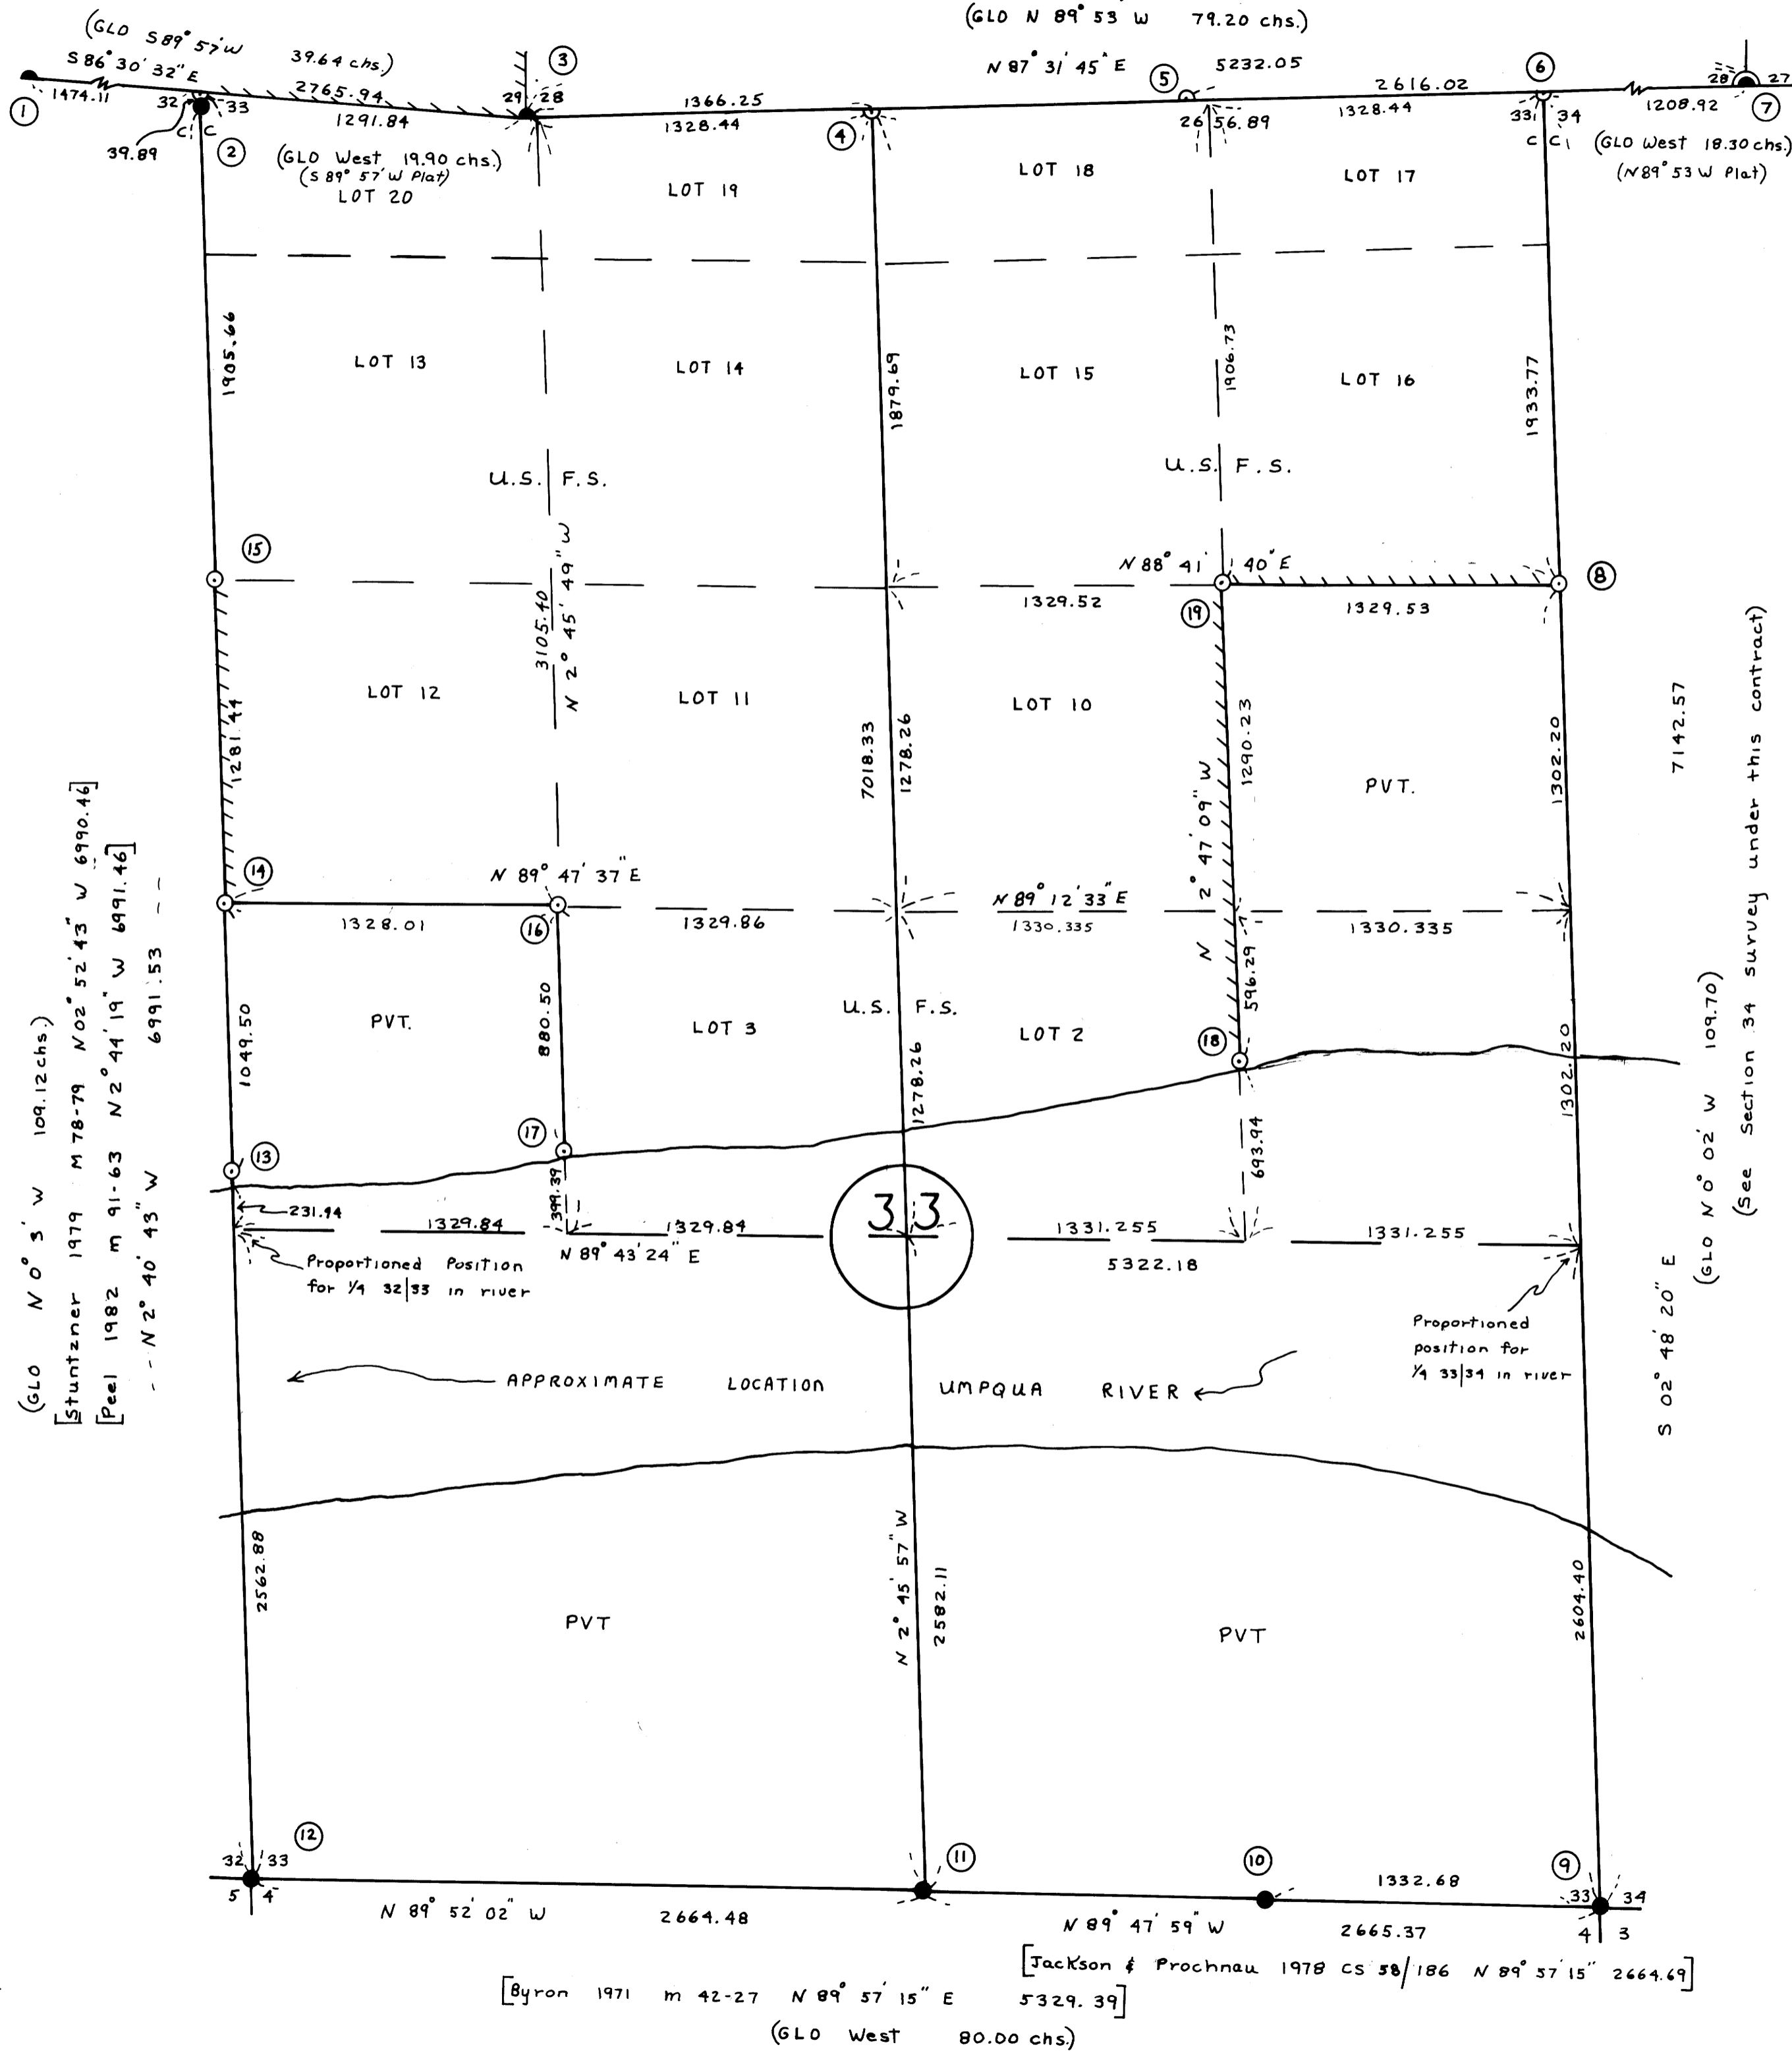
- Corner evidence found
- ⊙ Corner evidence found from adjacent survey under this contract.
- Corner set by survey
- ▬ Property line posted with 6' fiberglass posts with F.S. decals 54-2a or 1/2"x5" rebar with F.S. signs 54-2.
- [ ] Bearings and distances of record by other surveys.
- ( ) Bearings and distances of record from original GLO survey.

Narrative: This survey is a closed traverse by T-16 theodolite with DI-4 EDM and T-1 theodolite with Citation 460 EDM, made by Jackson & Prochnau, Inc., P.O. Box 177, Albany, Oregon 97321. The South boundary of the township, the meanders of the Umpqua River and subdivision of portions of the township along the river was originally done by W.H. Gyars in 1879. William Thiel subdivided portions of the township North of the river in 1891. The Southwest corner of Section 28, corner No. 3, as monumented by Stuntzner M 78-79, was accepted by our survey as the original section corner established in 1891. Acceptance is based on the 36" Cedar bearing tree and supporting topographic calls to the West. The Cedar is the correct age and size (12" per GLO notes) and was opened up in the 1950's. No scribing can be found due to heart rot. The position for the corner, as determined from the Cedar, falls 63 ft. East of a creek bearing Southwesterly, which fits with the original call of 1.00 chains. The calls further West fit very good. The position for the corner was accepted by Hintz M 70-10, and Hootman M 15-23. The closing corner 32|33 was monumented on line between corner 1 and corner 3. Corner Nos. 4, 5, 6 and 13 were set by single proportion measure following a thorough search of the respective areas. In order to subdivide the section, proportioned positions for the East and West 1/4 corners were computed. Both corners fall in the river and were not originally set. The N 1/16 32|33, No. 14 and 1/16 80 32|33, 15, were previously monumented by Stuntzner, M 78-79, in 1979. Stuntzner's positions per his survey, for the N 1/16 32|33 bears S 3° 05' 39" W 0.56 ft, and for the 1/16 80 32|33 brs N 73° 37' 06" 4.15 ft, from the proportioned positions monumented by our survey. Stuntzner removed his monuments during the course of our survey.
