SURVEY FOR
SIUSLAW NATIONAL FOREST
I. P. EXCHANGE CADASTRAL
CONTRACT NO. 53-04TO-7-82030
SECTION 5, T20S, R10W, W.M.
DOUGLAS COUNTY, OREGON

JUNE 30, 1987

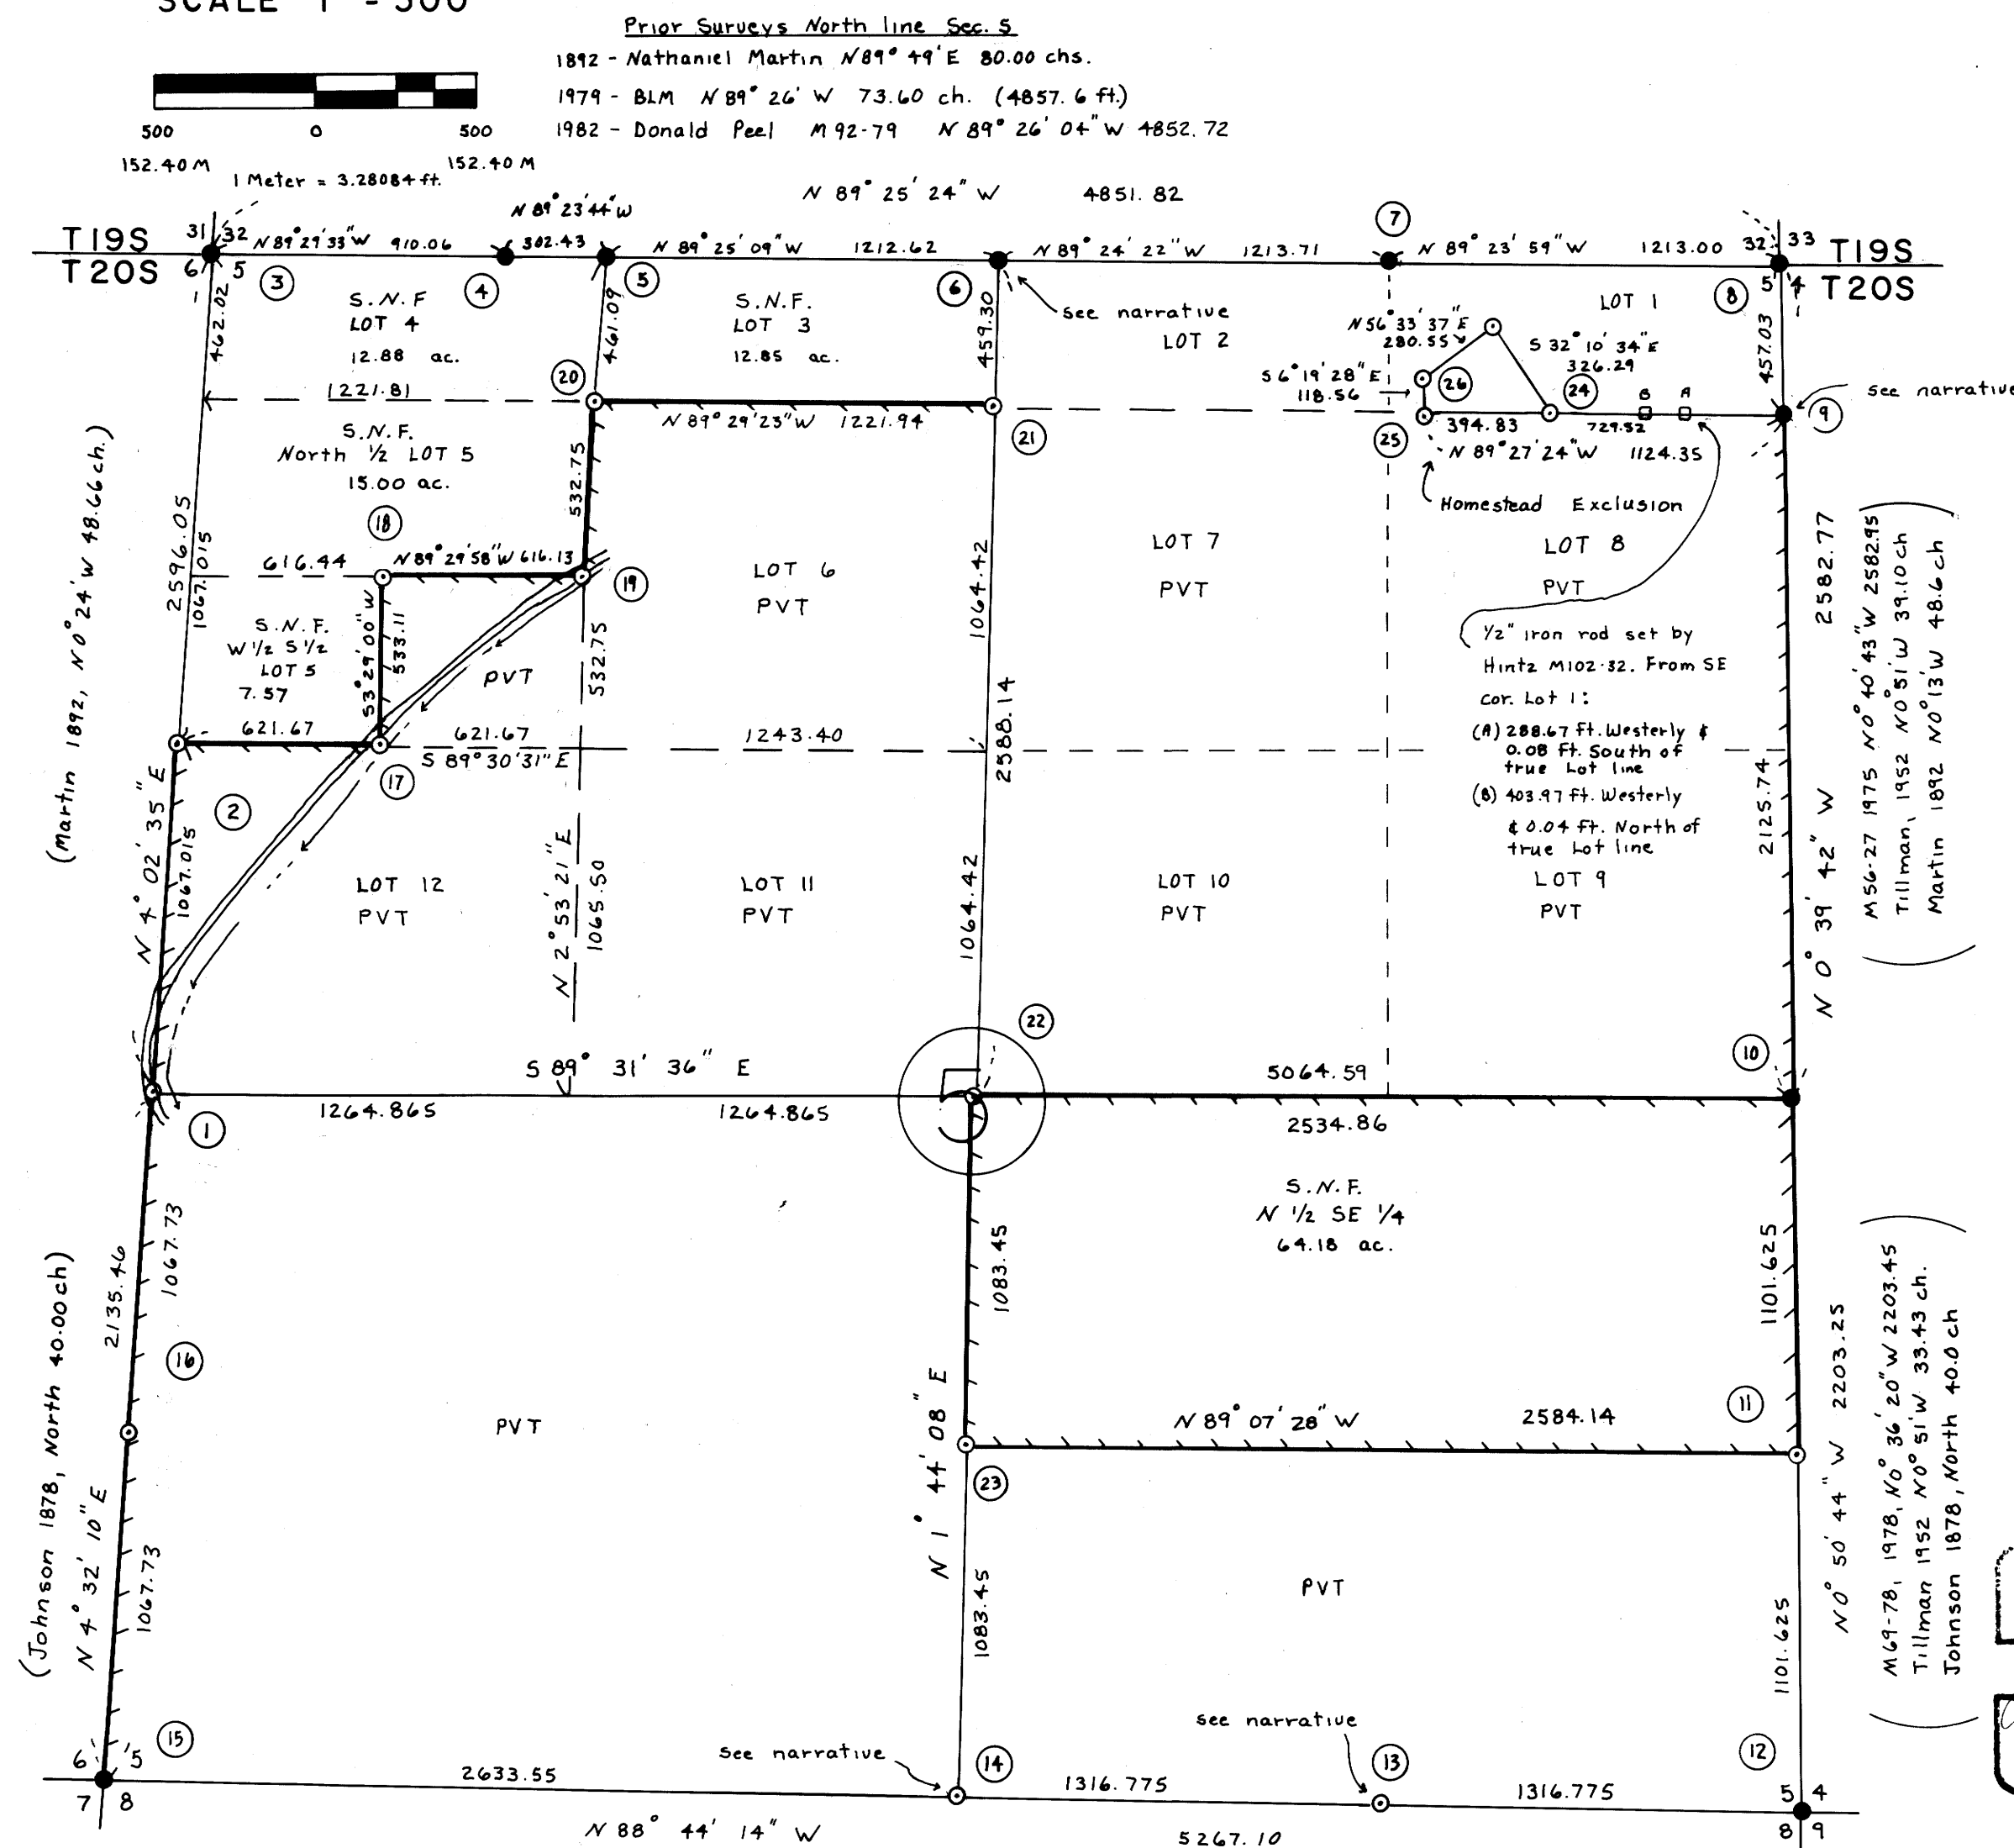
Basis of Bearing
Solar Observation

SCALE 1" = 500'

Narrative: This survey is a closed traverse made by Jackson & Prochnau, Inc., P.O. Box 177, Albany, Oregon 97321. The purpose of this survey was to mark and monument the boundaries as shown. Also locate and record the positions of existing monuments as set in 1975 by Richard Hintz C.S.# M56-27 based upon C.S. M31-6 by Wilford Haines in 1965, and monuments set in 1971 by James Prochnau C.S.# M43-56. Equipment used was a Wild T-16 theodolite with a Wild DI-4 E.D.M.

Description & Location of corners mentioned above: In C.S. M56-27 the 13/4" I.P. set for the NW cor. of Lot 7 was found and brs. N89°59'W 98.8 ft. from the 1/4 cor. Sec. 5 as set by BLM in 1979. This pipe is referenced by a 42" D. Fir which brs S 8 1/2° W 19.9 ft. The other 13/4" I.P. shown to be in Browns Creek on the Lot line between Lot 2 and Lot 7 was found out of position lying in the bottom of Browns Creek under a log. This position is recorded in field book #1. A detail of these corners is not drawn on the plat since the 13/4" I.P. in Browns Crk. is out of position. Both corners are incorrect as they were based on the Haines survey later corrected by the BLM 1979 survey. In reference to the monuments set in 1971 by James Prochnau C.S.# M43-56 the B.C. at the E 1/4 cor. 5/8 (13) was found to be S 29°59'W 16.71 ft. from the position proportioned in this project which compares closely to the position determined in 1983 by Richard Hintz C.S.# M90-42. An alum. cap & pipe was set at the position as shown on this plat. The 1971 B.C. was replaced with a 3/8" x 30" steel rebar with a plastic cap marked LS1305. The B.C. set at the 1/4 cor. 5/8 (14) was found to be S 25° 23' W 10.77 ft. from the position proportioned in this project which compares closely to the position determined in 1983 by Richard Hintz C.S. M90-42. Since the correct position of the 1/4 cor. is now a cor. tree the 1971 B.C. has been modified and used as a RM as shown in the cor. description on this plat. The following corners set by Prochnau C.S. M43-56 were based on the Haines survey M31-6 which was later found to be incorrect by the BLM 1979 survey: 1/4 G/S, SW cor. Lot 5, midpoint West line Lot 5 and NW cor. Lot 5. As these corners are now out of position they were destroyed by obliterating B.T.'s, replacing monument with 3/8" rod with PLS 1305 plastic cap and burying original monument. At the 1/16 80 cor. S | S | 54 (9) this plat, a 3/4" I.P. 4 ft. out of ground from which a 28" D. Fir brs N63°E 3.4 ft. and a 12" D. Fir brs N03°W 19.2 ft. (as recorded by Richard Hintz in a letter to the Douglas County Surveyor dated Aug. 13, 1977) was found. The pipe was loose in the ground causing difficulty in accurately locating an exact position for the existing monument.

Narrative & Private Surveys Continued: A further purpose of this survey was to correct the subdivision of Section 5 to reflect the correct position of the Northwest corner of said Section 5 as determined by the B.L.M. in 1979. This corrected position of the NW corner Section 5 was determined as follows: In July of 1977 Phillip Larson, PLS #474 found evidence of the 1/4 31/6 (per letter of August 1, 1977 to Larry Hunnemuller, Siuslaw National Forest.) In a 1979 resurvey the B.L.M. accepted this position and proportioned corners accordingly, including those on the North line of Section 5. This invalidated corners on the North line of Section 5 set by Haines, M 31-6, who did not find the original 1/4 31/6 and proportioned directly from the Southeast corner Section 32 to the Southwest corner Section 31. Since the Prochnau 1971 survey (M43-56) and the Hintz 1975 survey (M56-27) were based on the Haines survey, certain corners set in these surveys were also invalidated.
