RECORD OF SURVEY

IN THE SOUTHEAST 1/4, SECTION 30, T.25S., R.7W., W.M.,
DOUGLAS COUNTY, OREGON

SURVEY NARRATIVE

FOR: HIRAM B. GERMOND

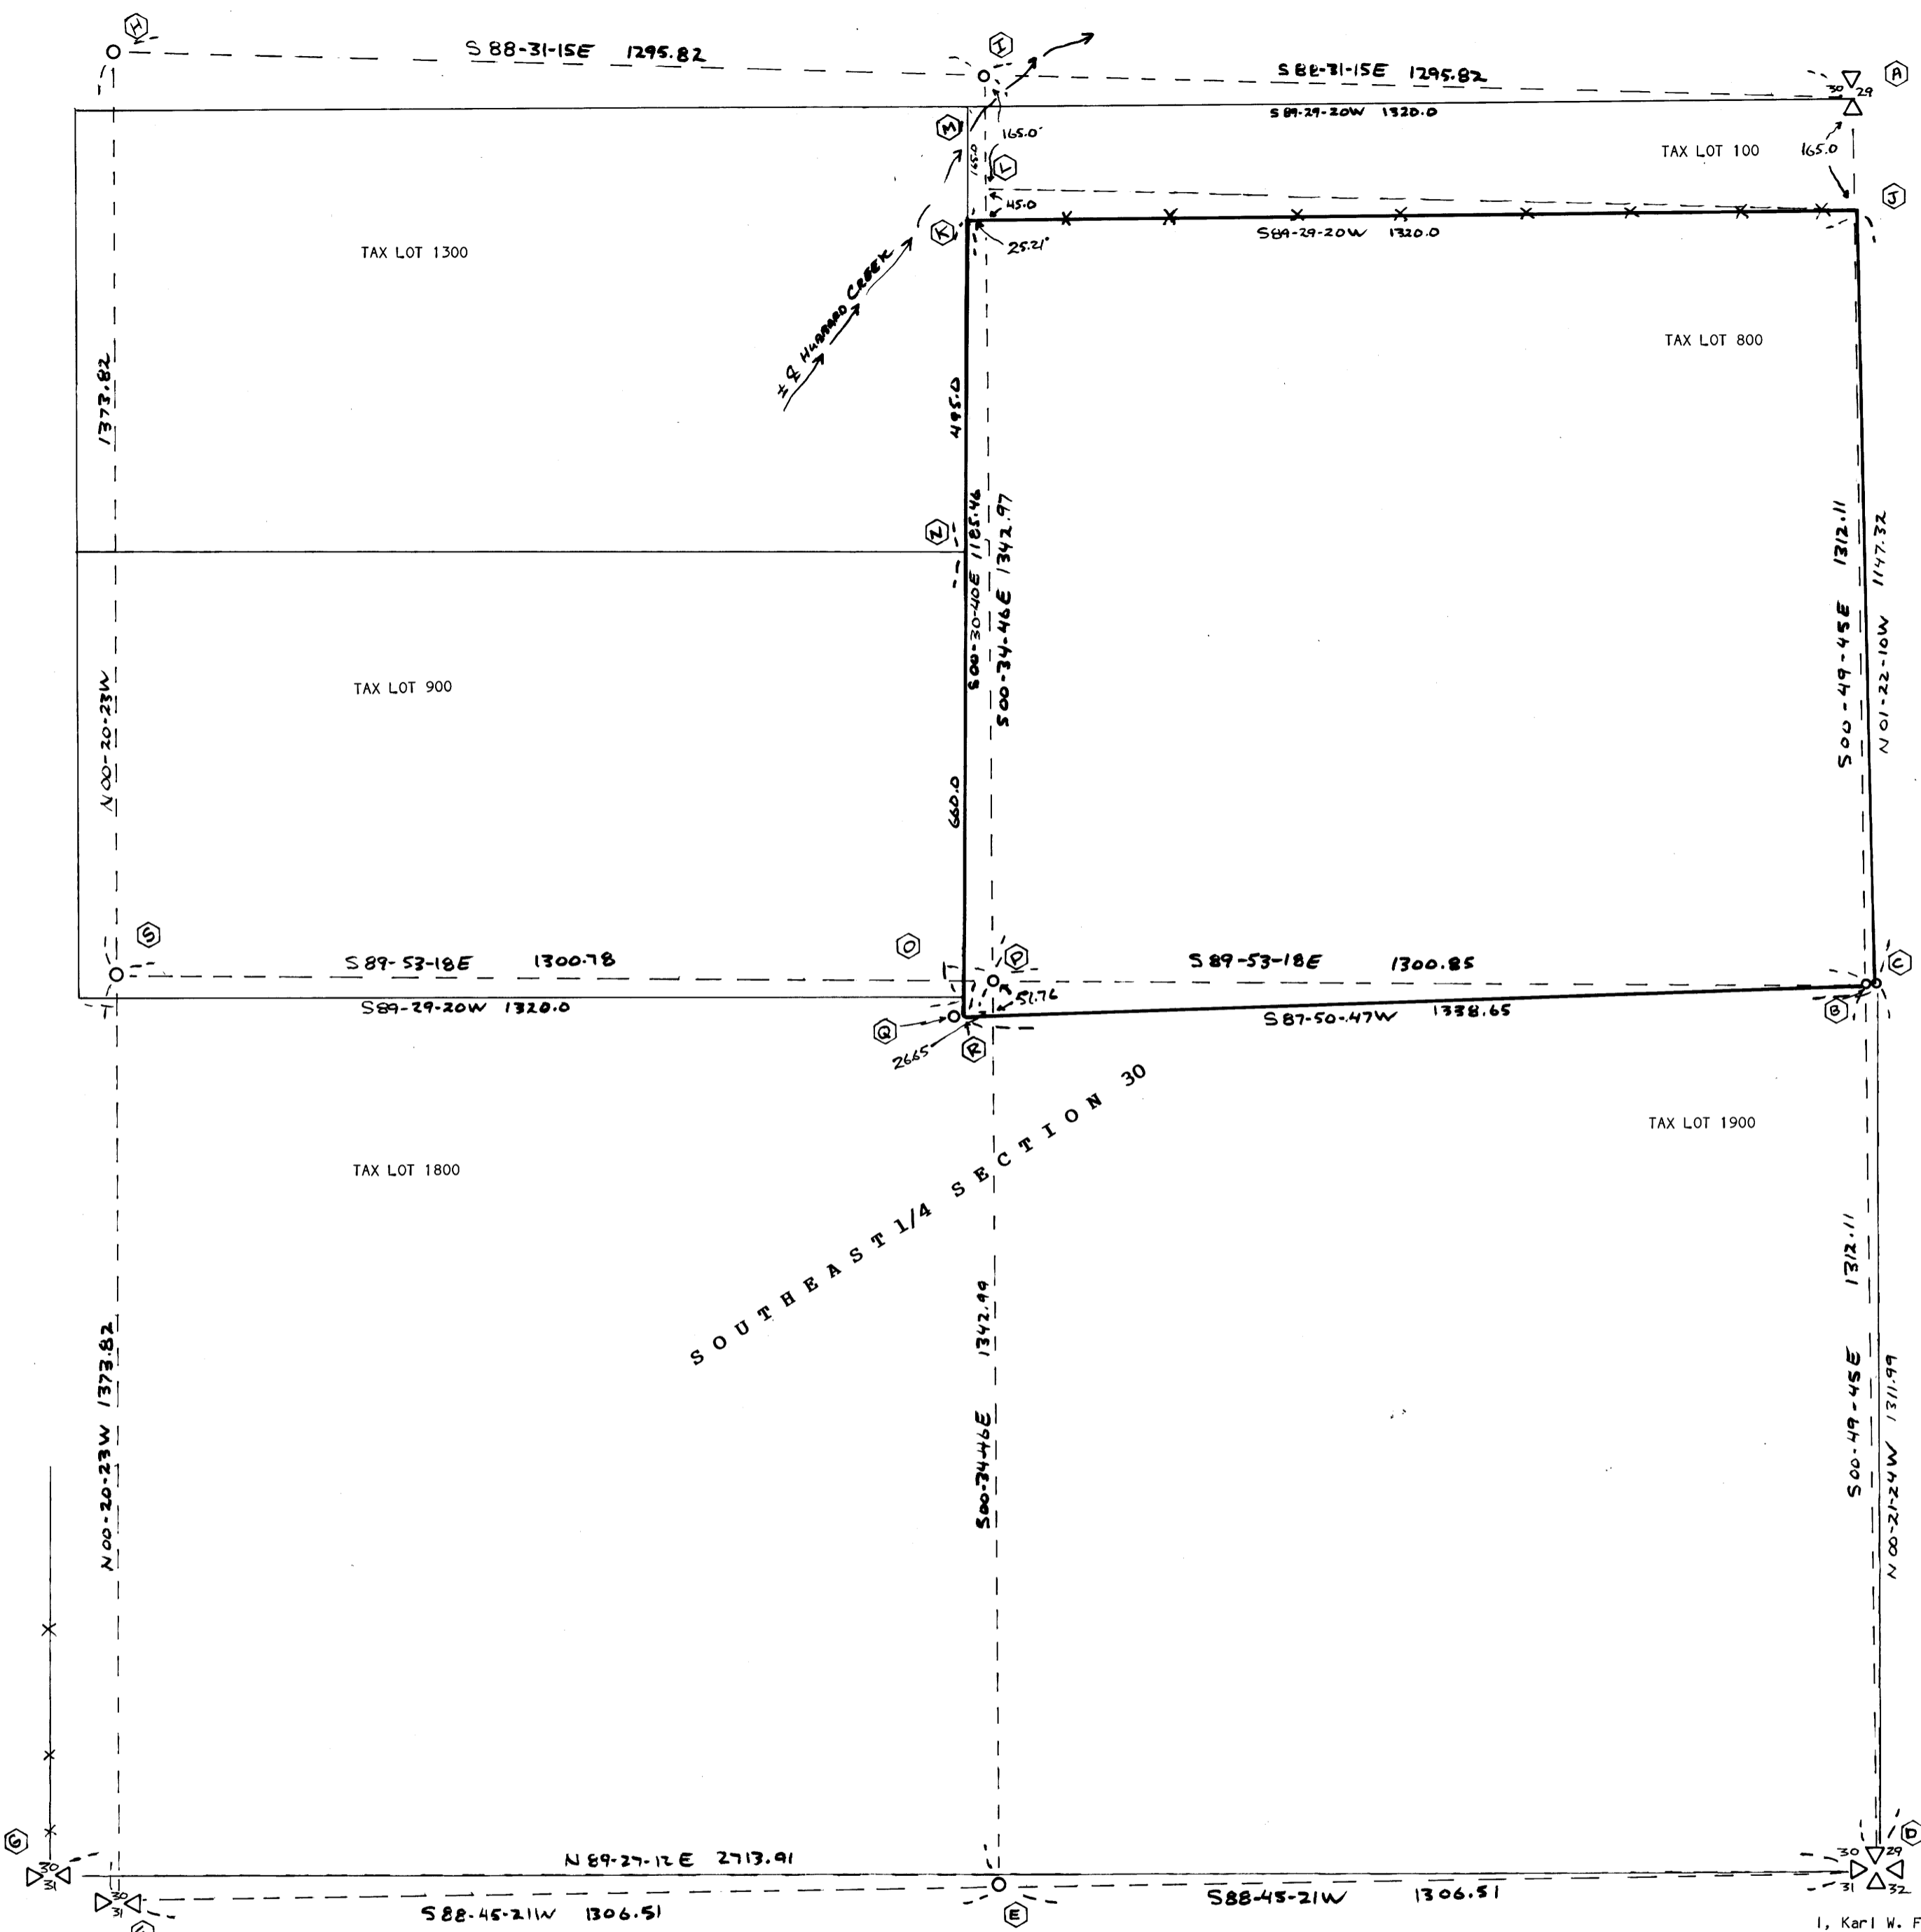
SCALE ONE INCH=200 FEET

- OWNERSHIP BOUNDARY LIMITS OF THE GERMOND PROPERTY
- - - LINES BASED ON THE THIEL SURVEY, AND BOYER SURVEY
- - - LINES BASED ON THE NORTHCRAFT, INGRAM AND CHAMPION SURVEYS
- x INDICATES OLD FENCES
- (A) INDICATES A CORNER EITHER MONUMENTED OR CALCULATED, REFER SHEET TWO

A. East 1/4 Sec.30, established by US GLO Deputy Surveyor, WH Byars, in 1874; found by Milton Germond prior to 1921, remonumented by G.G. Stewart in 1921 who set an eye-bolt, and was further remonumented with a Brass Cap in 1964 by the Bureau of Land Management. I believe it is beyond a reasonable doubt the original East 1/4; found as reported.

B. S1/16th, Sec.30&29 established by H.L. Northcraft in his survey for John Roeder (CS#M102-79). Mr. Northcraft set a 1 1/2" Iron Pipe with a tee top. He set this monument based on a point midway between Monuments A&D, apparently per the Manual; found as reported.

C. S1/16th, Sec.30&29 established by G.G. Stewart in 1921 during his survey for H.F. Roeder (CS# File 2/23). Mr. Stewart set a 1" Iron Pipe, apparently per the Manual, this monument bears East 10.82' from Monument B and apparently was accepted by the Roeder family from 1921 to 1986 as a boundary corner of their property and that of the Germond's. The effect is there are now in the field two monuments which purport to be said boundary corner; found as reported.

D. The SE Sec. corner of Sec 30, common to Sec. 30,29,31&32 established by US GLO Deputy Surveyor W.H. Byars in 1874, found by J.S. Germond prior to 1921, who piled rocks around original stake. G.G. Stewart renewed this corner with a 1" Iron Pipe in his survey, mentioned above, for H. Roeder. This corner was further renewed by the County Surveyor in 1957, who set a Brass Cap; apparently there is no dispute as to the location of this corner and I believe beyond a reasonable doubt it is the original corner. I did not visit this corner, but evaluated it based on the record.

H. Center 1/4 Sec.30, established by Champion Inc., in 1983 (CS# M94-31), they set an aluminum monument based on Mr. Ingram's S 1/4 and other found 1/4 corners in Sec.30. Their survey was apparently done per the Manual and was relied on by Mr. Northcraft in his survey. However if any 1/4 corner they relied on was not based on an original 1/4 corner their survey would be in error, most specifically the S 1/4 of Mr. Ingram (F above). I did not visit this monument but evaluated it based on the record.

I. CE1/16th Sec.30, established by H.L. Northcraft during his above-mentioned survey. He set a 5/8" Iron Rod, apparently per the Manual, however, here again, this is based on surveys by Champion and Ingram and if their surveys are in error, so would this corner. Mr. John Roeder told me on 12/6/89, that the Northcraft monument is not in the position of the corner which the adjoining landowners, including himself, relied on to build their fences and claim to as their ownership. I found this monument as reported.

J. I found a fence corner which measures 165' South of Corner A which agrees with the pertinent deed (10 rods) and has been accepted by Mr. Roeder and Mr. Germond for many years as a boundary corner of their corresponding lands.

Q. Found a 3/4"x30" angle Iron which bears South 54' and West 59' from Corner P. I find no record as to who may have set it and has been in the ground no more than 10-15 years. It generally is on an extended line of the old cutting line (line B-R) but is West, about 30' from reconstructed line K-N-O-R.
