SUBDIVISION OF SECTION 11, T.22S., R.6W., W.M.

SURVEY FOR
U.S. NATIONAL BANK OF OREGON
EAST 1/2, SEC. 11, T.22S., R.6W., W.M.
DOUGLAS COUNTY, OREGON
MARCH 28, 1990

FILED
APR 9 1990
COUNTY SURVEYOR
DOUGLAS COUNTY, ORE.

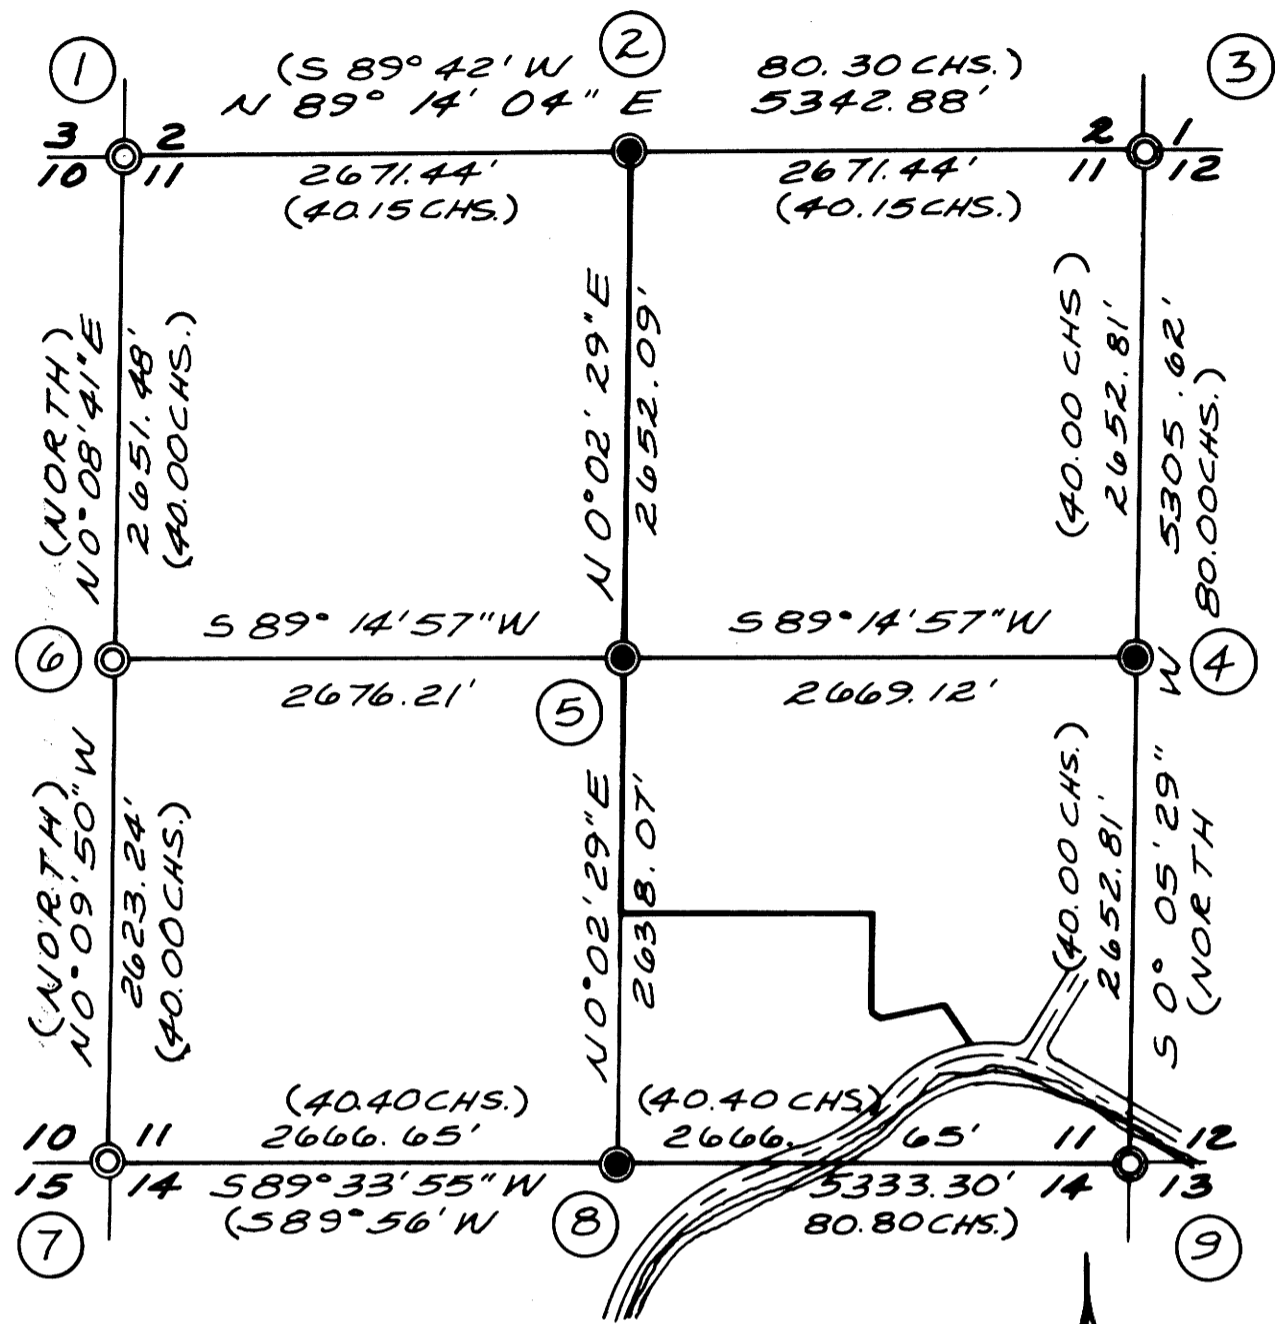
CORNER DATA INFORMATION

SCALE 1" = 1000'

- 1 Northwest Corner Section 11
Found 'T' iron set by Wilford Haines in C.S. File No. 42/75. Brass cap on top of 'T' iron is missing. Found 30" (16" - 1955) Ash bearing tree bearing S05°08'E 26.8 feet lying on the ground.
Blazed and scribed new bearing trees as follows:

- 3 Northeast Corner Section 11
Found Douglas County Surveyor's Office brass cap marked: "Douglas Co. Surveyor, T22S R6W, S2/S1, S11/S12, 1983". Brass cap was found in good condition.

4) 17" Douglas Fir scribed "C 1/4 S 11" "BT" bears S51°30'W 17.8 feet.
- 6 West 1/4 Corner Section 11
Found Douglas County Surveyor's Office brass cap marked: "County Surveyor's Office, T22S R6W, 1/4 S 10/11, 1961". Brass cap was found in good condition.

- 7 Southwest Corner Section Section 11
Found Bureau of Land Management brass cap marked: "U.S. Cadastral Survey, T22S R6W, S 10/S11, S15/S14, 1968 Bureau of Land Management". Brass cap was found in good condition.

4) 12" White Oak scribed "N 1/4 S 14" "BT" bears S45°15'W 134.4 feet.
- 9 Southeast Corner Section 11
Found Douglas County Surveyor's Office brass cap marked: "County Surveyor's Office 1968, T22S R6W, S11/S12, S14/S13". Brass cap was found in good condition.

- 13 Set 5/8 inch by 30 inch rebar with yellow plastic cap marked "Branch Eng LS 1138". Corner was set by holding deed call bearings and distances from the found monument at Engineer's Centerline Station 1655+00, left 50.00 feet (Corner No. 15).

- 14 Found 5/8 inch iron rod with aluminum cap marked "Oregon State Hwy". Corner was found to be N89°52'E 1.49 feet from true corner.
Position for corner was established by holding deed call bearing and distance from the found monument at Engineer's Centerline Station 1655+00, left 50.00 feet (Corner No. 15).

- 15 Right of Way Monument Station 1655+00, Left 50.00 Feet
Found 5/8 inch iron rod with aluminum cap marked "Oregon State Hwy". Monument was held as found and was used as one monument to determine the basis of bearings.

- 16 Right of Way Monument Station P.T. 1640+88.1, Left 40.00 Feet
Found bent 1/2 inch iron rod. Monument was found to be N30°43' E 1.96 feet from called position.
