M113-35A

RECORD OF SURVEY
for CHAMPION INTERNATIONAL CORP.
by WARD NORTHWEST INC.
in SECTION 23, T 22 S, R 12 W, WM
DOUGLAS COUNTY, OREGON
5/15/91

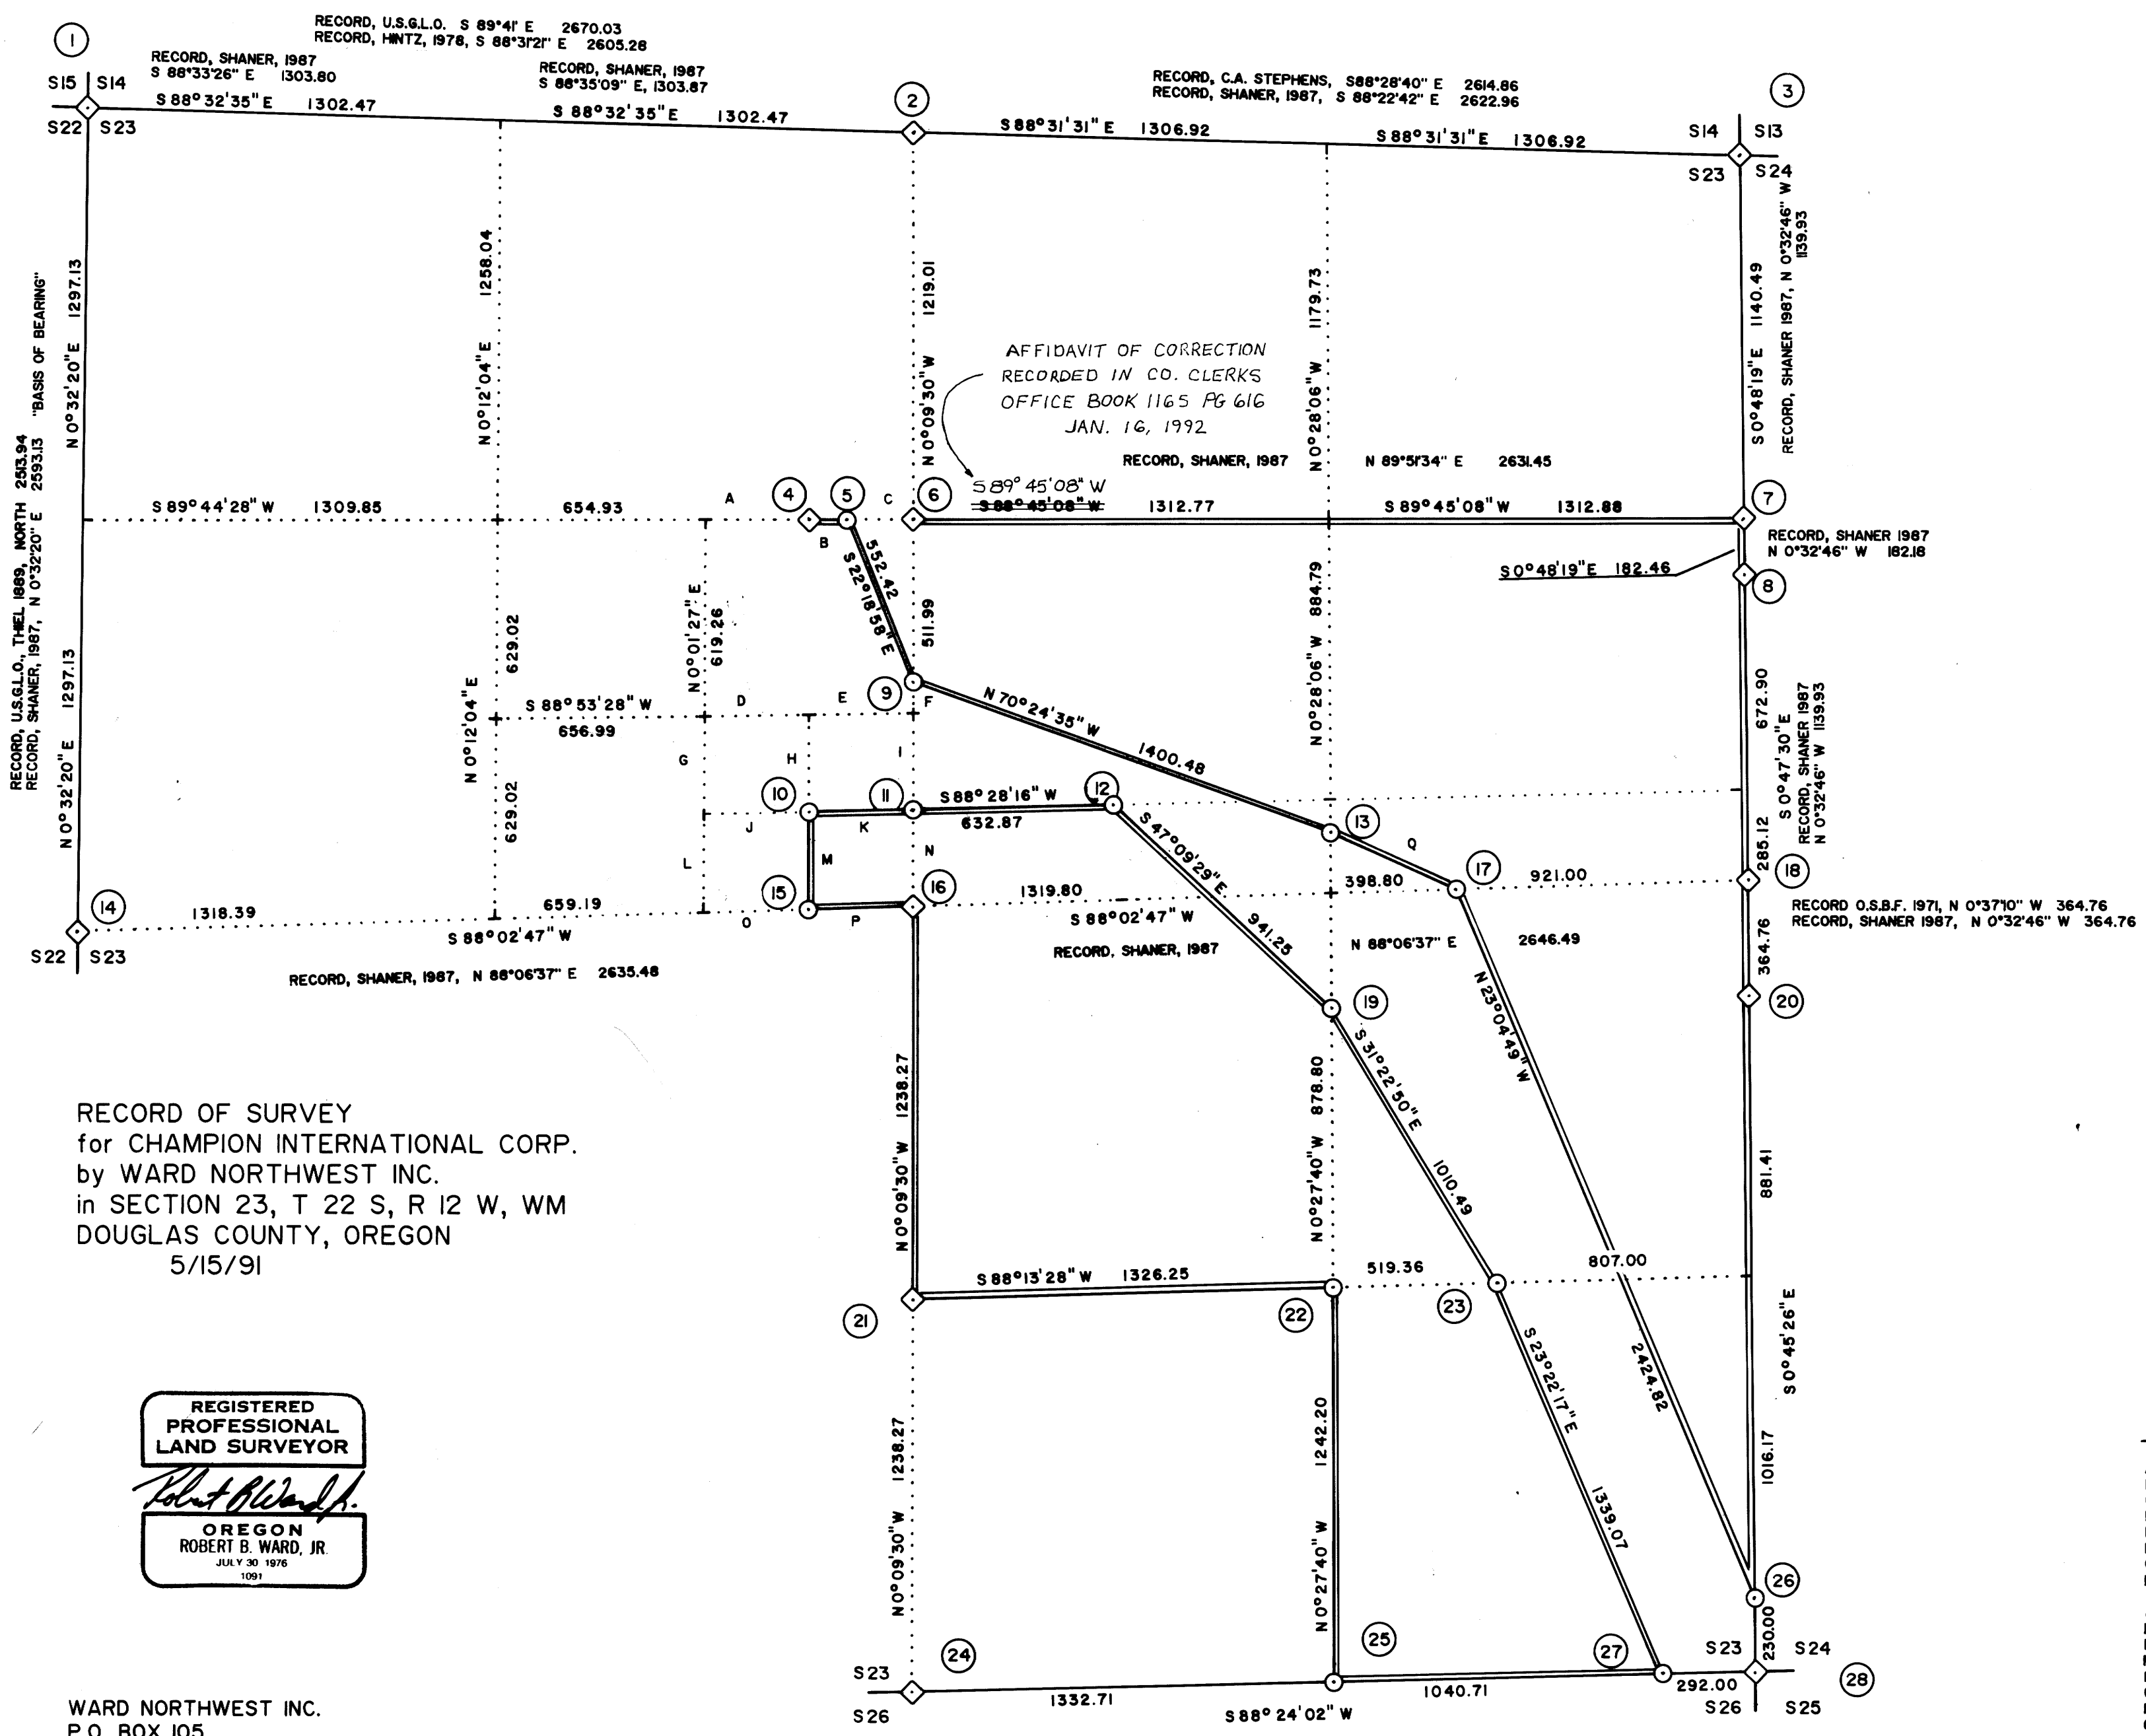
The purpose of this survey was to establish property corners and land lines which define Champion International Corporation ownership.

The Basis of Bearing for this survey was the bearing of the north 1/2 of the west section line as established by Bruce Shaner in 1987 - (Reference RM3-66A)

As part of Shaner's 1987 survey, he established the CS1/16, C1/4, CNI/16 corners for section 23. I found each of these corners to be out of position the amount noted on sheet 2 of this survey map. In order to avoid multiple corners, I did not set a monument at my computed position but show a reference to Shaner's monument and BT's from the computed corner position.

I also found the N1/16 corner on the east line of section 23 and the E1/4 corner for section 23, which were set by Shaner, to also be out of position. Again, without setting a new monument I held my computed position and show a reference to Shaner's monuments and BT's. I felt uncomfortable holding these corner positions since my return for the east 1/2 of the north section line differed from that of Shaner's by 9.12 feet.

I held the north 1/16 corner on the west section line of section 24 set by Oregon State Board of Forestry as control for the section line between section 23 and section 24.
