M115-78

**SURVEY IN
SECTIONS 34 & 35, T22S, R4W, W.M.
LANE & DOUGLAS COUNTIES, OREGON**
FOR
WEYERHAEUSER COMPANY
BY
PEEL BAKER LAND SURVEYING, INC.
1385 OAK ST. - SUITE 3, EUGENE, OREGON
OCTOBER 1, 1992

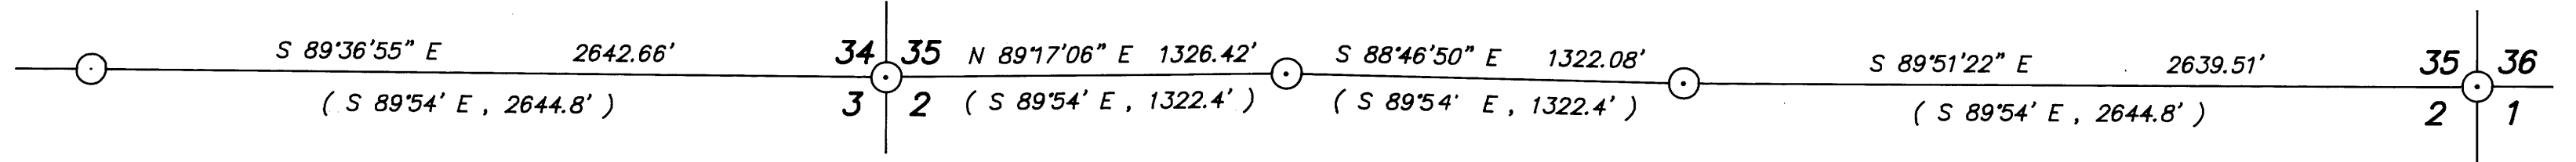
WEST 1/16 CORNER 35 & 2
FOUND : HAINES "T" BAR WITH BRASS DISK

1/4 CORNER 35 & 2
FOUND : HAINES "T" BAR WITH BRASS DISK

1/4 CORNER 34 & 3.
FOUND : 2" IRON PIPE WITH BRASS CAP
DATED 1988

SECTION CORNER 34, 35, 2, 3
FOUND : 1-1/4" IRON PIPE WITH DOUGLAS COUNTY
BRASS CAP DATED 1981

SECTION CORNER 35, 36, 1, 2
FOUND : 1-1/4" IRON PIPE WITH DOUGLAS COUNTY
BRASS CAP DATED 1991

**BASIS OF BEARING : SOLAR OBSERVATION
AS PER C.S. M106-59**

SCALE : 1" = 500'

THIS SURVEY WAS MADE IN JULY OF 1992 BY DONALD L. PEEL OF PEEL BAKER LAND SURVEYING, INC., 1385 OAK ST. - SUITE 3 EUGENE, OREGON. THE PURPOSE OF THIS SURVEY WAS TO SHOW THAT THE WEST 1/16 CORNER BETWEEN SECTIONS 35 AND 2 WAS SET OUT OF POSITION. THE 1/4 CORNER 35 & 2, THE WEST 1/16 CORNER 35 & 2 AND THE SECTION CORNER 34, 35, 2, 3 WERE ALL SET BY WILFORD HAINES IN C.S. NO. M22-6. ACCORDING TO THE HAINES PLAT, THE BEARING BETWEEN ALL CORNERS WAS S 89°54' E, ie. ALL CORNERS WERE ON A STRAIGHT LINE. MY RETRACEMENT OF THE HAINES SURVEY SHOWS THAT IF ONE IGNORES THE WEST 1/16 CORNER 35 & 2, A SLIGHT BEARING DEFLECTION IN THE SAME DIRECTION EXISTS AT EACH 1/2 MILE SEGMENT OF THE LINE. HOWEVER, A MAJOR BEARING DEFLECTION EXISTS TO AND FROM THE WEST 1/16 CORNER. I FIND THE HAINES 1/16 CORNER TO BE OUT OF POSITION (FROM A STRAIGHT LINE BETWEEN THE SOUTH 1/4 CORNER AND THE SOUTHWEST SECTION CORNER) BY 22.35 FEET.

⊙ CORNERS FOUND
() RECORD DATA, C.S. M22-6
