MAP FILE M 121-24-A

NARRATIVE

This survey was performed at the request of the Weyerhaeuser Company to monument and mark a portion of the boundary lines of the company ownership in Section 4, as shown. All the necessary controlling corners, that we could find, were tied in a closed traverse scheme. The section was then subdivided according to the 1973 Manual of Survey Instructions.

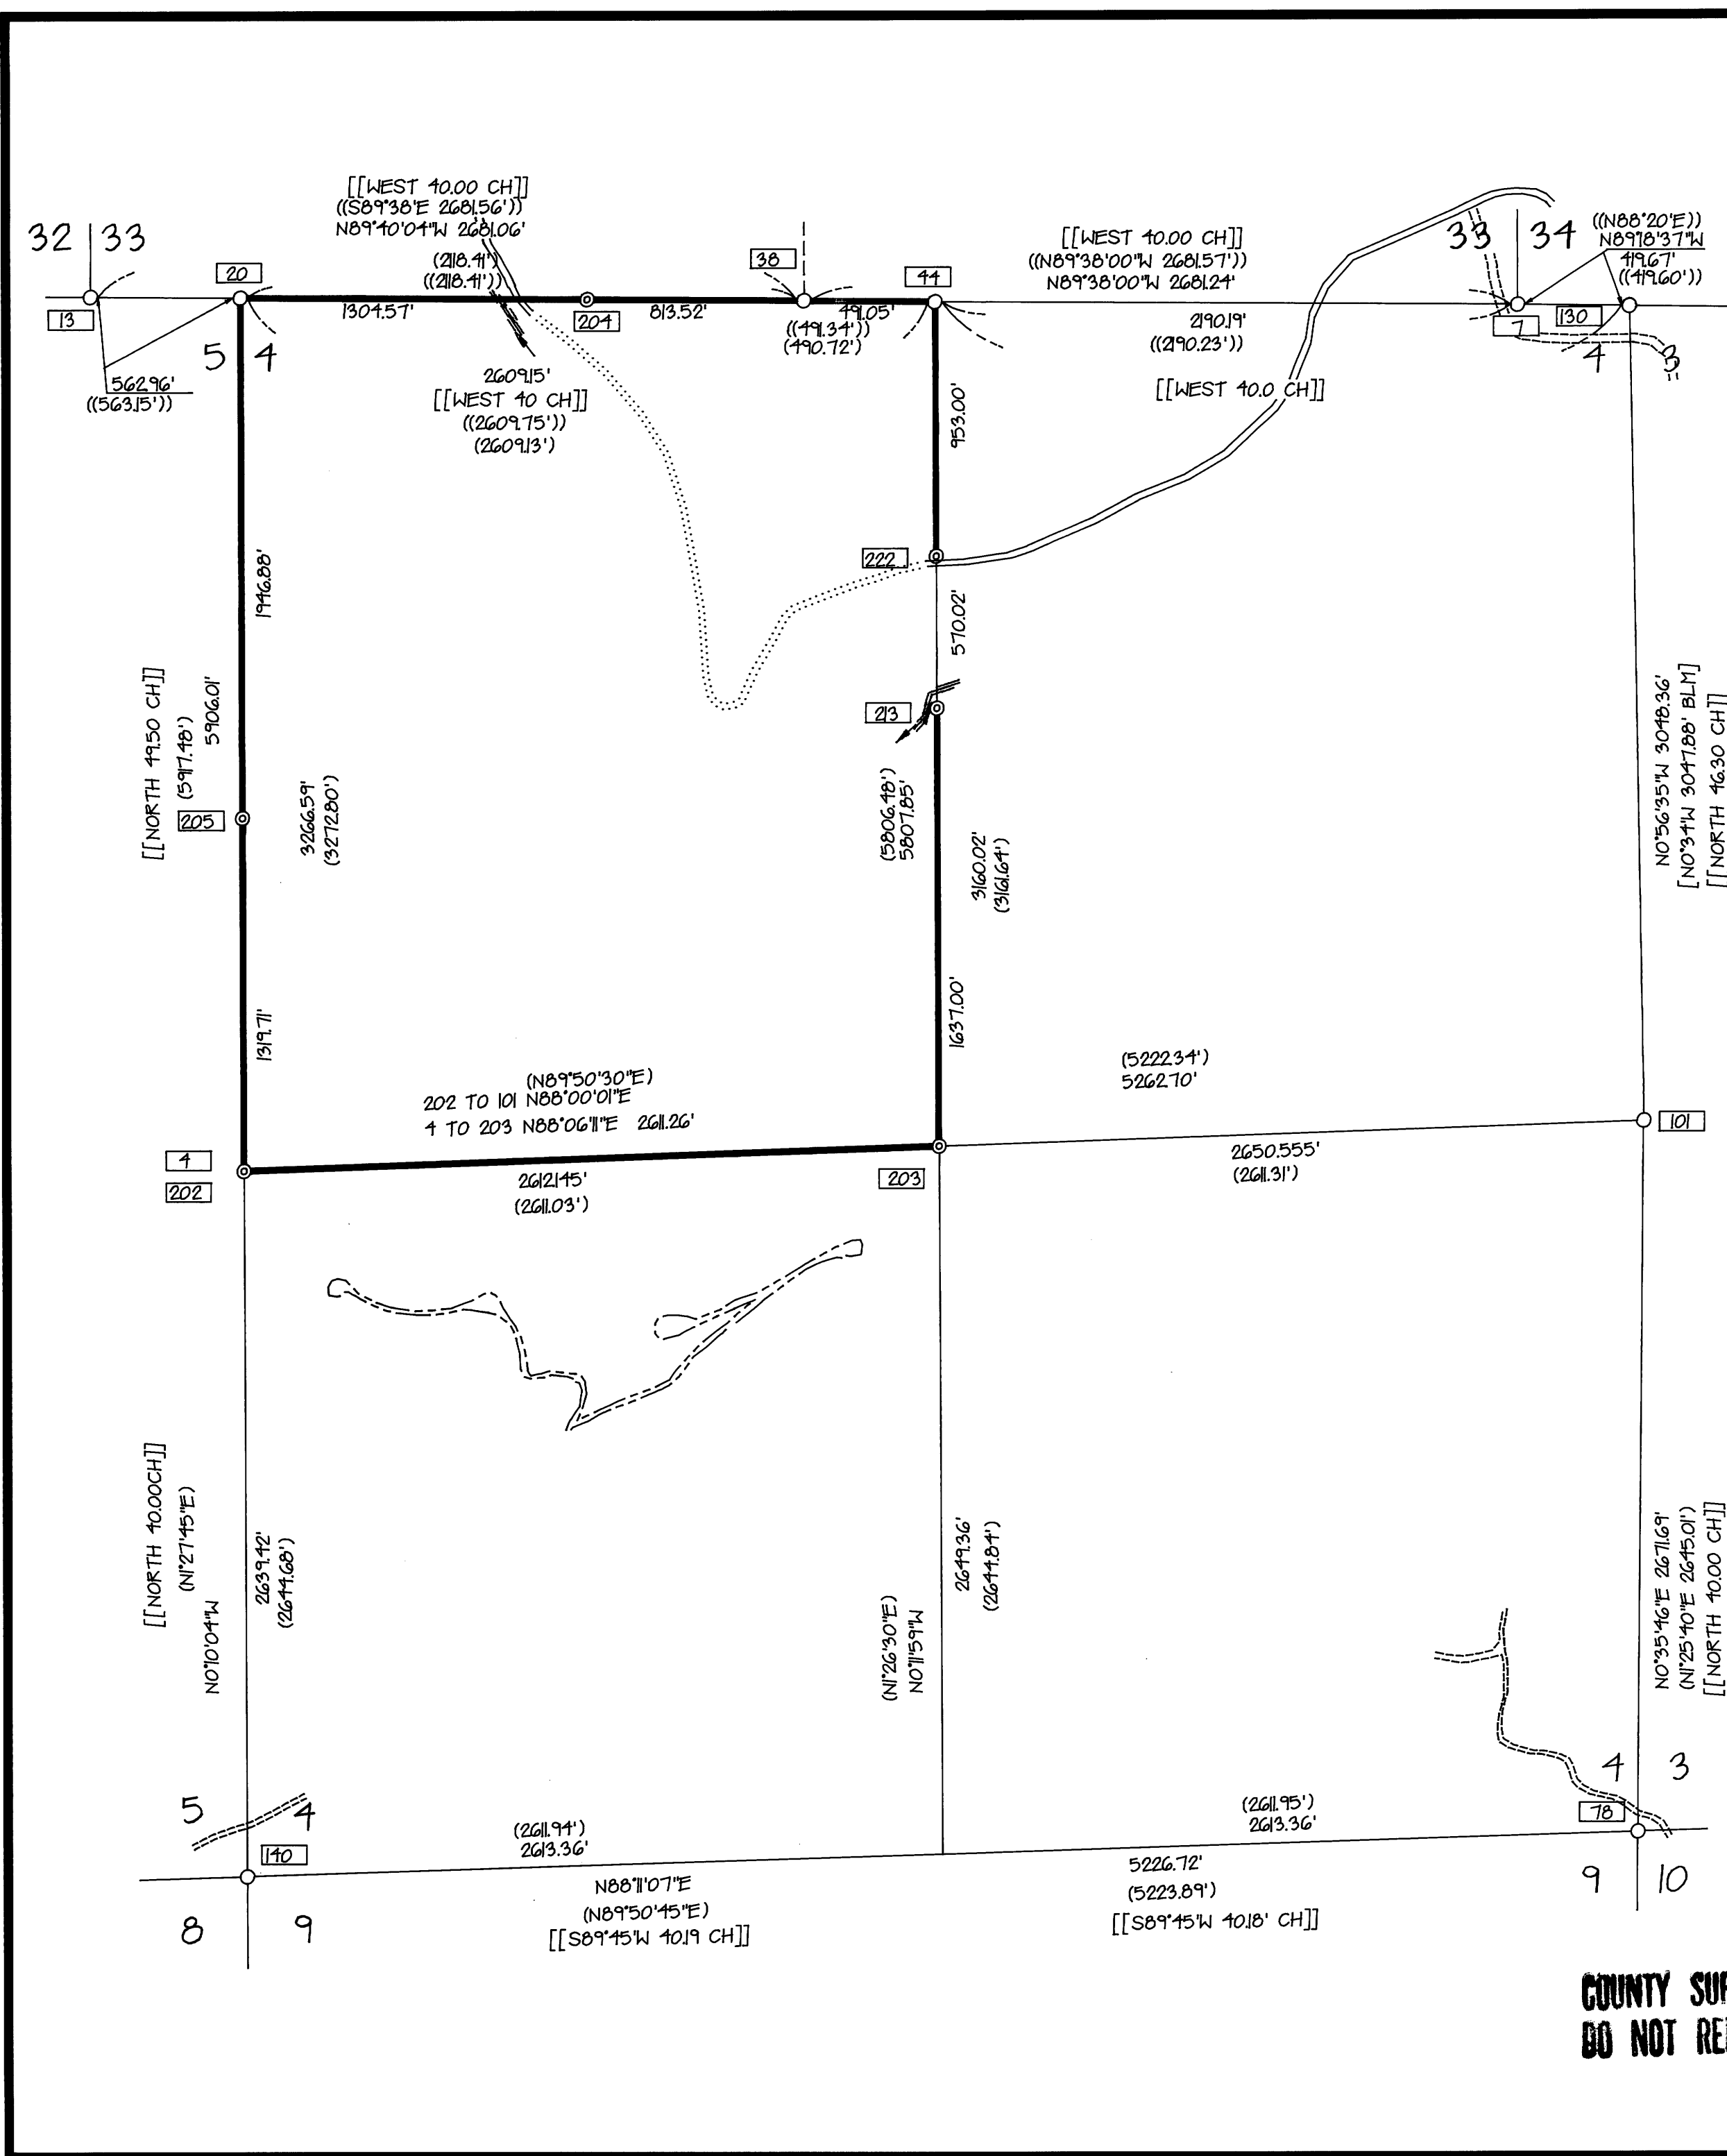
An extensive search was made for all missing government corners, that is the West 1/4 corner, the Northwest corner, the North 1/4 corner and particularly the South 1/4 corner of Section 4. This effort proved fruitless, so the previously proportioned corner positions at the Northwest and the North 1/4 corners were accepted in this survey. We also searched for evidence at the Southwest corner and the South 1/4 corner of Section 33, T.20S., R.6 W., and after finding none, accepted these proportioned positions. At the West 1/4 corner of Section 4, we found the proportioned position established in survey M105-15 to be in error. We determined a proportioned position about 5 feet south of the position from M105-15 and which position was re-monumented by the Douglas County Surveyor's Office. As this difference exceeds what I feel to be acceptable accuracy limits, I decided to monument our proportioned position for the West 1/4 corner. The procedure I used was to proportion our distance to the monument at the northwest corner of Section 4 not the intersection point, to the 1884 GLO record distance. That is 5905.71 feet to 89.50 chains (5907.00 feet) not the 5906.01 feet to the intersection with the South line of Section 33. So our proportion would be $\frac{5905.71}{(5907.00)} = \frac{2639.42}{(2640.00)}$ As mentioned above, I did make

an extensive search for the South 1/4 corner of Section 4. The original 1884 GLO survey notes called for a post and a marked stone at the corner position and two 36" firs as accessories. Also, the original notes placed the corner 132 chains east of a ridge top. From 1967 Weyerhaeuser aerial photos, I determined a search area, but could find no evidence of the post or stone nor a pattern of old stumps, or stump holes, that would fit the original calls to the 36" firs. This area had been logged some 50 to 80 years ago, so chances of finding the post or stone would be remote. However, evidence of the firs should still remain. In comparing the topo calls from the 1884 notes to the aerial photos, the west 1/2 mile is almost identical to the photos, but the east 1/2 mile topo calls miss two ridge crossings and a main draw. It is possible that this corner was "stubbed" and thus could be out of position in latitude. It is also possible that the corner was never set or that it was destroyed by logging as there is evidence of a "swing road" used for logging about 100 feet to the west of my search area. A search was also made, with hand compass and steel tape, from our closest traverse point for the CW 1/16 corner set in C.S.F. #M105-15. Because of heavy logging debris and brush, we were unable to locate the monument, assuming it was not destroyed by logging.
