PROPERTY SURVEY FOR MENASHA CORPORATION

LOCATED IN THE SOUTH 1/2 OF SECTION 8, T.22 S., R. 12 W. W.M.

OCTOBER 1995
SCALE 1" = 400'

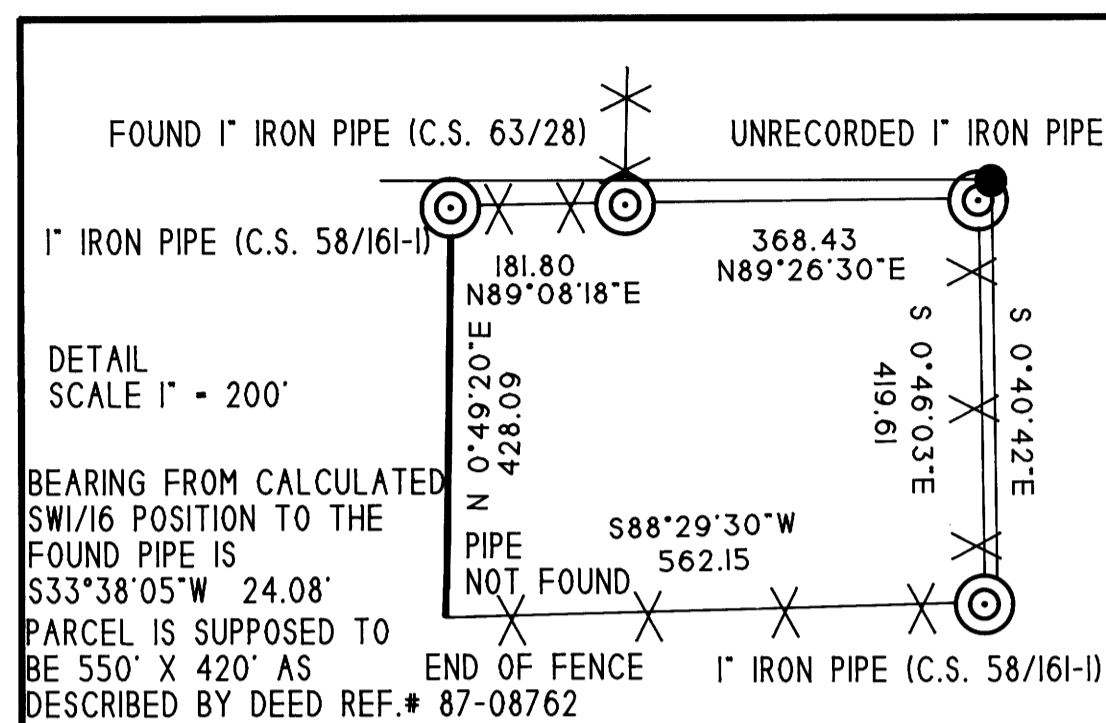
DETAIL SCALE 1" = 200'
BEARING FROM CALCULATED SW1/16 POSITION TO THE FOUND PIPE IS S33°38'05"W 24.08'
PARCEL IS SUPPOSED TO BE 550' X 420' AS DESCRIBED BY DEED REF.# 87-08762
END OF FENCE
1" IRON PIPE (C.S. 58/16-I)

THREE 1 INCH IRON PIPES WERE FOUND AROUND THE FIVE ACRE PARCEL SHOWN IN THE DETAIL MAP. THESE PIPES HAVE BEEN IN PLACE SINCE 1977 AND HAVE MAINTAINED FENCES BUILT TO THEM. THE PIPE NEAR THE SOUTHWEST 1/16 POSITION IS SHOWN ON A SKETCH MAP, DRAWN BY MENASHA IN 1977, FOR THE SALE OF THIS PARCEL BY MENASHA TO LASKEY-CLIFTON. THESE PIPES ALONG WITH DURHAMS, WHICH WAS SET BY IMPROPER METHODS, MAY CAUSE AN AREA OF CONFUSION FOR THE LANDOWNERS ADJACENT TO THESE CORNERS.

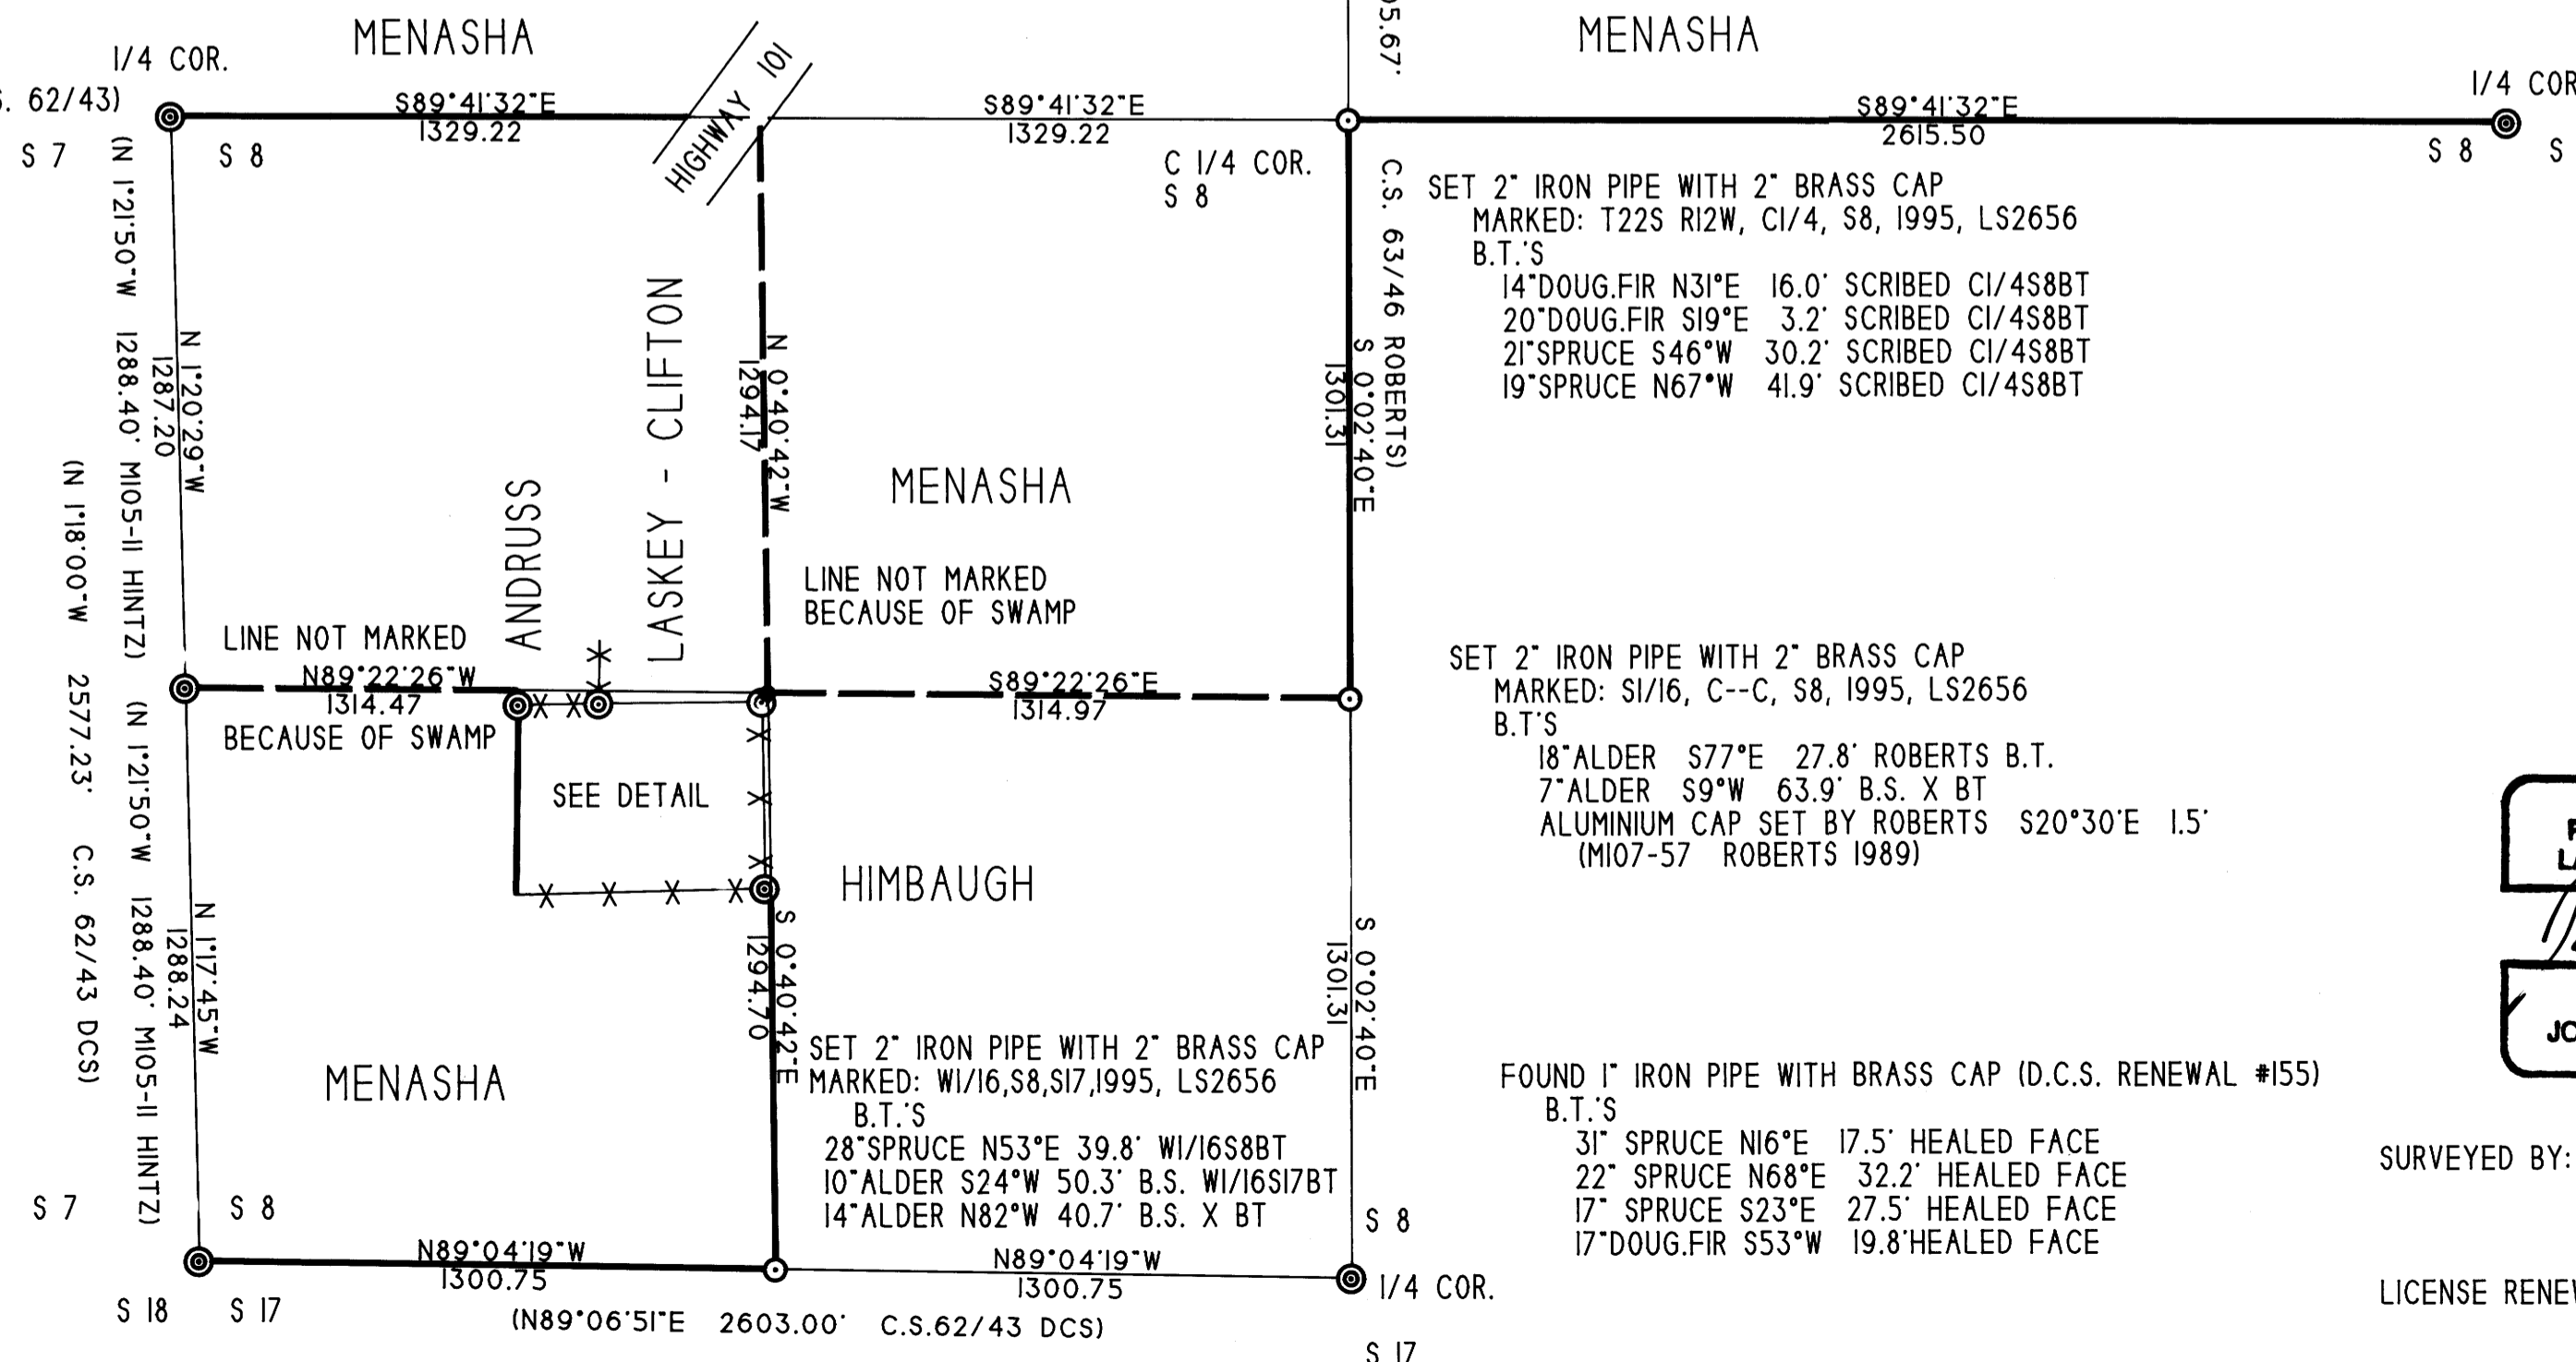
S 5
1/4 COR.
S 8

FOUND 1 1/4" IRON PIPE WITH BRASS CAP (C.S. M94-34)
B.T.'S
21" SPRUCE N51°E 11.9' SCRIBE VISIBLE
23" DOUG.FIR S20°E 24.2' SCRIBE VISIBLE

SET 2" IRON PIPE WITH 2" BRASS CAP
MARKED: W1/16, C--C, S8, 1995, LS2656
B.T.'S
5/8" REBAR WITH PLASTIC CAP (LS2656) N45°E 20.0'
5/8" REBAR WITH PLASTIC CAP (LS2656) S45°W 20.0'
5/8" REBAR WITH PLASTIC CAP (LS2656) N45°W 20.0'

FOUND 2" IRON PIPE WITH BRASS CAP (M94-34)
B.T.'S
33" DOUG.FIR S48°E 10.4' HEALED FACE
23" DOUG.FIR S30°30'W 10.1' HEALED FACE
NEW B.T.'S
21" DOUG.FIR N58°E 10.6' SCRIBED 1/4S9BT
22" HEMLOCK N64°W 25.2' SCRIBED 1/4S8BT

FOUND 1" IRON BAR ABOUT 5 FEET HIGH
REFERENCE MONUMENT

1 1/2" IRON PIPE WITH BRASS CAP S30°W 42.8' (C.S. 62/43)
B.T.'S
8" ALDER S83°E 3.2' BARK SCRIBED
6" ALDER STUMP N83°W 5.7' NO MARKS VISIBLE
20" SPRUCE N74°W 49.3' HEALED FACE

FOUND 1/2" IRON PIPE WITH ALUMINIUM CAP (M105-II)
B.T.'S
14" SPRUCE N37°E 18.3' HEALED FACE
21" SPRUCE S12°30'W 109.2' HEALED FACE

FOUND 1 1/2" IRON PIPE WITH BRASS CAP (M101-18)
B.T.'S
24" SPRUCE N13°E 7.5' HEALED FACE
20" SPRUCE S27°E 21.9' HEALED FACE
39" SPRUCE S21°30'W 35.1' HEALED FACE
19" SPRUCE N11°30'W 34.6' HEALED FACE

SET 2" IRON PIPE WITH 2" BRASS CAP
MARKED: T22S R12W, C1/4, S8, 1995, LS2656
B.T.'S
14" DOUG.FIR N31°E 16.0' SCRIBED C1/4S8BT
20" DOUG.FIR S19°E 3.2' SCRIBED C1/4S8BT
21" SPRUCE S46°W 30.2' SCRIBED C1/4S8BT
19" SPRUCE N67°W 41.9' SCRIBED C1/4S8BT

SET 2" IRON PIPE WITH 2" BRASS CAP
MARKED: S1/16, C--C, S8, 1995, LS2656
B.T.'S
18" ALDER S77°E 27.8' ROBERTS B.T.
7" ALDER S9°W 63.9' B.S. X BT
ALUMINIUM CAP SET BY ROBERTS S20°30'E 1.5'
(M107-57 ROBERTS 1989)

FOUND 1" IRON PIPE WITH BRASS CAP (D.C.S. RENEWAL #155)
B.T.'S
31" SPRUCE N16°E 17.5' HEALED FACE
22" SPRUCE N68°E 32.2' HEALED FACE
17" SPRUCE S23°E 27.5' HEALED FACE
17" DOUG.FIR S53°W 19.8' HEALED FACE

THE PURPOSE OF THIS SURVEY WAS TO ESTABLISH MENASHA CORPORATION'S PROPERTY LINES AND CORNERS IN THE SOUTH HALF OF SECTION 8, TOWNSHIP 22 SOUTH, RANGE 12 WEST, W.M.. THE SURVEYS USED TO CONTROL THIS SURVEY WERE C.S.62/43 BY DOUGLAS COUNTY, C.S.58/140 AND M105-II BY HINTZ, C.S.63/46 BY ROBERTS, AND C.S.63/28 BY DURHAM. THE SECTION WAS SUBDIVIDED FOLLOWING THE 1973 BLM MANUAL OF INSTRUCTIONS. THE EQUIPMENT USED WAS A NIKON DTM A5 TOTAL STATION WITH DATA COLLECTOR AND TRIMBLE 4000ST GPS RECEIVERS. BASIS OF BEARING WAS A SOLAR OBSERVATION USING THE HOUR ANGLE METHOD.

ALL BEARING TREES WERE MEASURED TO AN 8" SPIKE IN SIDE CENTER OF THE TREE AND ANGLES MEASURED TO THE CENTER OF THE TREE. THE TREES WERE PAINTED ORANGE WITH A TAG ATTACHED FACING THE MONUMENT. THE PROPERTY LINES WERE BLAZED AND PAINTED ORANGE. THE INSTRUMENT MAN WAS JOHN BENTLEY AND THE HEAD CHAINMAN WAS DOYCE ROSE.
