ADJUSTMENT OF COMMON BOUNDARY LINE SURVEY

DOUGLAS COUNTY PLANNING
DEPARTMENT FILE NUMBER 97-190.

Located in the:
SOUTHWEST 1/4 of SECTION 12,
and in the
NORTHWEST 1/4 of SECTION 13,
TOWNSHIP 30 SOUTH, RANGE 6 WEST,
WILLAMETTE MERIDIAN, DOUGLAS COUNTY, OREGON

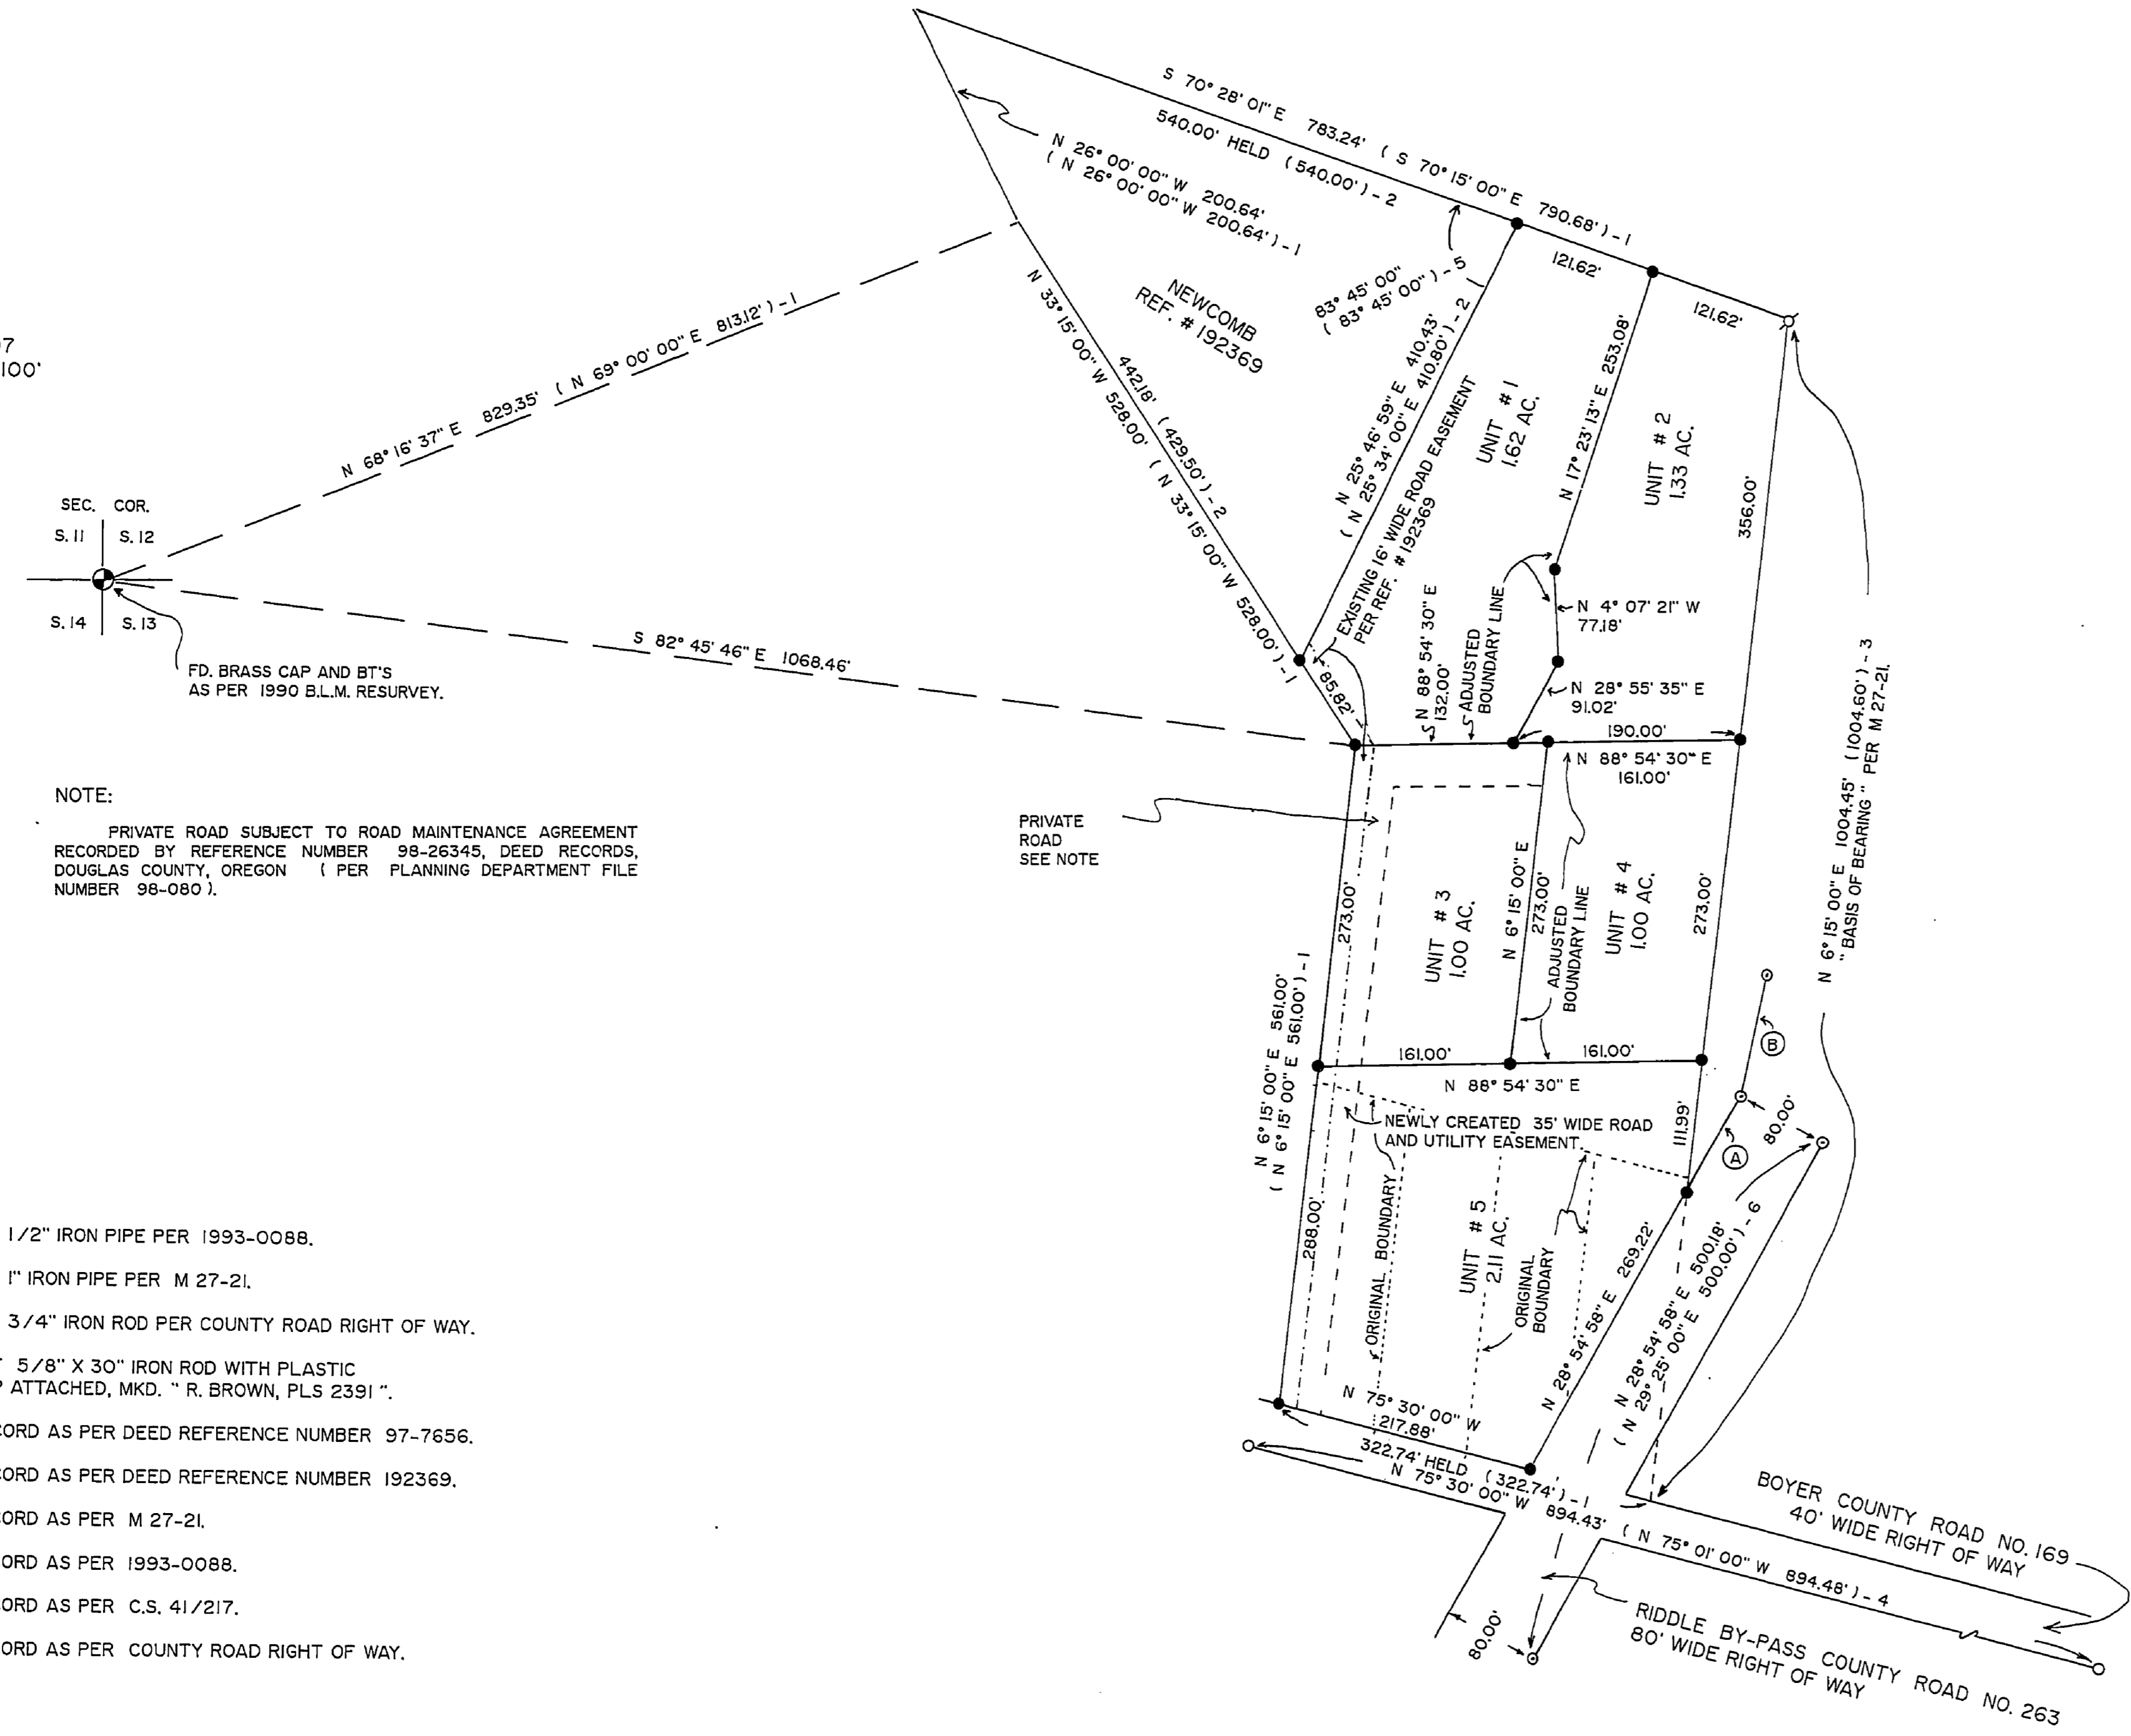
DEC., 1997
SCALE: 1" = 100'

PURPOSE OF THE SURVEY WAS TO ADJUST THE FIVE EXISTING UNITS OF LAND INTO THE UNITS SHOWN. FIELD INVESTIGATION LOCATED THE SAID FOUND MONUMENTS AND CONDITIONS. THE SOUTHERLY RIGHT OF WAY OF BOYER COUNTY ROAD NUMBER 169 CONTROLLED THE SOUTH BOUNDARY. BY HOLDING THE DEED BEARING OF SAID BOYER COUNTY ROAD AND RUNNING A INTERSECT LINE FROM THE SAID FOUND 1 INCH IRON PIPE AT THE NORTHEAST PROPERTY CORNER ON THE DEEDED BEARING, I FOUND THAT THE INTERSECT POINT IS SOUTH 6° 15' 00" WEST 1004.45 FEET FROM THE SAID 1 INCH IRON PIPE. THIS DISTANCE IS VERY CLOSE TO THE DISTANCE OF 1004.60 FEET AS RECORDED IN DOUGLAS COUNTY SURVEYOR'S OFFICE FILE NUMBER M 27-21. THIS EASTERLY BOUNDARY OF THE PROPERTY AS DEFINED BY SAID M 27-21 WAS BEFORE THE SUBTRACTION OF THE RIGHT OF WAY OF COUNTY ROAD NUMBER 263 AND WAS USED AS MY " BASIS OF BEARING ". THE BALANCE OF THE EASTERLY BOUNDARY WAS CONTROLLED BY EXISTING RIGHT OF WAY MONUMENTS PER SAID COUNTY ROAD NUMBER 263.
