SURVEY IN T 22 S, R 8 W, W. M., DOUGLAS COUNTY, OREGON TO ESTABLISH PROPERTY LINES IN SECTIONS 16 AND 22

FOR ROSEBURG RESOURCES CO

BY MARK F. SMALLEY
ROSEBURG FOREST PRODUCTS CO
P. O. BOX 1088
ROSEBURG, OREGON

DECEMBER, 2000

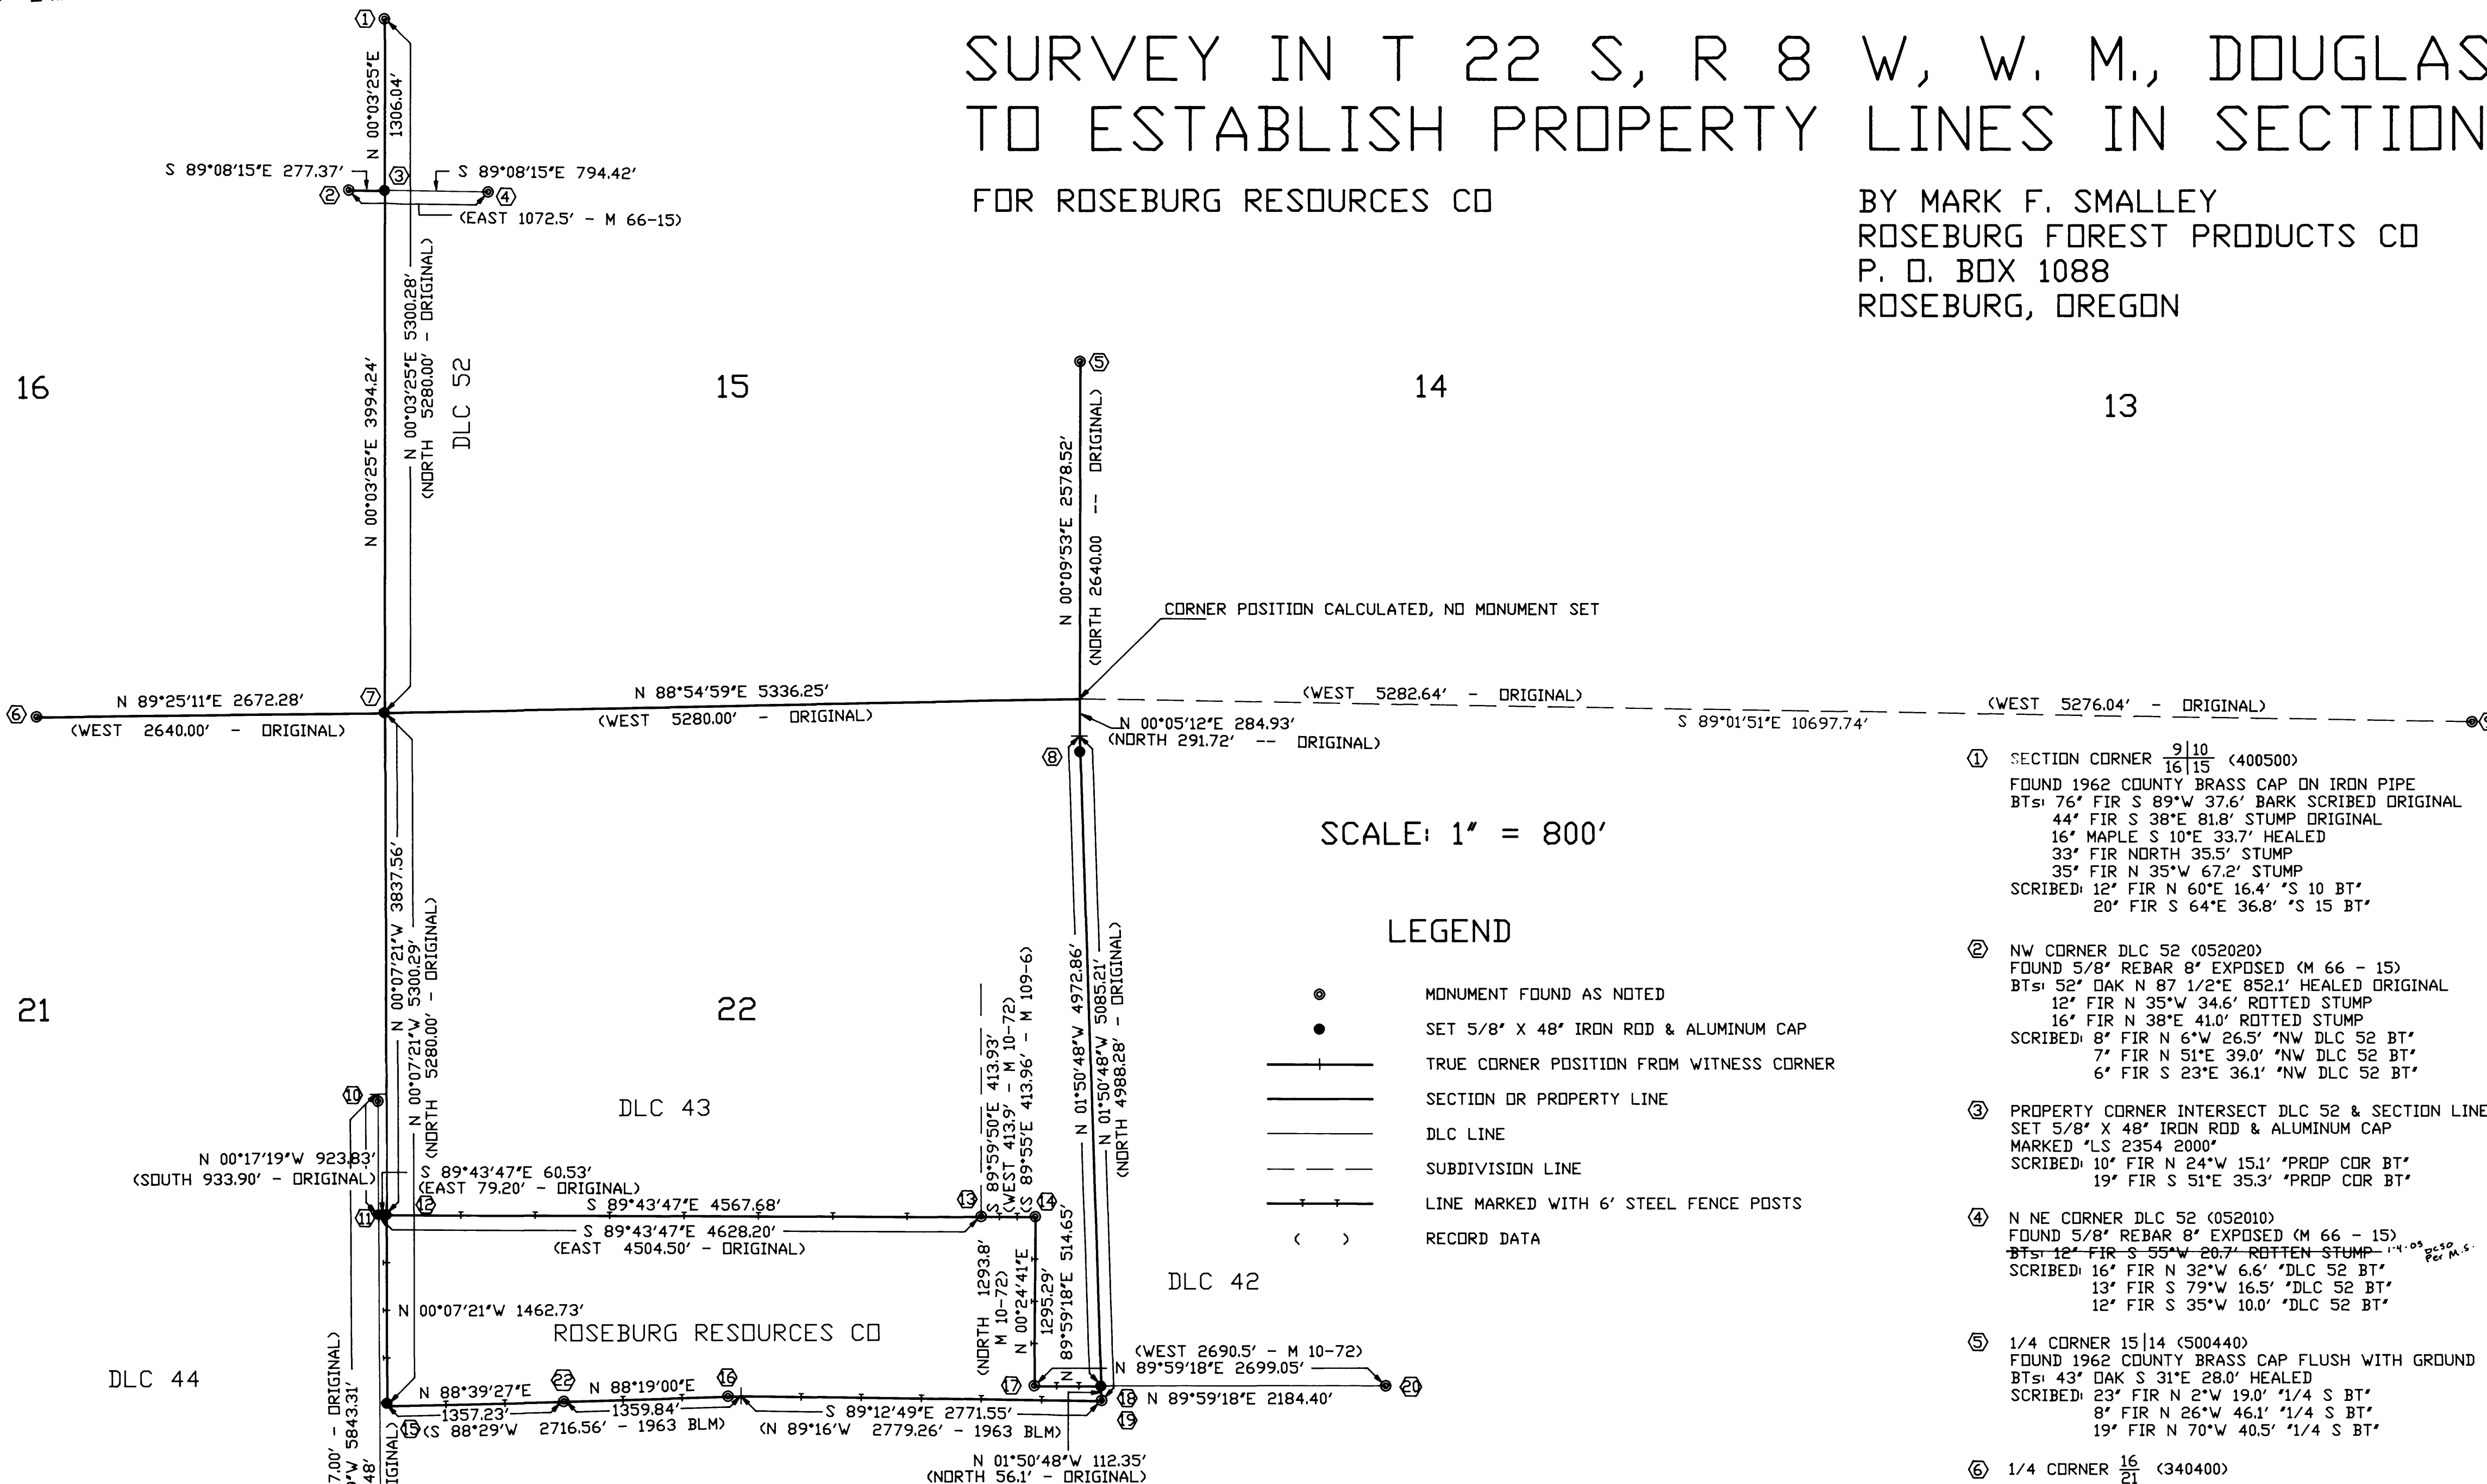
SCALE: 1" = 800'

THE PURPOSE OF THIS SURVEY WAS TO MARK ROSEBURG RESOURCES PROPERTY LINES IN SECTION 22 TOWNSHIP 22 SOUTH, RANGE 8 WEST (RECORDER'S NO. 97-6315) AND TO SET THE SOUTHEAST PROPERTY CORNER OF ROSEBURG RESOURCES PROPERTY IN SECTION 16 (RECORDER'S NO. 97-26039).

THE NORTH LINES OF ROSEBURG RESOURCES PROPERTY IN SECTION 22 ARE THE NORTH LINES OF GOVERNMENT LOTS 4, 10, 11 AND 12. THE NORTH LINE OF THESE LOTS IS COINCIDENT WITH THE SOUTH LINE OF DLC 42 AND DLC 43. THE SOUTHWEST CORNER OF DLC 43 (043070) WAS RE-ESTABLISHED BY THIS SURVEY USING SINGLE PROPORTIONATE METHODS BETWEEN THE EAST SOUTHEAST CORNER OF DLC 44 (044130) AND THE NORTHEAST CORNER OF DLC 44 (043060) WHICH WERE PREVIOUSLY RENEWED BY THE COUNTY SURVEYOR. I DID NOT ACCEPT THE POSITION OF THE SOUTHWEST CORNER OF DLC 43 AS COMPUTED BY DOLAN IN HIS 1989 SURVEY (M 109-6) SINCE THE ORIGINAL SURVEYOR CALLS FOR THE CORNER ON THE EAST LINE OF DLC 44 AND DOLAN'S CORNER POSITION IS NOT ON THE EAST LINE. THE SOUTHEAST CORNER OF DLC 43 (042050) AS RENEWED BY THE COUNTY SURVEYOR (M 10-72) AND THE INTERIOR SOUTHWEST CORNER OF DLC 42 (042060) AS PROPORTIONED BY THE COUNTY SURVEYOR (M 10-72) WERE ALSO USED TO CONTROL THE NORTH LINE OF THIS SURVEY.

THE EAST LINES OF LOTS 12 AND 13 ARE CONTROLLED BY THE SOUTH SOUTHWEST CORNER OF DLC 42 (042070) AND THE INTERIOR SOUTHWEST CORNER OF DLC 42 (042060), BOTH AS PROPORTIONED BY THE COUNTY SURVEYOR (M 10-72) AND THE SOUTHEAST CORNER OF DLC 42 (041040) WHICH WAS RENEWED BY THE COUNTY SURVEYOR FROM ORIGINAL EVIDENCE. A PROPERTY CORNER WAS SET AT THE INTERSECTION OF THE SOUTH LINE OF DLC 42 (AS DETERMINED BY THE ABOVE MENTIONED CONTROL) AND THE EAST LINE OF SECTION 22 AS CONTROLLED BY THE SOUTHEAST SECTION CORNER OF SECTION 22 (500300) AS PROPORTIONED BY THE BLM IN 1963 AND THE MEANDER CORNER ON THE EAST LINE OF SECTION 22 (500376) AS RENEWED BY THE COUNTY SURVEYOR. THE NORTHEAST CORNER FOR SECTION 22 FALLS IN THE RIVER, BUT THE POSITION WAS CALCULATED BY DOUBLE PROPORTIONATE METHOD USING AS CONTROL THE SOUTH ONE-QUARTER CORNER OF SECTION 16 (340400) AS RENEWED FROM ORIGINAL EVIDENCE BY THE BLM, THE EAST ONE-QUARTER CORNER OF SECTION 15 (500440) AND THE MEANDER CORNER ON THE EAST LINE OF SECTION 22 (500376), BOTH AS RENEWED BY THE COUNTY SURVEYOR, AND THE NORTHEAST CORNER OF SECTION 24 (700400) AS PROPORTIONED BY THE BLM IN 1977.
