MAP OF SURVEY

LOCATED in Section 22, T. 26 S., R. 2 W., W.M. in Douglas County, Oregon.

SURVEYED FOR: ROSEBURG RESOURCES
P.O. BOX 1088
ROSEBURG, OREGON

SURVEYED BY: DAVID EDWARDS LAND SURVEYING
P.O. BOX 361
OAKLAND, OREGON 97462
PHONE: (541) 459-0512

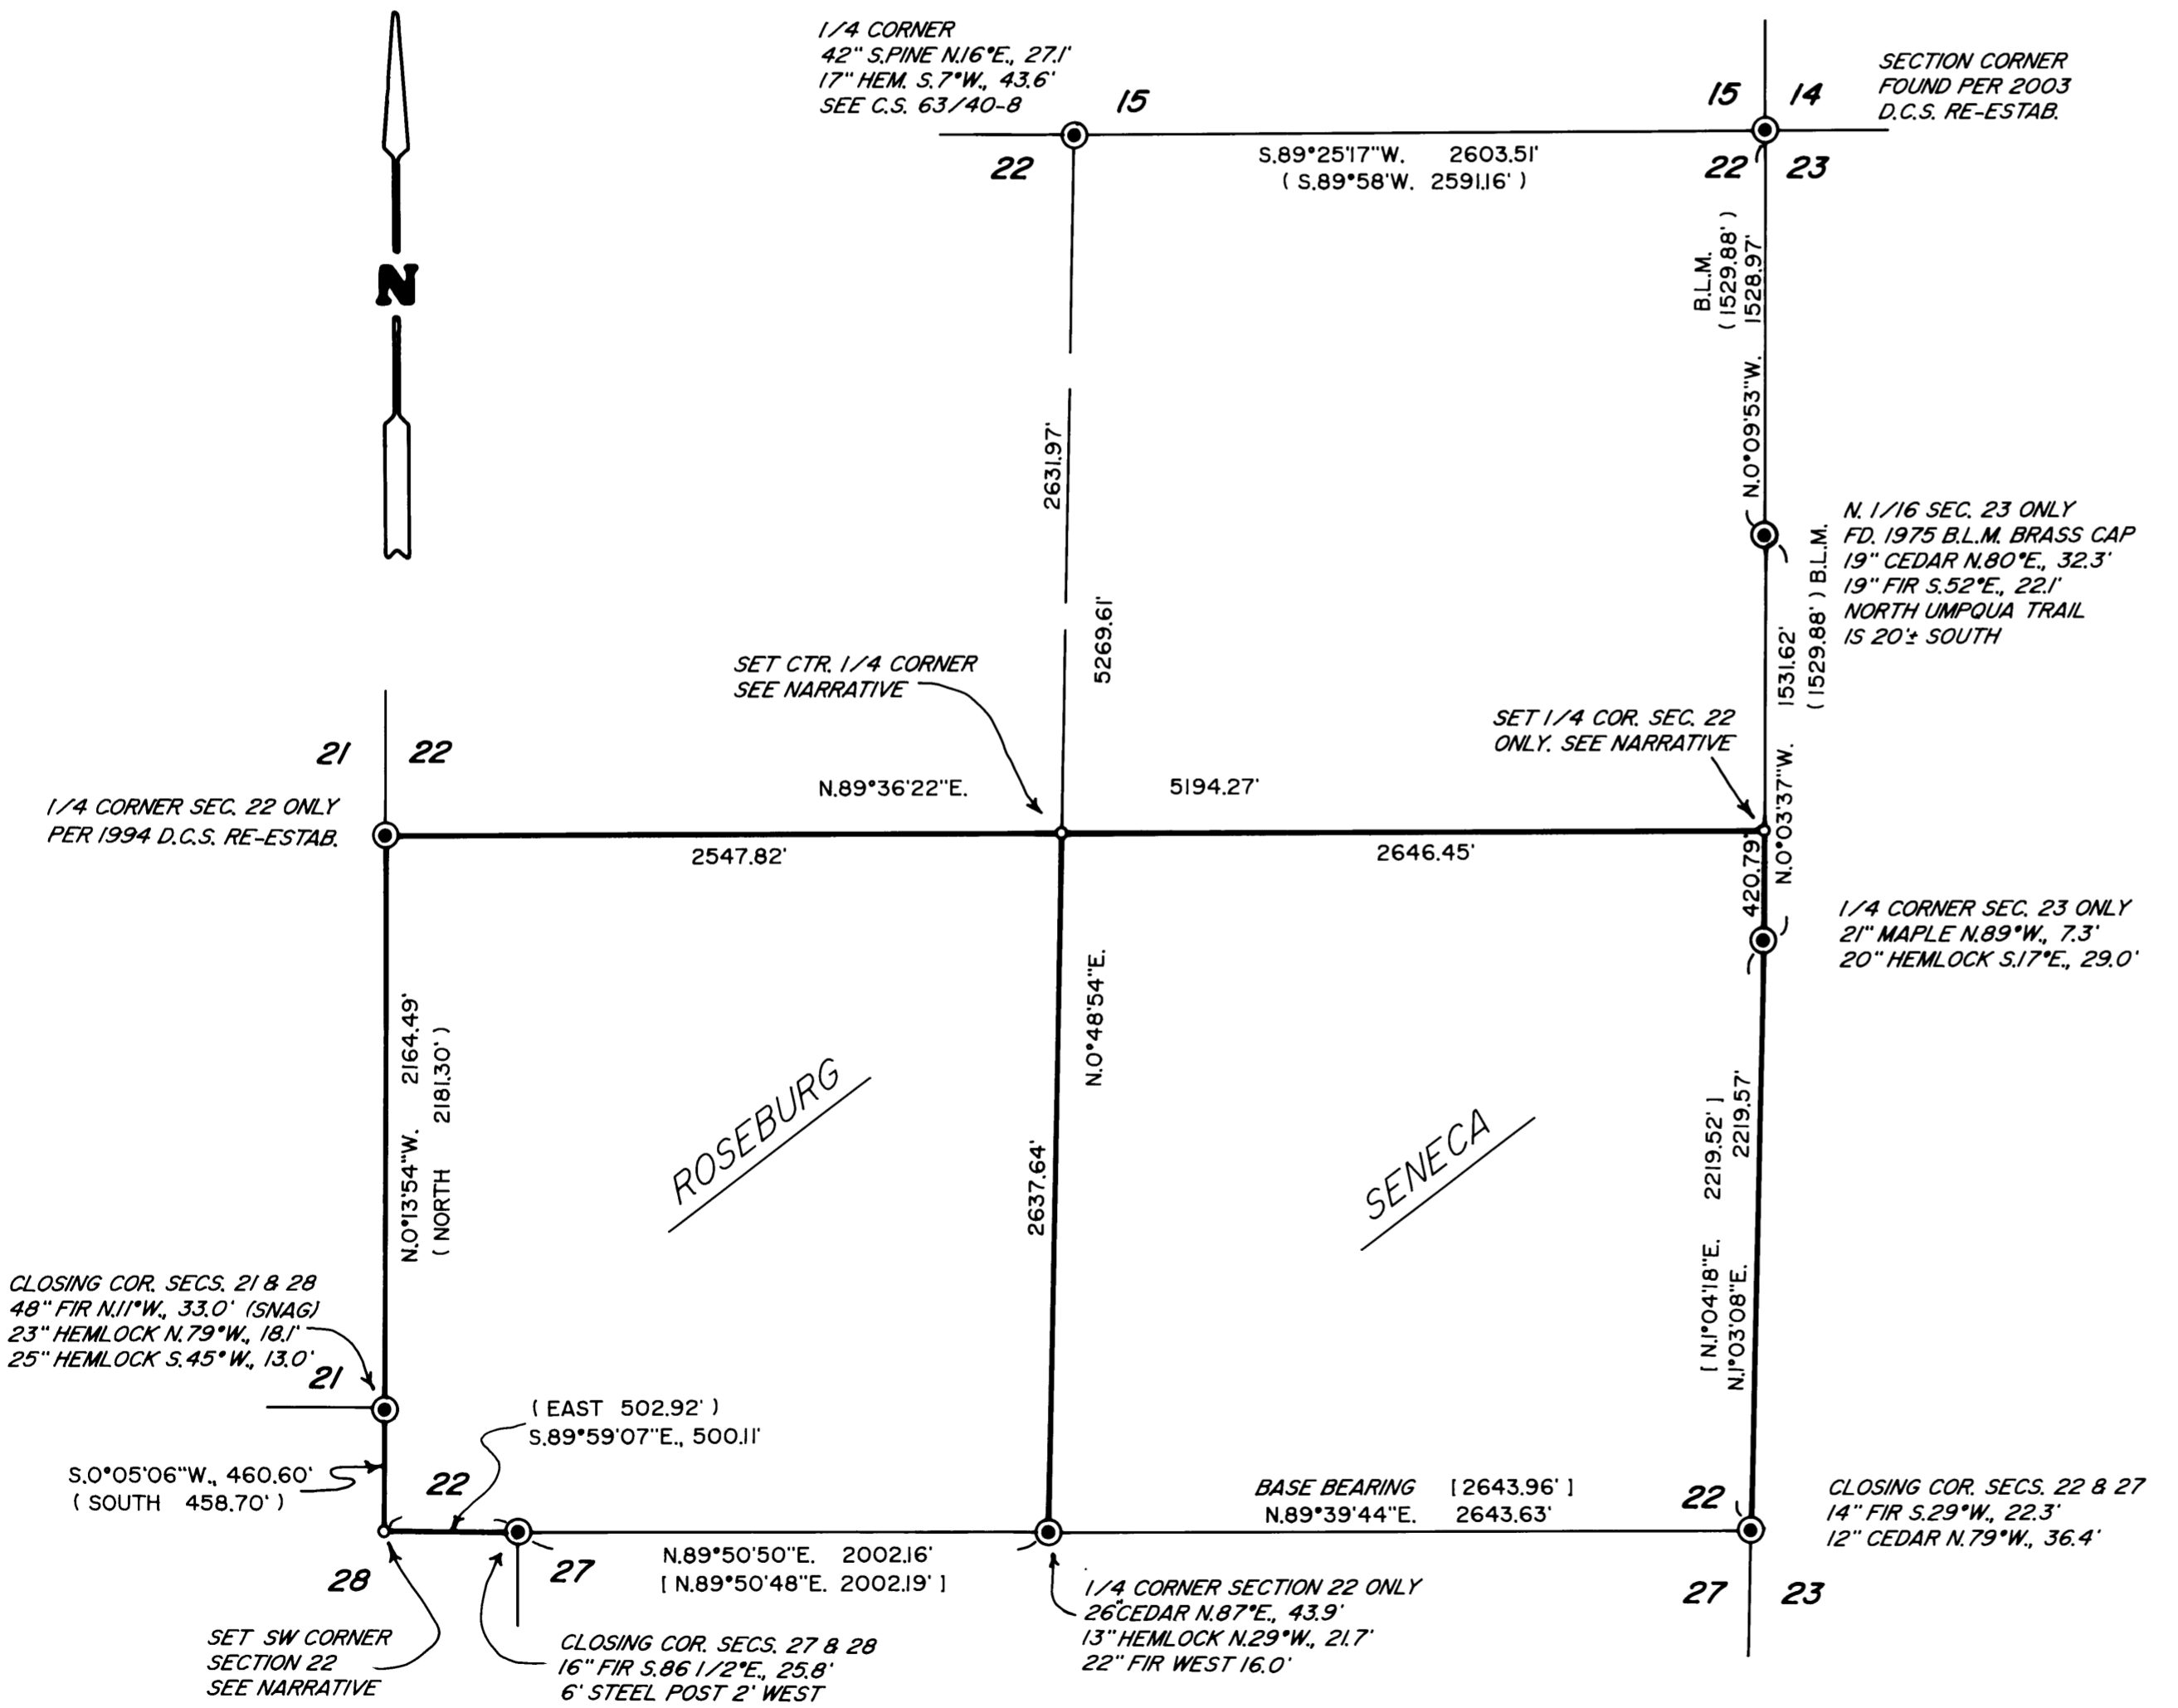
THE PURPOSE OF THIS SURVEY IS TO BLAZE, POST AND FLAG THE BOUNDARY LINES SHOWN AS BOLD HEREON AND TO MONUMENT THE EAST 1/4 CORNER, THE CENTER 1/4 CORNER AND THE SOUTHWEST CORNER OF SECTION 22. CONTROL TRAVERSES WERE MADE WHICH TIED IN THE NECESSARY CONTROLLING MONUMENTS AND THE SUBDIVISION OF SECTION 22 WAS COMPUTED. AFTER DISCUSSING THE SITUATION WITH LOCAL B.L.M. SURVEYORS I SET THE MISSING EAST 1/4 CORNER AT A LATITUDINAL MID-POINT BETWEEN THE NORTHEAST AND SOUTHEAST CORNERS OF SECTION 22, ON LINE BETWEEN THE NORTH 1/16 CORNER AND THE WEST 1/4 CORNER FOR SECTION 23 ONLY, AS SHOWN HEREON.

FROM SAID SET 1/4 CORNER: A 27" DIAM. CEDAR BEARS S.60°W., 14.0 FEET. BOTH SCRIBED "1/4 S22 BT" A 15" DIAM. FIR BEARS N.56°W., 60.2 FEET. SIX FOOT STEEL POSTS BEAR SOUTH 2 FEET AND WEST 2 FEET.

SEVERAL OPTIONS FOR POSITIONAL RESOLUTION OF THE MISSING SW CORNER OF SECTION 22 WERE ANALYZED. CONSIDERING THAT THE NEAREST EXISTING CORNERS ARE CLOSING CORNERS A BEARING EXTENSION INTERSECTION WAS REJECTED. COMPARISON OF MY RETURNED DISTANCES RELATIVE TO THE 1918 G.L.O. RESURVEY SHOWS INCONSISTENT DISHARMONY. THEREFORE A DISTANCE-DISTANCE INTERSECTION WAS ALSO REJECTED. A BROKEN BOUNDARY ADJUSTMENT USING THE TWO NEAREST MONUMENTED CORNERS WAS ULTIMATELY UTILIZED TO PLACE THE MISSING CORNER.
