# RECORD OF SURVEY

IN THE NW 1/4, SEC 17, E 1/2, SEC 8, NW 1/4  
SEC 9, SW 1/4, SEC 4 AND THE SE 1/4, SEC 5. T. 26 S., R. 5 W., W.M.  
DOUGLAS COUNTY, OREGON - SEPT. 2016

SCALE: 1" = 600' DRAWN BY: D. SWEEDEN SHEET: 1 OF 2

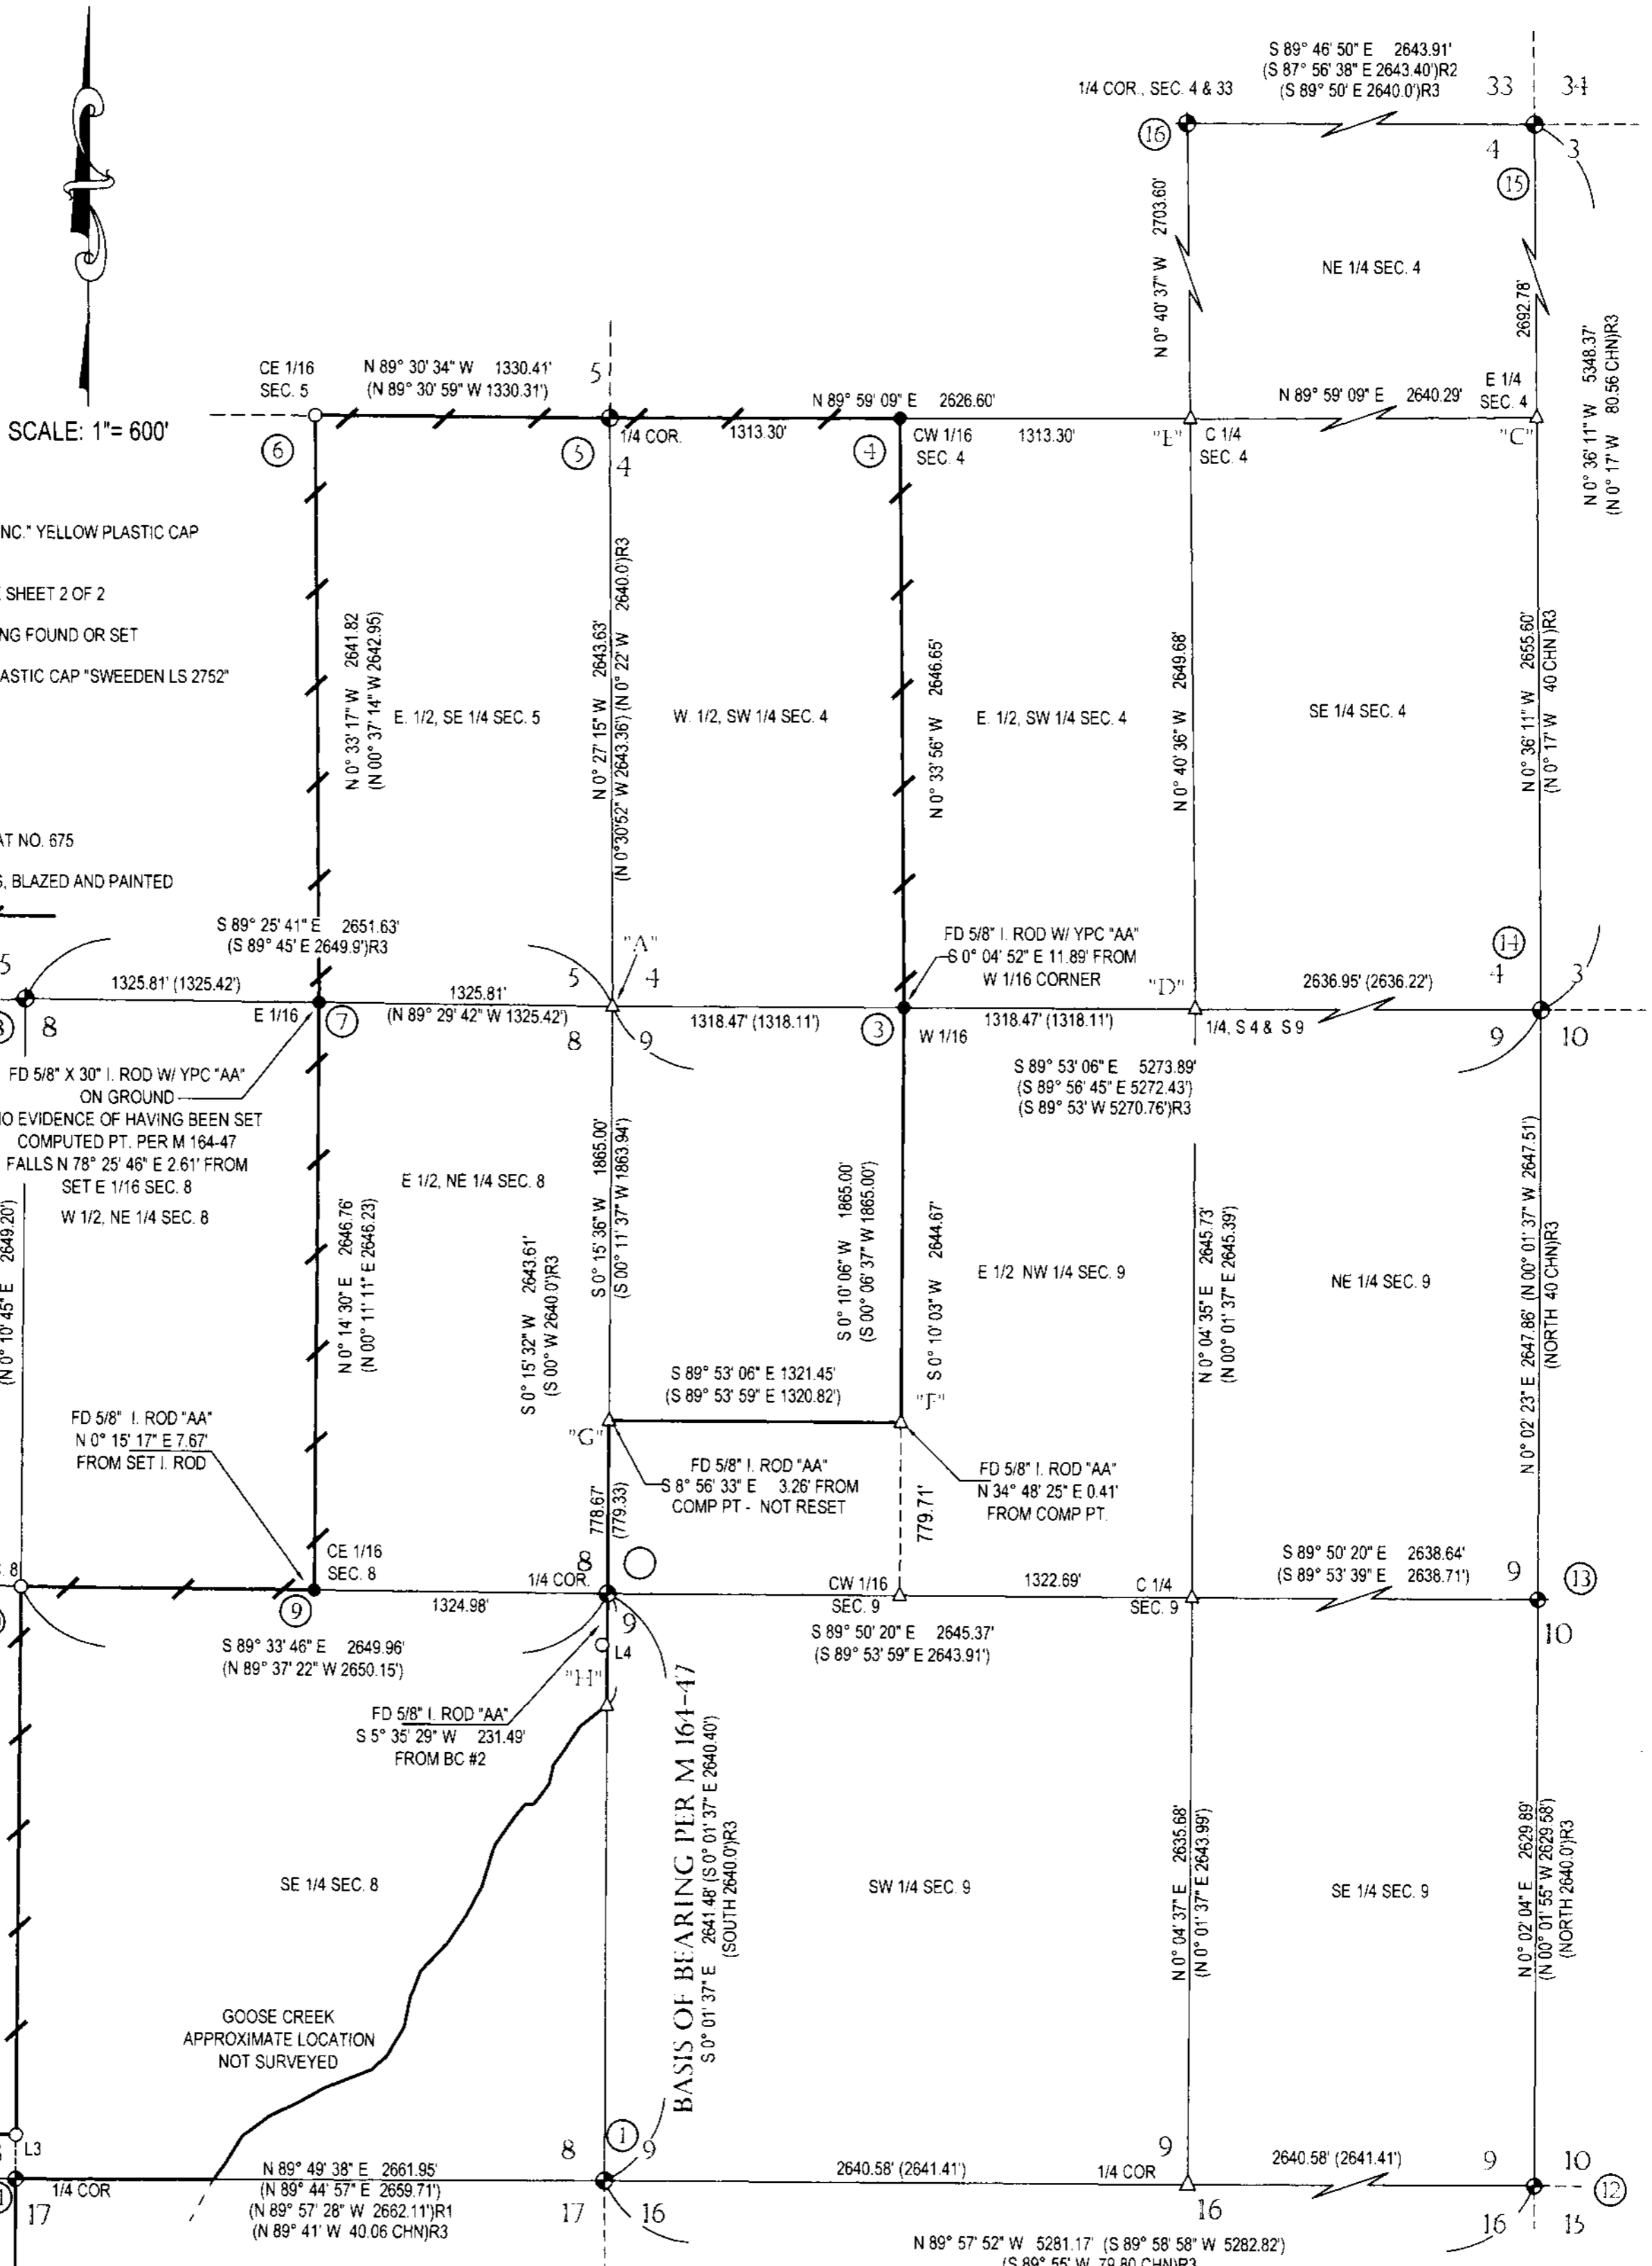
LINE POSTED W/ 7" T" POSTS, BLAZED AND PAINTED

NOTE:  
THERE IS NO CORNER POSITION "B" ON THIS RECORD OF SURVEY!

LINE	BEARING	DISTANCE
L1	S 0° 34' 43" W (S 0° 10' 45" W)	193.25' (200.00')
L2	S 89° 45' 06" E (S 89° 09' 23" E)	598.84' (600.00')
L3	S 0° 17' 32" W (S 0° 10' 45" W)	199.90' (200.00')
L4	S 0° 01' 37" E	502.90'

THIS SURVEY WAS COMPLETED AS DIRECTED BY THE OWNER AS A RESULT OF ERRORS FOUND WHILE TRAVERSING BETWEEN MONUMENTS AS SET IN SURVEY M 164-47 TO MARK LINE FOR FENCING. AFTER COMPLETION OF THE RE SURVEY OF M 164 - 47 THE SURVEY WAS EXTENDED TO MONUMENT THE NORTHEAST CORNER OF THE WEST 1/2 OF THE SW 1/4 OF SECTION 4. STARTING AT THE SOUTHWEST CORNER OF SURVEY M 164-47 AND USING MONUMENTS FROM M 164 - 47 TRAVERSE WORK COMMENCED RUNNING NORTH ALONG THE WESTERLY BOUNDARY TO THE EAST 1/16TH CORNER OF SECTION 5 & 8. AT THIS POSITION A 5/8" IRON ROD WITH A YELLOW PLASTIC CAP "AA SURVEY INC." WAS FOUND LYING NEAR THE COMPUTED POSITION BUT WITH NO EVIDENCE OF HAVING BEEN DRIVEN. THE BEARING TREES REFERENCED IN M 164 - 47 WOULD HAVE BEEN USED TO SET A MARKER BUT THE BEARING TREES REFERENCED DO NOT EXIST. DISCOVERY OF THIS ISSUE LED TO ADDITIONAL SURVEYING TO TIE THE ESTABLISHED BRASS CAPS AT CORNERS 8, 14, 2 AND 5 IN ORDER TO COMPUTE THE POSITION OF THE COMMON SECTION CORNER FOR SECTIONS 4, 5, 8 AND 9. BEING COMPUTED POSITION "A" WHICH WAS COMPLETED BY DOUBLE PROPORTION. THE POSITION OF THE EAST 1/16TH CORNER, CORNER 7 WAS REESTABLISHED BY SINGLE PROPORTION BETWEEN THE BRASS CAP AT 8 AND POSITION "A". CONTINUING THE LINE TRAVERSE NORTH FROM THE COMMON 1/4 CORNER OF SECTIONS 8 AND 9, CORNER 2 AND USING THE FOUND MARKER AT POSITION "H" IT WAS DETERMINED THAT A PROBLEM EXISTED ALONG THIS PORTION OF THE LINE AS CLOSURE INTO THE FOUND MONUMENT AT "G" DID NOT FIT WELL. ALSO THE MONUMENT FOUND AND USED AT THE CENTER EAST 1/16TH CORNER OF SECTION 8, POSITION 9 ALSO FIT VERY POORLY. TO RESOLVE THESE ISSUES TIES WERE THEN MADE TO THE BRASS CAPS AT CORNER 11 AND CORNER 1. THIS FOUND THAT THE CENTER 1/4 CORNER OF SECTION 8 FIT CLOSELY WITH RECORD BUT THAT THE MONUMENTS 9 AND AT POSITION "H" WERE OUT OF POSITION. THE CENTER EAST 1/16TH OF SECTION 8 WAS THEN SET AT THE PROPER POSITION BUT NO MONUMENT WAS SET IN THE AREA OF "H" AS PER THE OWNERS DIRECTION. A SECOND TRAVERSE OF THE LINE FROM THE EAST 1/4 CORNER OF SECTION 8 NORTH TO THE MONUMENT AT POSITION "G" FOUND IT TO BE OUT OF POSITION AS WELL BUT CONTINUING EAST FROM THIS COMPUTED POSITION FOUND THAT THE MARKER AT "F" FIT WELL. NO NEW MONUMENT WAS SET IN THE AREA OF "G" AS DIRECTED. WORK THEN BEGAN ON SECTION 4 TO SUBDIVIDE THE SECTION COMPUTING THE NORTHEAST CORNER OF THE WEST 1/2 OF THE SOUTHWEST 1/4 OF SECTION 4. THE BRASS CAPS AT THE NORTHEAST CORNER OF SECTION 4, CORNER 10 AND THE NORTH 1/4 CORNER OF SECTION 4, CORNER 16 WERE THEN TIED. THE EAST 1/4 OF SECTION 4, "C" AND THE SOUTH 1/4 CORNER, "D" WERE COMPUTED BY SINGLE PROPORTION. THE CENTER 1/4, "E" WAS THEN ESTABLISHED AND THE NORTHEAST CORNER OF THE WEST 1/2 OF THE SOUTHWEST 1/4 THEN COMPUTED AND MONUMENTED. POINT "4" WITH THIS COMPLETED THE EAST LINE OF THE WEST 1/2 WAS TRAVERSED AND MARKED HOLDING THE COMPUTED WEST 1/16TH POSITION OF SECTIONS 4 AND 9. IT WAS FOUND THAT THE MONUMENT SET AT THIS POSITION PER M 164 - 47 WAS ALSO OUT OF POSITION. ADDITIONAL SURVEY TIES WERE MADE TO CORNERS 13 AND 12 IN ORDER TO COMPUTE AND CHECK THE MONUMENT AT CORNER "F" SET IN M 164 - 47 WHICH WAS FOUND TO BE IN GOOD POSITION. NO PROPERTY LINES IN THE NW 1/4 OF SECTION 9 WERE MARKED PER OWNER REQUEST. THE SURVEYS REFERENCED FOR THIS WORK ARE: M 164-47, M 158-63, M 119-74 AND RECORD GLO NOTES. THE BASIS OF BEARING IS THE WEST LINE OF THE SOUTHWEST 1/4 OF THE SECTION 9 HOLDING THE BRASS CAPS AS FOUND. ALL COMPUTATION FOR COMPUTED POSITION OR SET POSITIONS WERE IN ACCORDANCE WITH THE 2009 BLM MANUAL OF INSTRUCTION AND BY USING PROPER SURVEY PRACTICES.
