MAP OF SURVEY

LOCATED in the SE 1/4 of Section 17, T. 25 S., R. 5 W., W.M.
in Douglas County, Oregon.

MAP FILE M182-42

THE PURPOSE OF THIS SURVEY IS TO LOCATE AND MONUMENT THE CORNERS OF LOT 6, BLOCK 38, AMENDED PLAT OF THE TOWNSITE OF SUTHERLIN. ALL BLOCK CORNER MONUMENTS SHOWN IN BLOCK 31 ON SURVEYS M 82-35 AND M 111-58 HAVE BEEN DESTROYED BY SIDEWALK CONSTRUCTION. THE ONLY OTHER MONUMENTS SHOWN AS FOUND OR SET IN BLOCK 31 ON THOSE SURVEYS OR ON SURVEY M 114-74 ARE AS SHOWN HEREON AND ALL OF THOSE FOUND HAVE BEEN DISTURBED. THE SE CORNER OF LOT 22 IS UNDER A SIDEWALK AND BENT. THE NE CORNER OF SAID LOT IS EMBEDDED IN A CONCRETE FENCE CORNER BASE. THE SW CORNER OF LOT 24 IS FOUND EMBEDDED IN THE SIDEWALK AND THE NW CORNER OF LOT 11 IS JUST PLAIN OLD BENT. THE FOUND IRON PIPE AT THE NE CORNER OF BLOCK 38 IS FOUND 6" DEEP IN A LAWN AND LOOKS IN GREAT SHAPE. GIVEN THAT THIS PIPE AND THE FOUND IRON ROD AT THE NE CORNER OF LOT 18, BLOCK 24 FIT TOGETHER AT NEARLY PLAT RECORD 1 ELECT TO HOLD TO THESE TWO MONUMENTS AND COMPUTE THE POSITIONS OF THE LOT 6, BLOCK 38 CORNERS USING PLAT RECORD DATA. I DID SEARCH FOR ALL OTHER MONUMENTS SHOWN AS FOUND OR SET ON THE SURVEYS NOTED IN THIS NARR

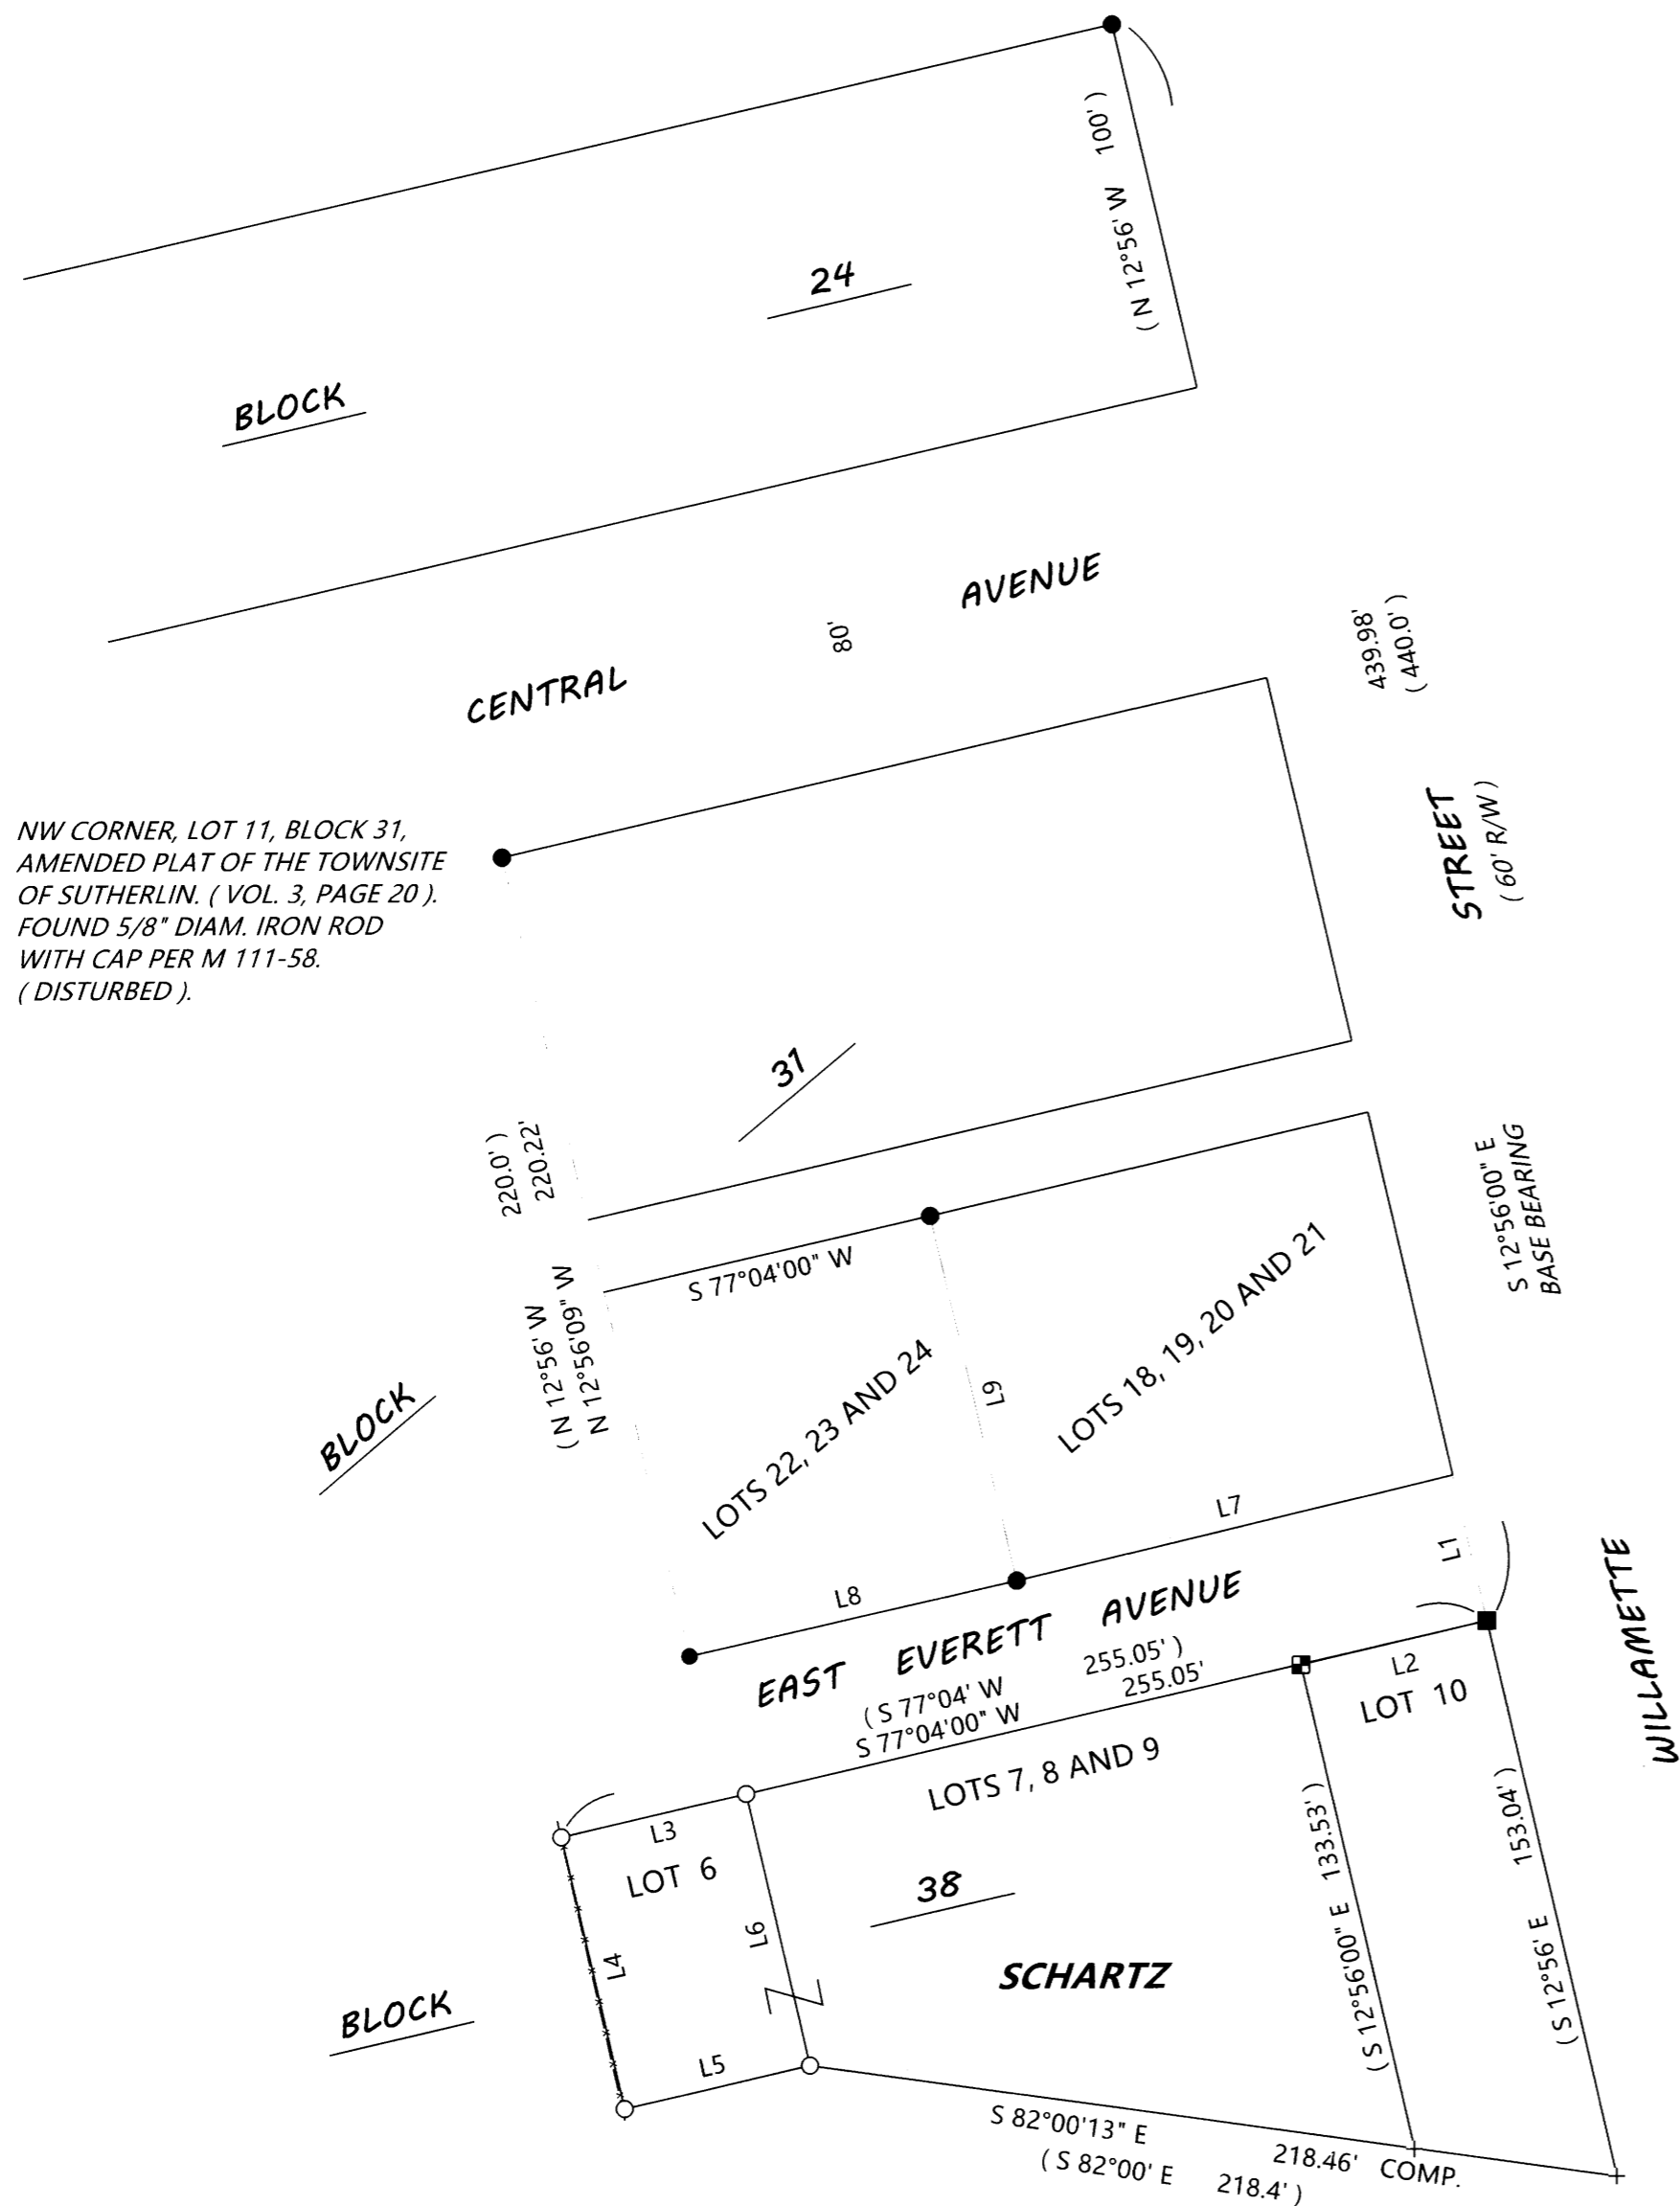
NE CORNER, LOT 18, BLOCK 24,
AMENDED PLAT OF THE TOWNSITE
OF SUTHERLIN. (VOL. 3, PAGE 20).
FOUND 5/8" DIAM. IRON ROD PER M 73-33.

NW CORNER, LOT 11, BLOCK 31,
AMENDED PLAT OF THE TOWNSITE
OF SUTHERLIN. (VOL. 3, PAGE 20).
FOUND 5/8" DIAM. IRON ROD
WITH CAP PER M 111-58.
(DISTURBED).
